PROPERTY CONDITION SURVEY - COMMERCIAL

AustDilaps was commissioned by {Client Name} to carry out a pre-construction condition inspection and report in accordance with AS.4349.1 for the {Project Name}

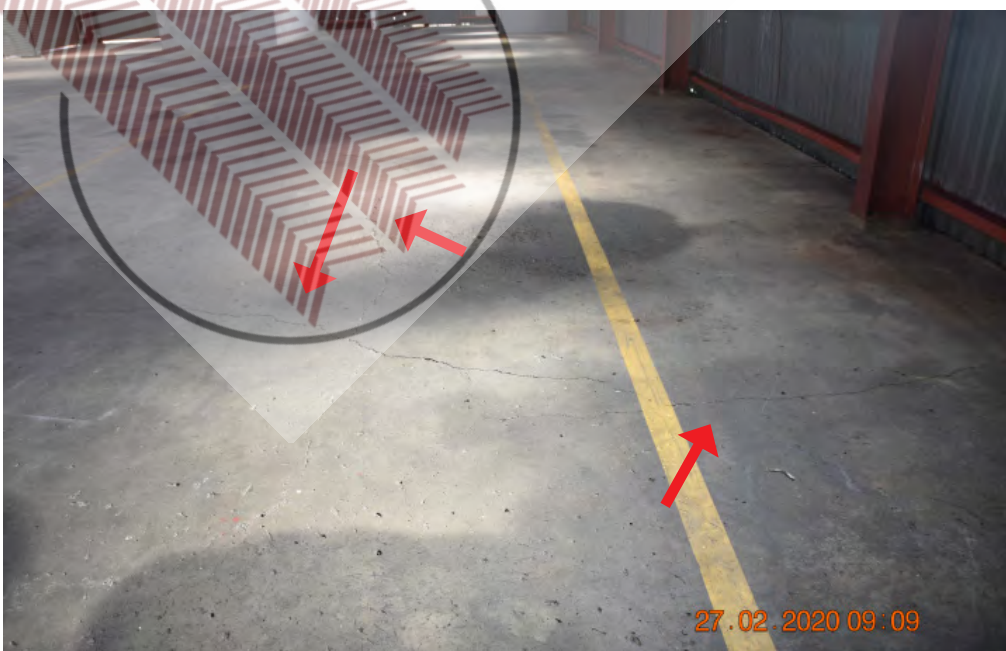
Figure: 0009

Cracking in the concrete flooring in the warehouse.

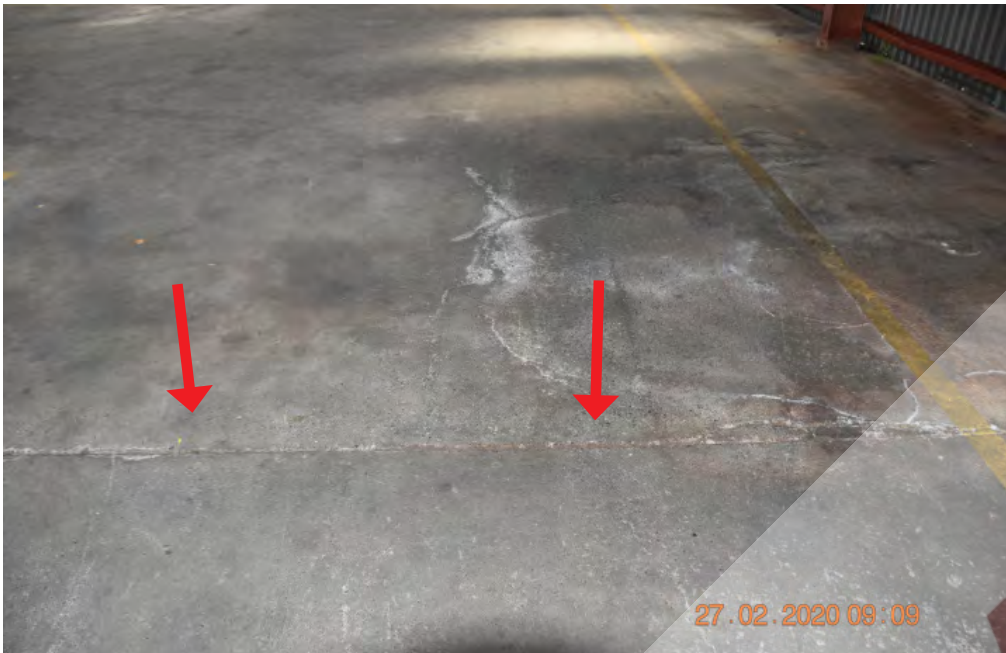
Figure: 0010

Cracking in the concrete flooring in the warehouse.

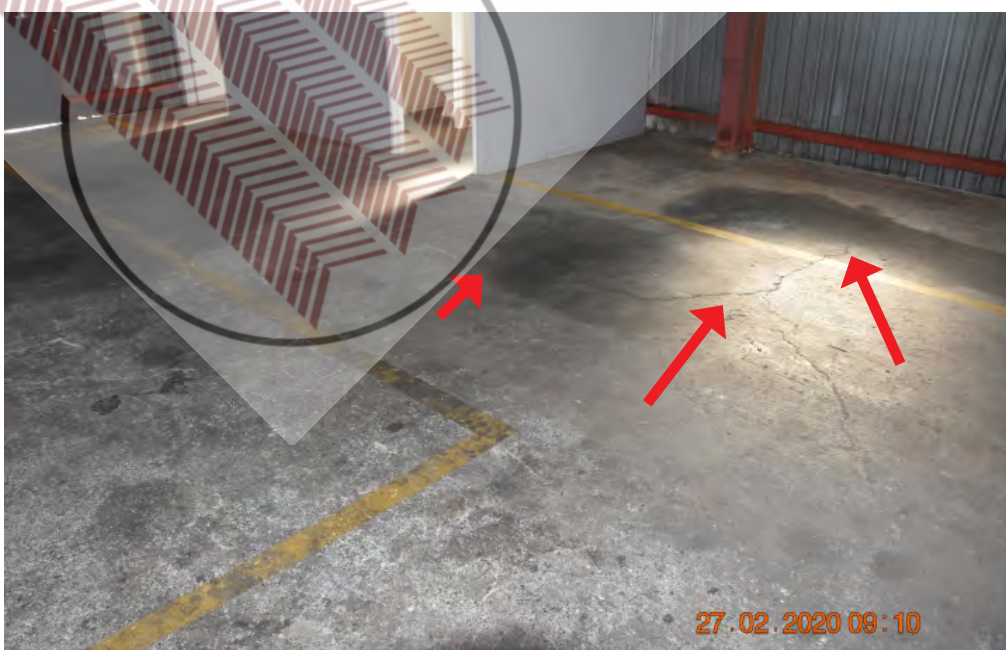
Figure: 0014

Cracking in the concrete flooring in the warehouse.

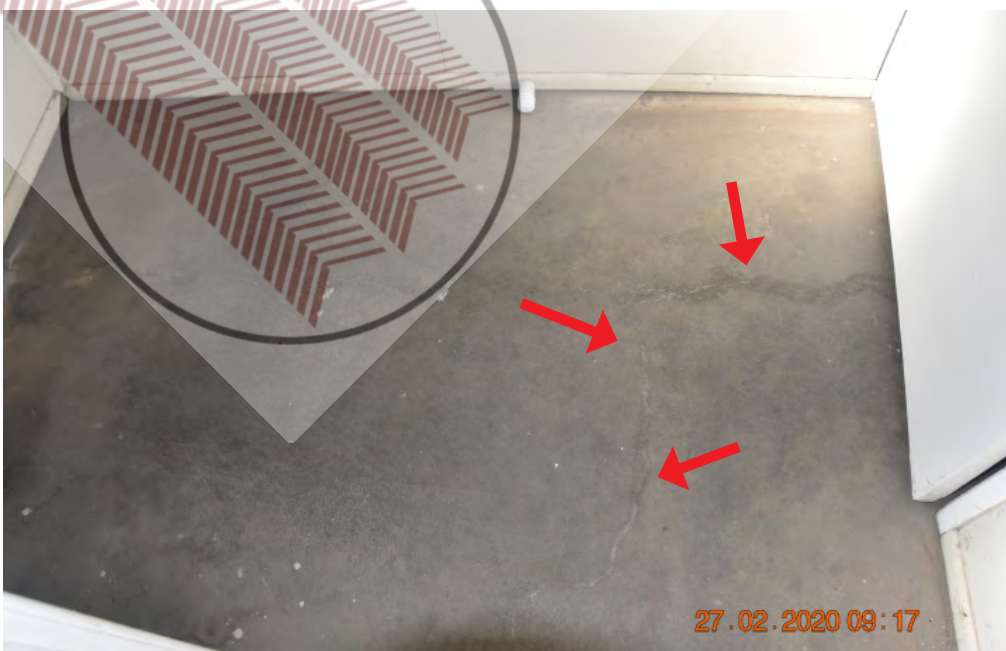
Figure: 0045

Fine cracking in the Concrete flooring in the toilet.

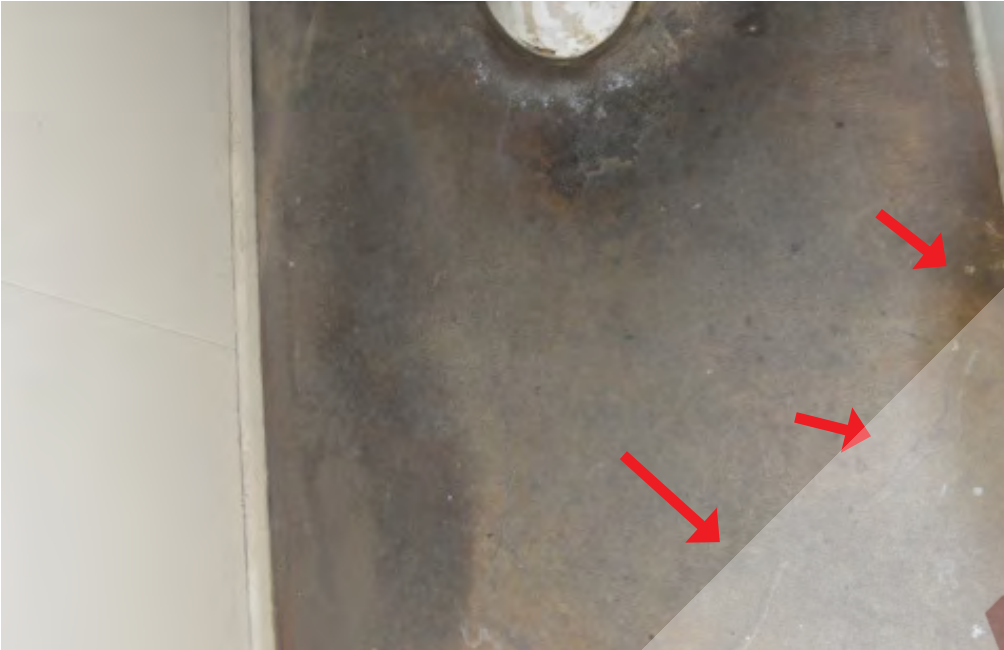
Figure: 0046

Fine cracking in the Concrete flooring in the toilet.

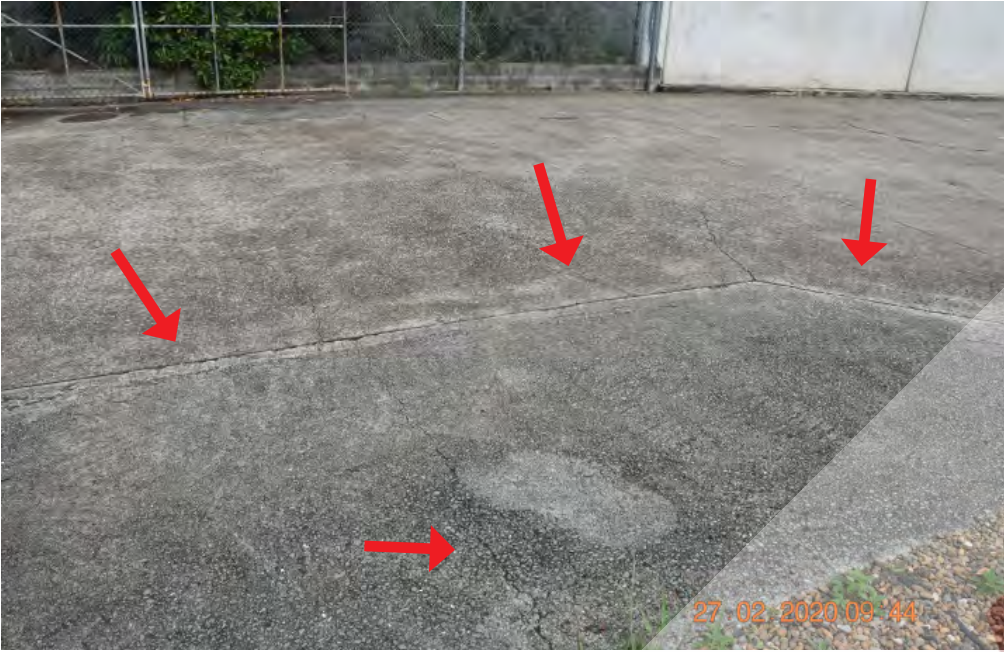
Figure: 0166

Cracking in the driveway.

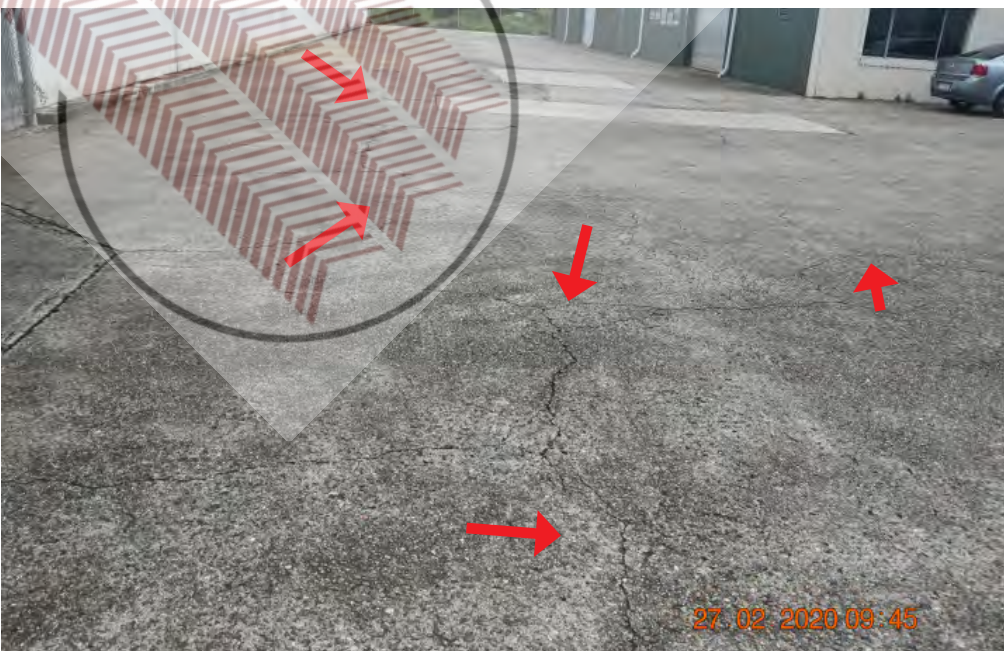
Figure: 0168

Severe cracking in the driveway.

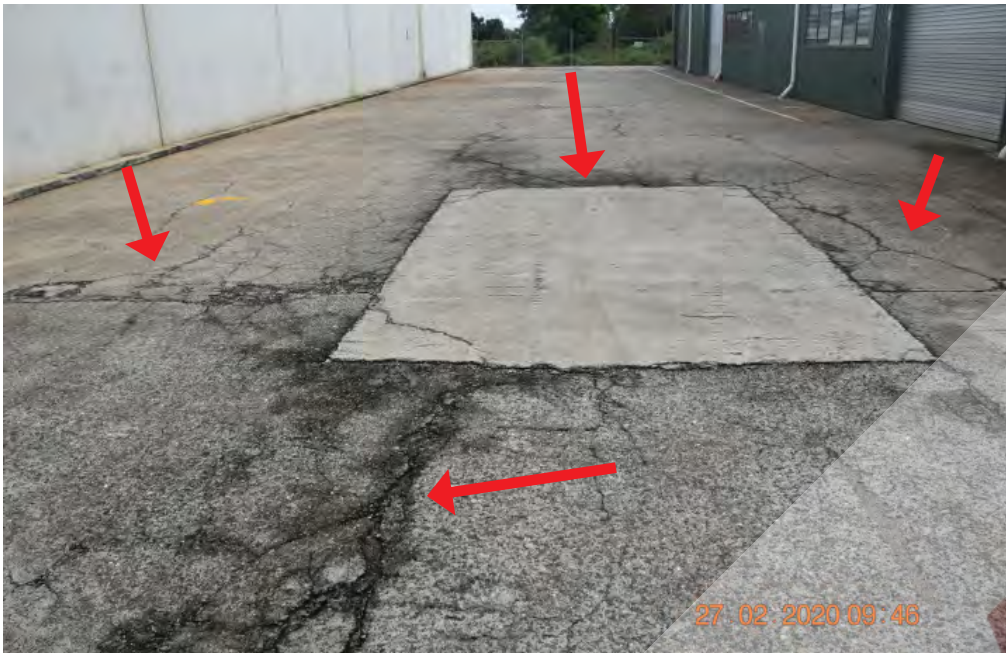
Figure: 0175

Massive cracking in the driveway.

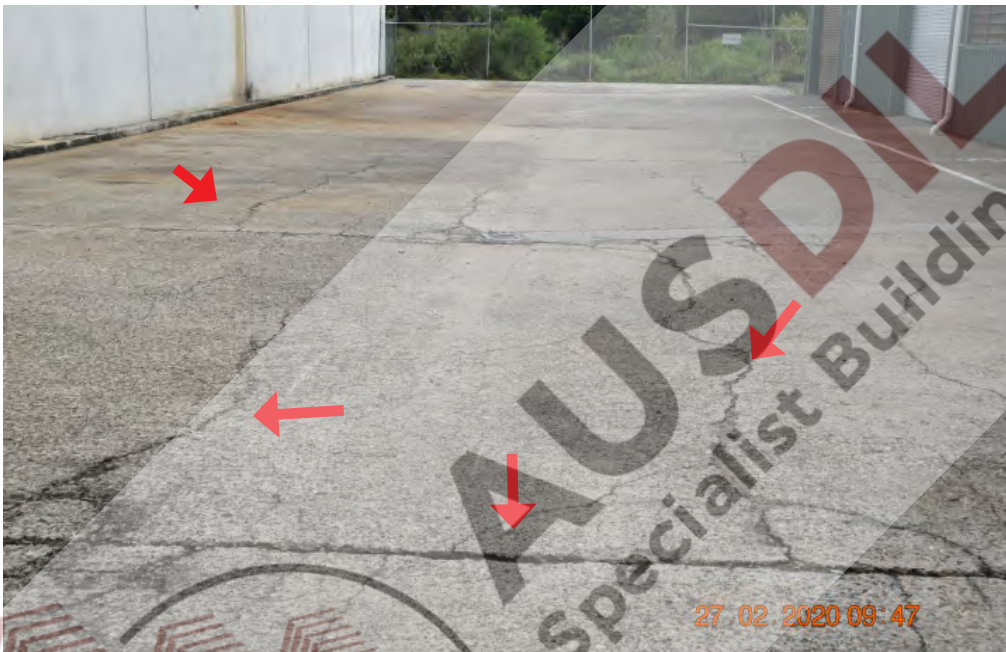
Figure: 0176

Massive cracking in the driveway.

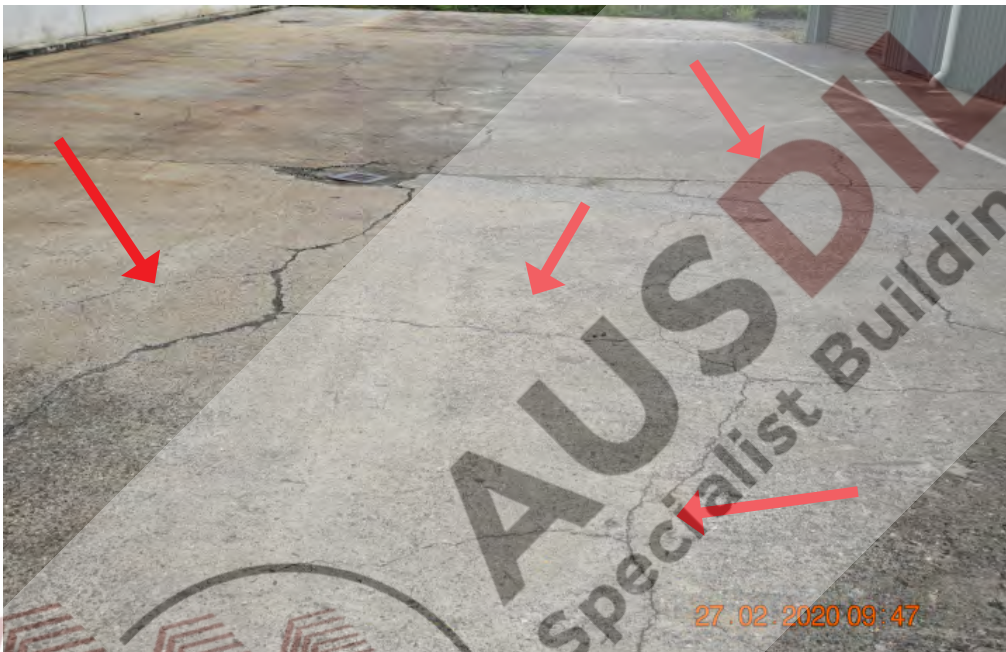
Figure: 0179

Cracking in the driveway.

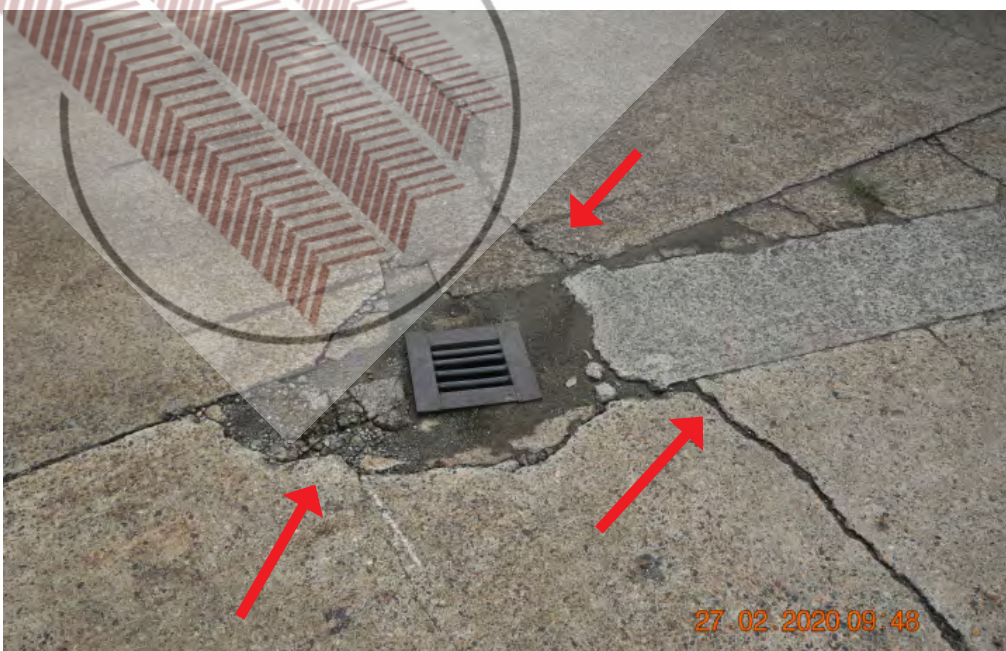
Figure: 0180

Severe cracking and damage around the drainage pit in the driveway.

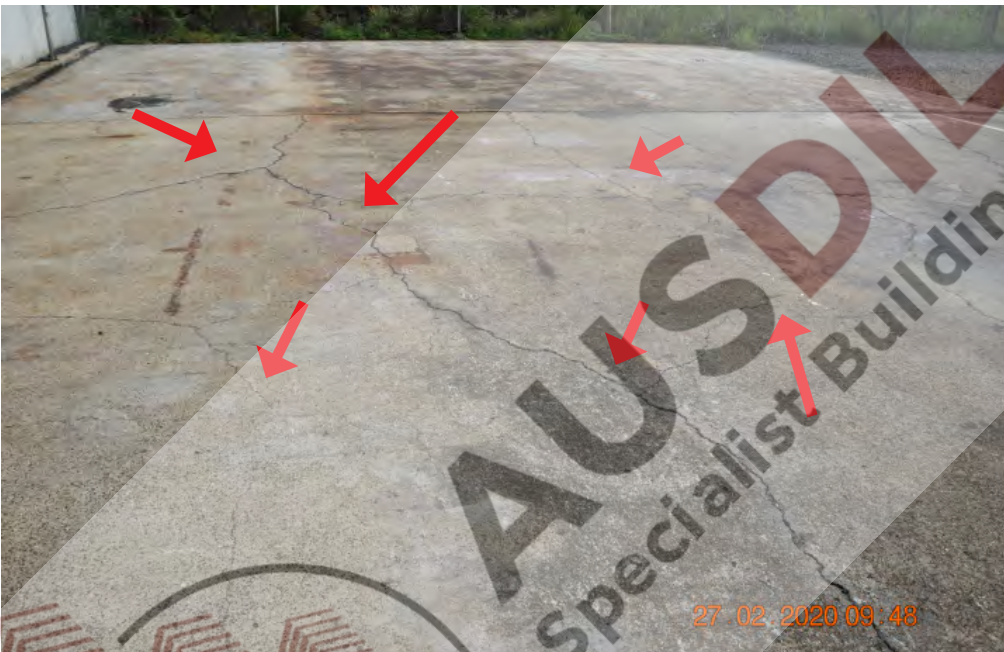
Figure: 0182

Cracking in the driveway.

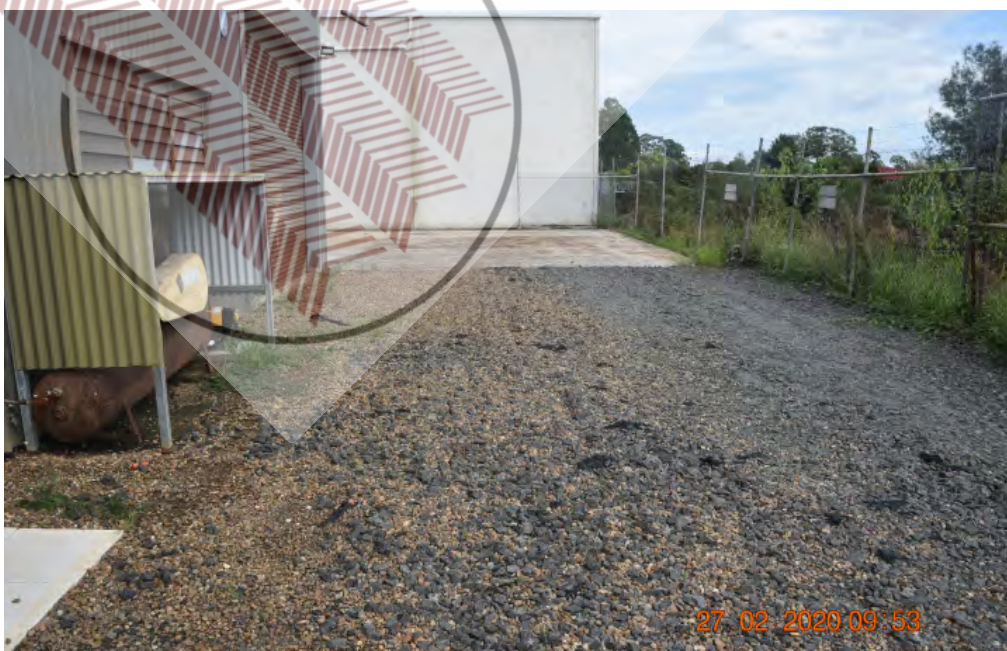
Figure: 0194

Hole in the right boundary fence, front side.
