PRE CONSTRUCTION CONDITION SURVEY - COUNCIL ASSETS

Council Assets
179-191 New South Head Road
EDGECLIFF NSW 2027

30 June 2020

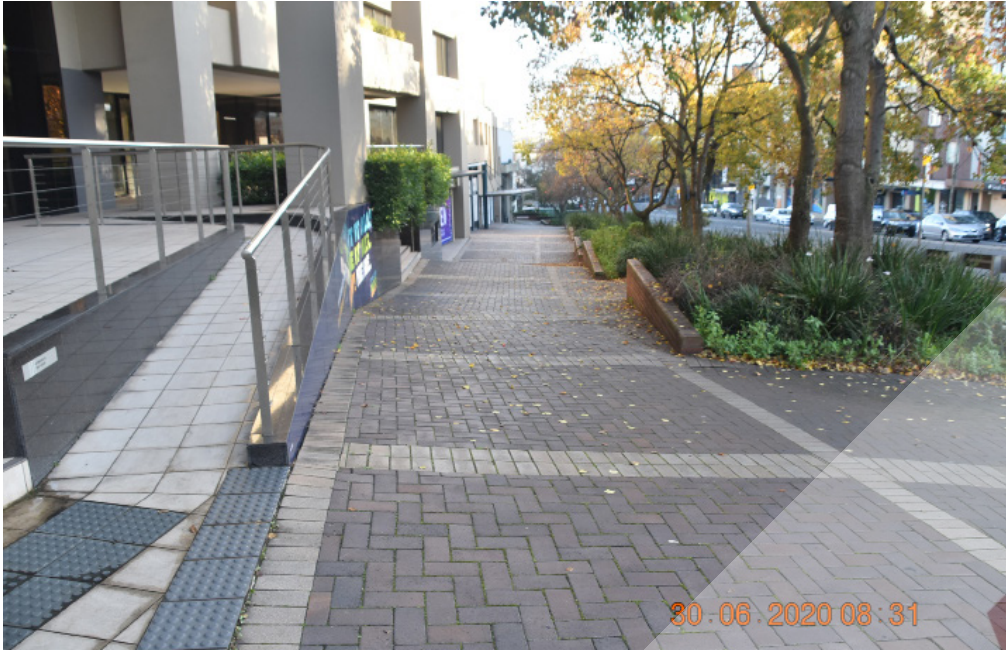
Figure: 0002

Uneven paving in the footpath outside 179-191 New South Head Road, adjoining the stairway.

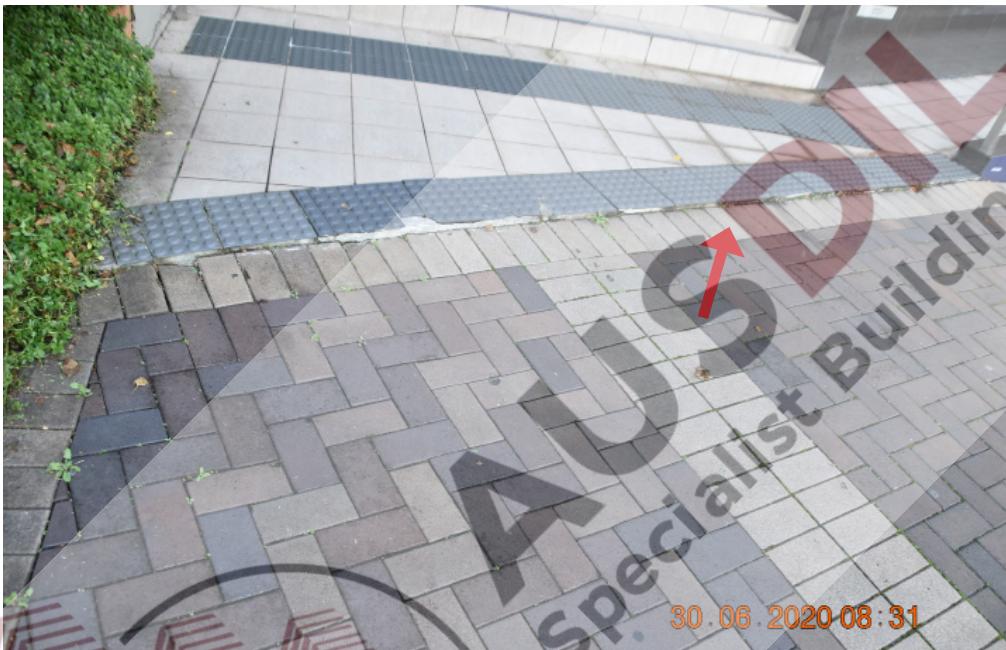
Figure: 0003

Subsidence in the footpath, outside 179-191 New South Head Road - reason code 2.

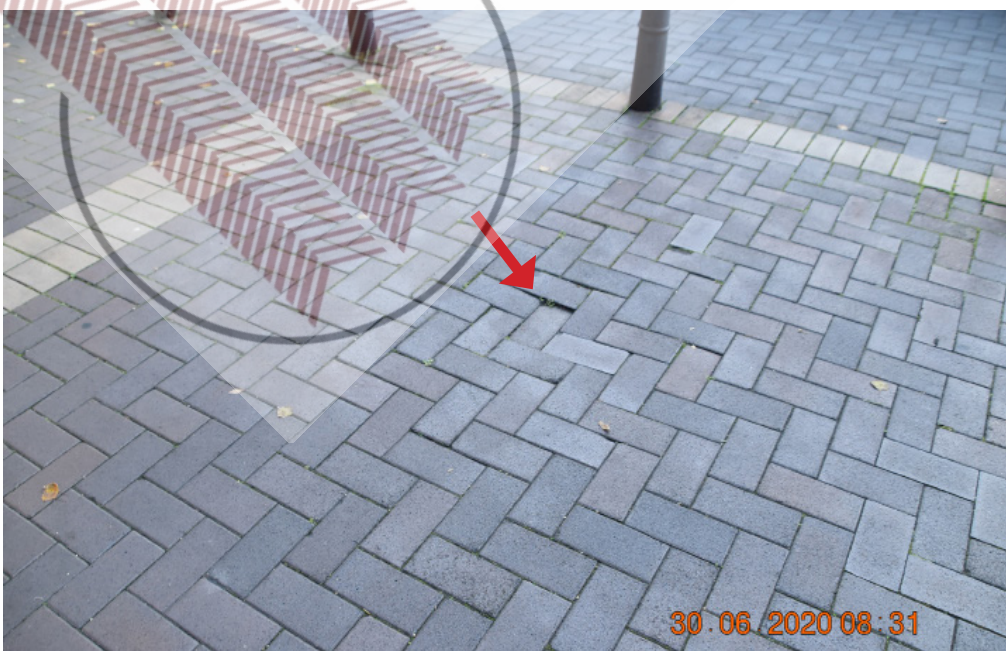
Figure: 0004

Movement in the footpath, outside 179-191 New South Head Road.

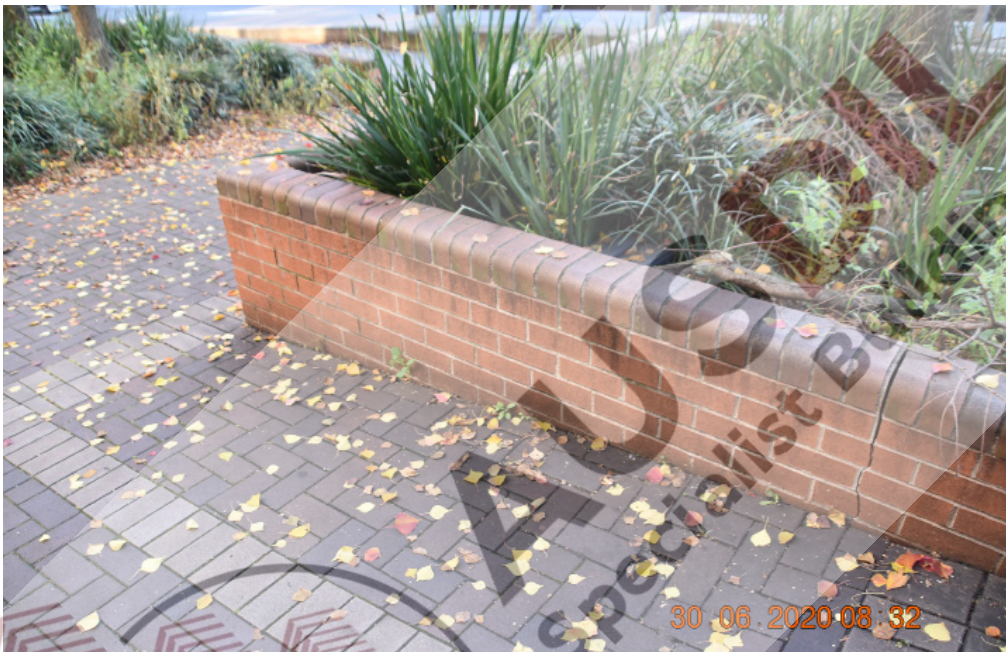
Figure: 0009

Slight cracking in the brick retaining wall, outside 179-191 New South Head Road.

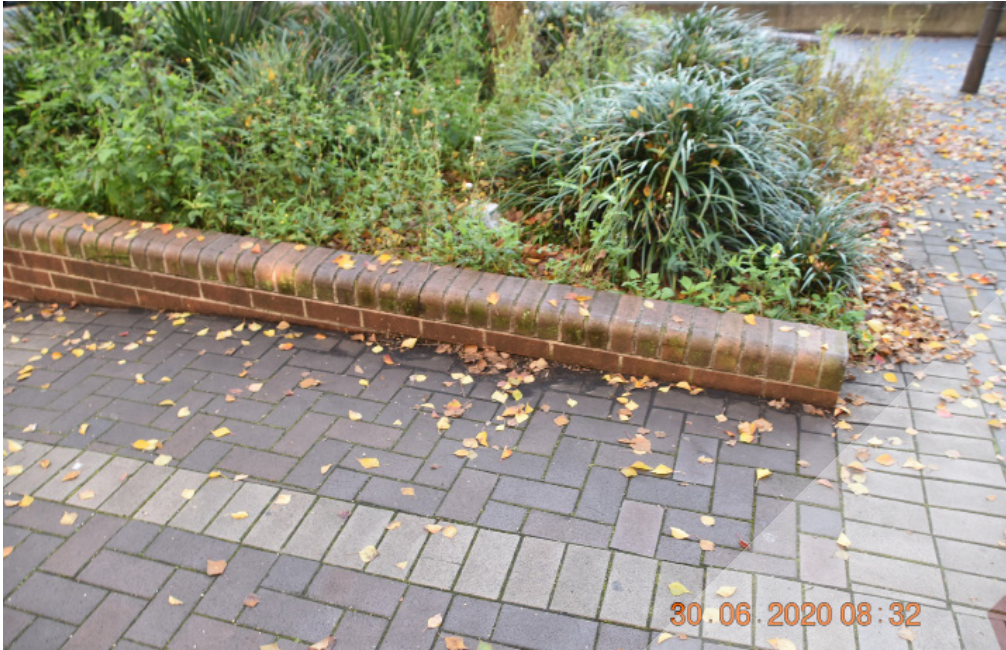
Figure: 0014

Chipping in the brickwork in the retaining wall, outside 179-191 New South Head Road.

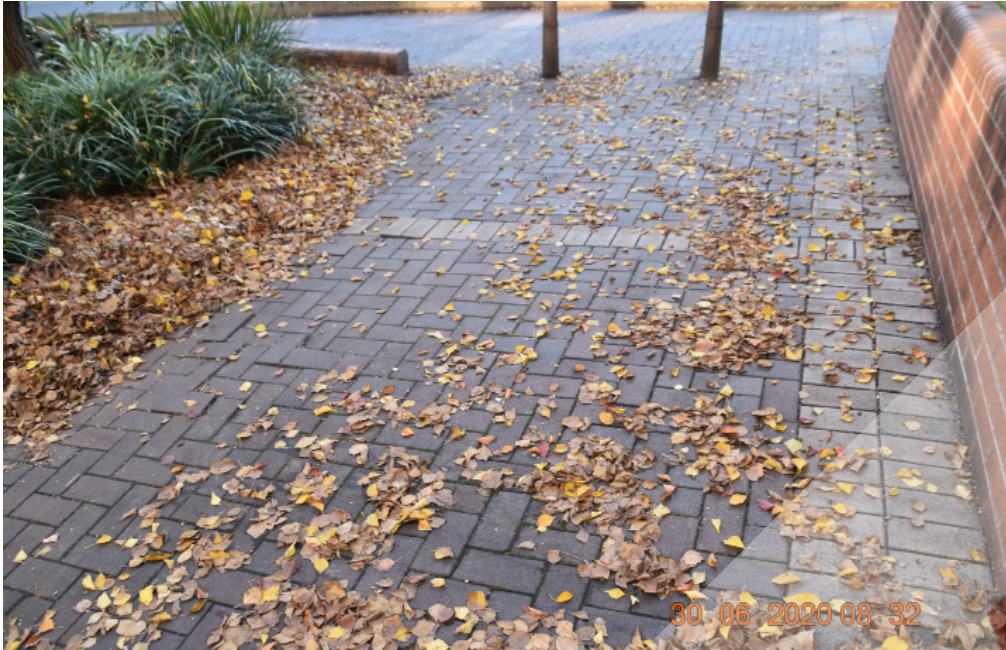
Figure: 0017

Subsidence in the footpath, outside shop 1 at 179-191 New South Head Road - reason code 2.

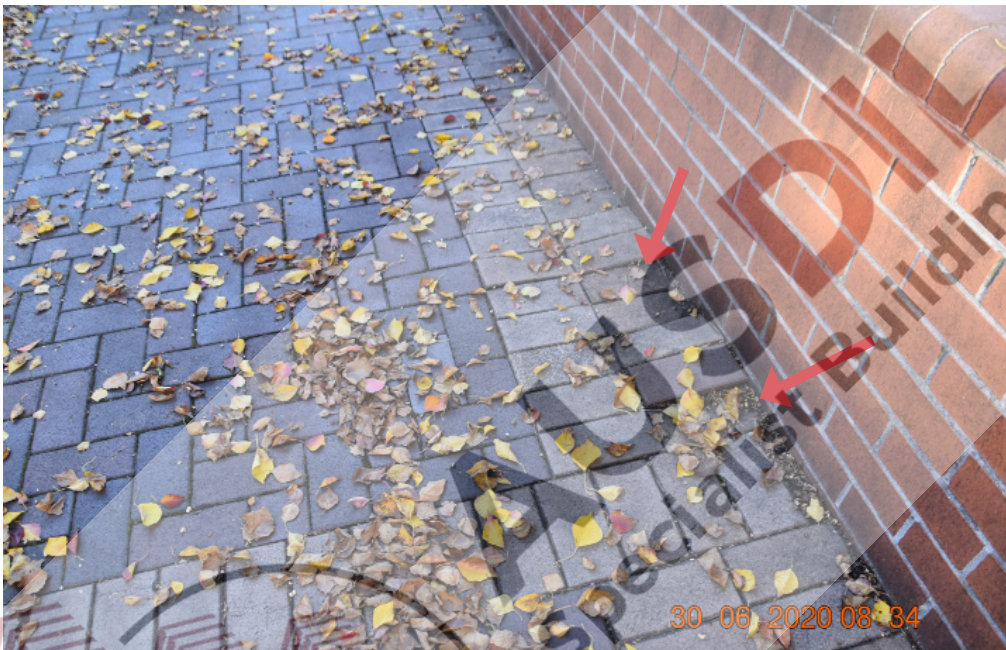
Figure: 0018

Uneven paving in the footpath, outside shop 1 at 179-191 New South Head Road.

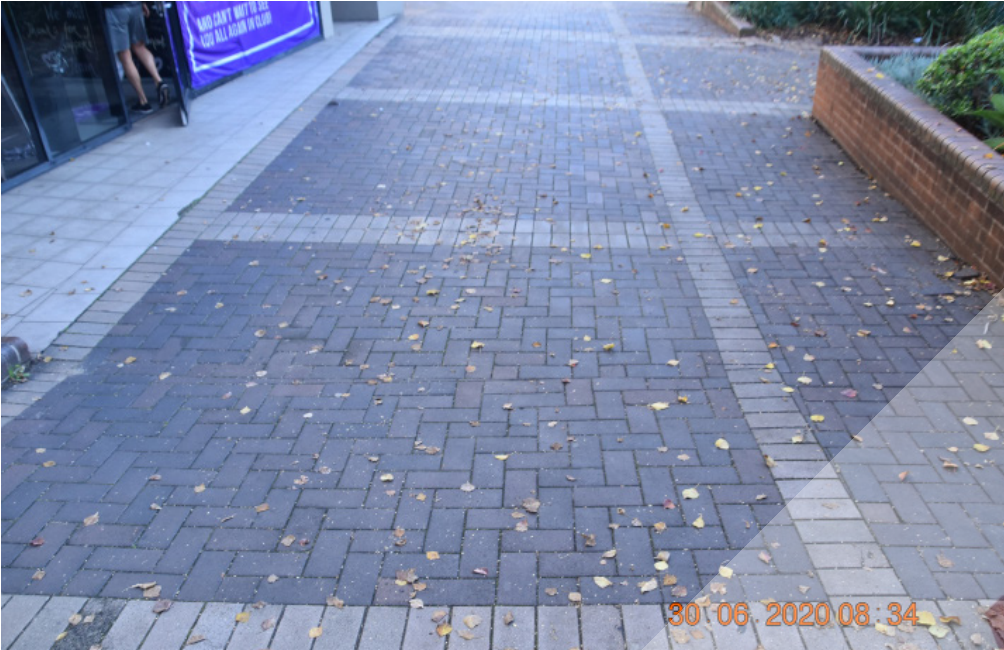
Figure: 0020

Chipping in the tile paving, outside shop 1 at 179-191 New South Head Road.

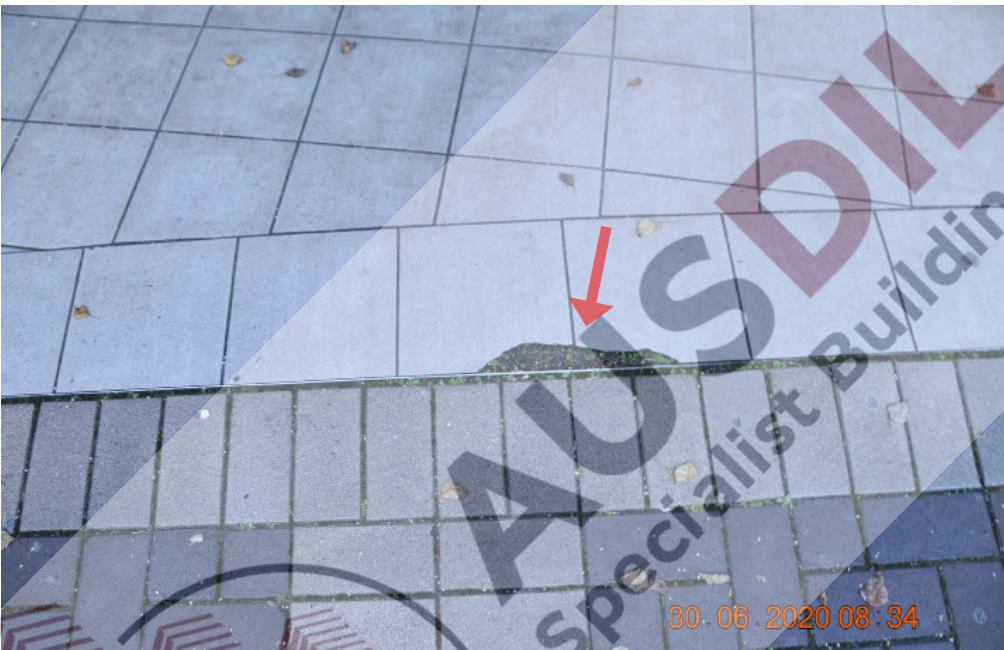
Figure: 0021

General view of the brick retaining wall, outside shop 1 at 179-191 New South Head Road. Showing movement in the brick pavers - reason code 2.

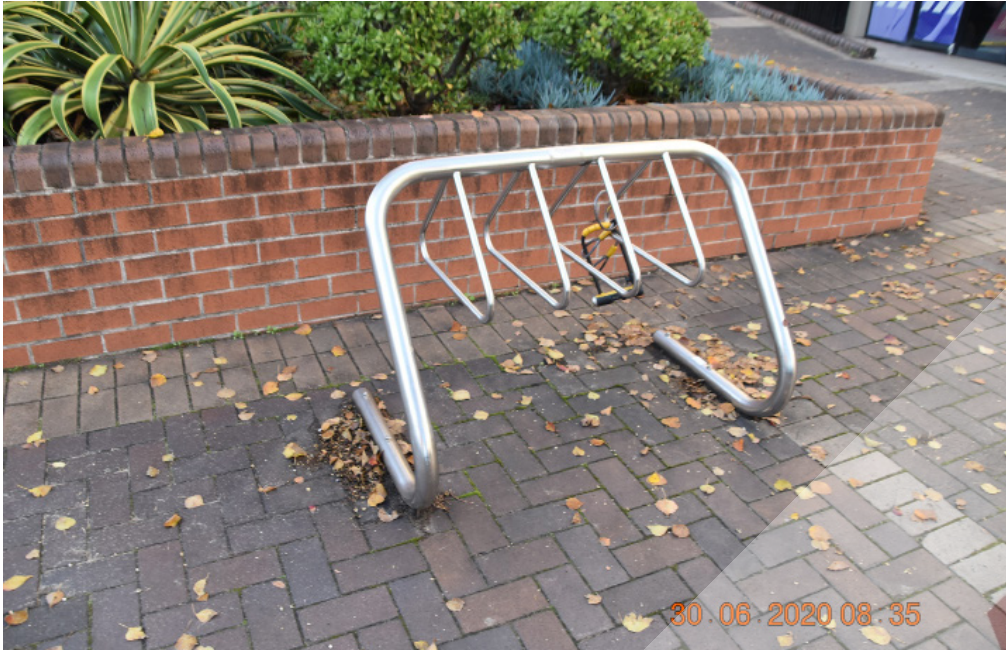
Figure: 0026

Subsidence and movement in the pavers, outside shop 1 at 179-191 New South Head Road - reason code 2.

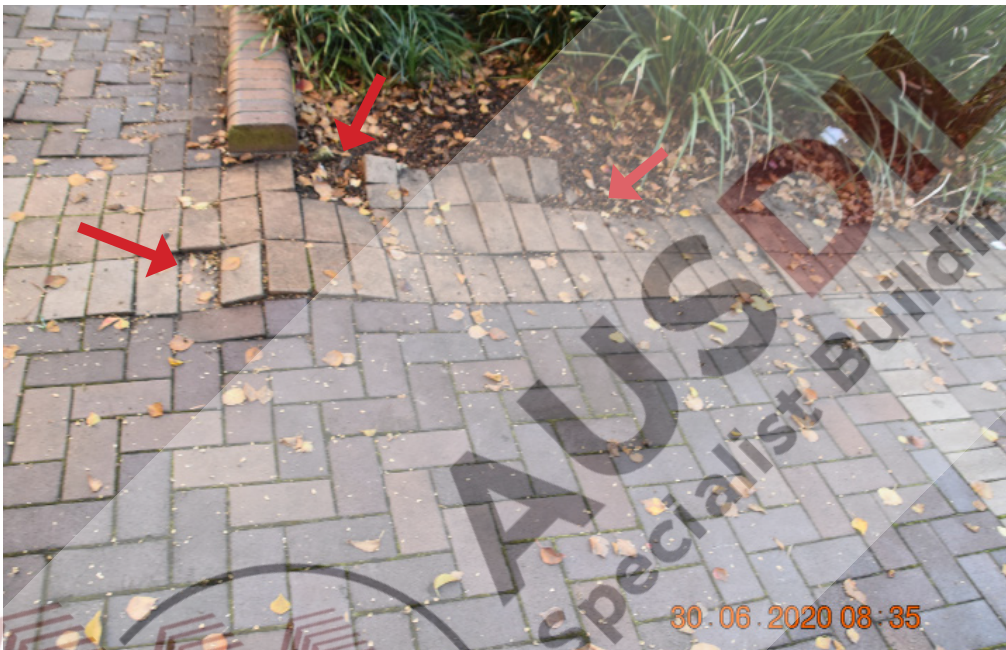
Figure: 0027

Movement in the pavers, outside shop 1 at 179-191 New South Head Road.

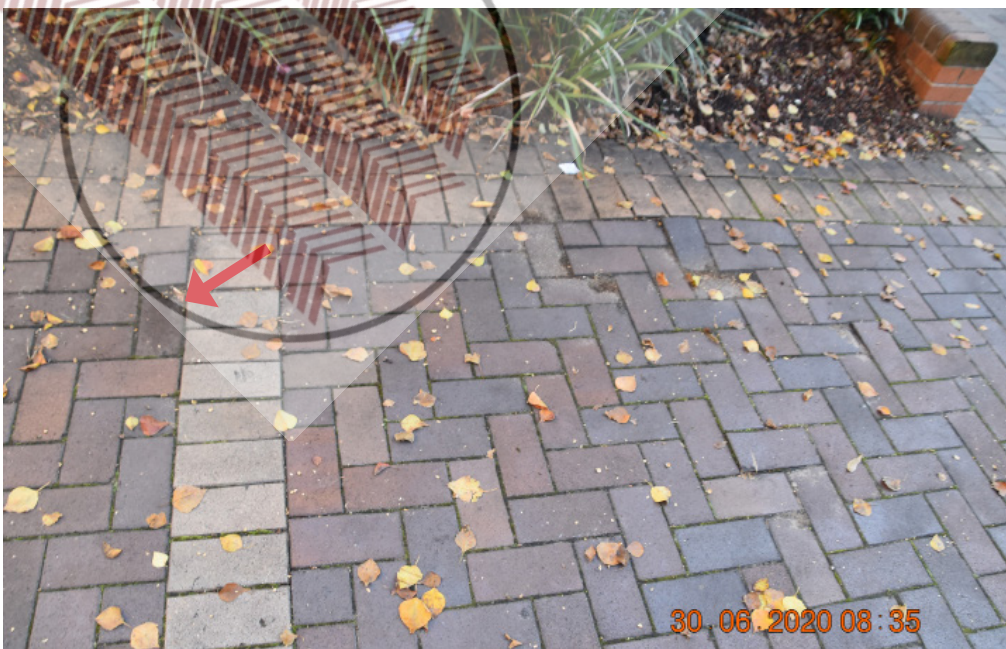
Figure: 0028

Subsidence and movement in the pavers, outside shop 1 at 179-191 New South Head Road - reason code 2 and 3.

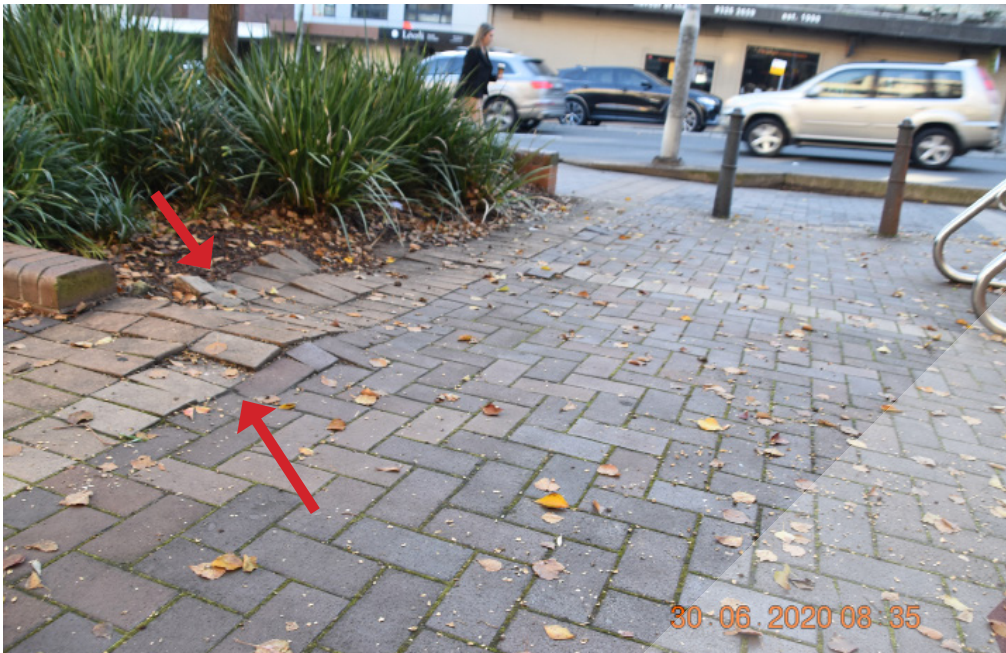
Figure: 0029

Uneven pavers in the footpath, outside shop 1 at 179-191 New South Head Road.
