## PROPERTY CONDITION SURVEY - COMMERCIAL

AusDilaps was commissioned by XXXXXXXXXXXXXXXX to carry out pre-construction condition inspection and report in accordance with AS.4349.1 for the XXXXXXXXXXXXXXXX project.

Newtown Rail Corridor NEWTOWN NSW 2042

# NEWTOWN Rail Corridor Station Street

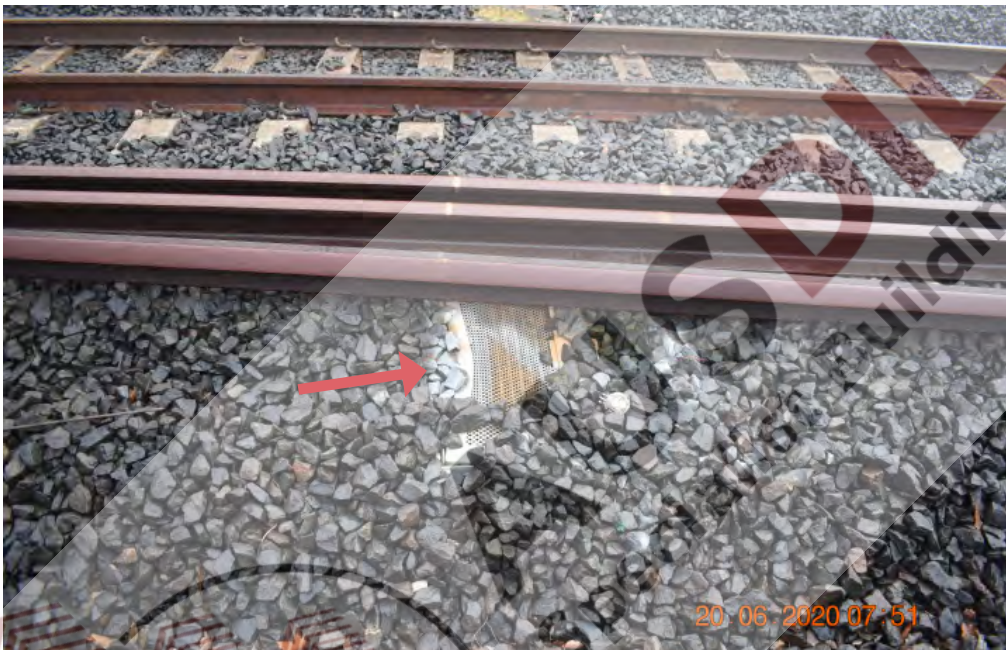
Figure: 0086

| Damage in the pit lid between the suburban up-track and the main down-track, at approximately 5 metres east of chainage 3+382. | 41 |

Damage in the pit lid between the suburban up-track and the main down-track, at approximately 5 metres east of chainage 3+382.

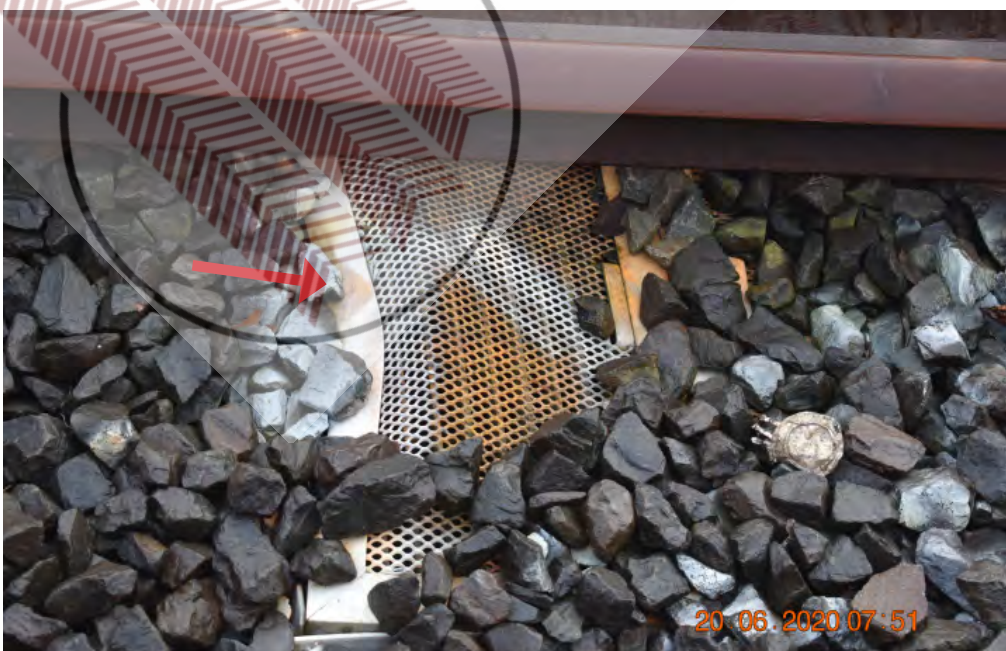
Figure: 0087

| Damage in the pit lid between the suburban up-track and the main down-track, at approximately 5 metres east of chainage 3+382. | 41 |

Damage in the pit lid between the suburban up-track and the main down-track, at approximately 5 metres east of chainage 3+382.

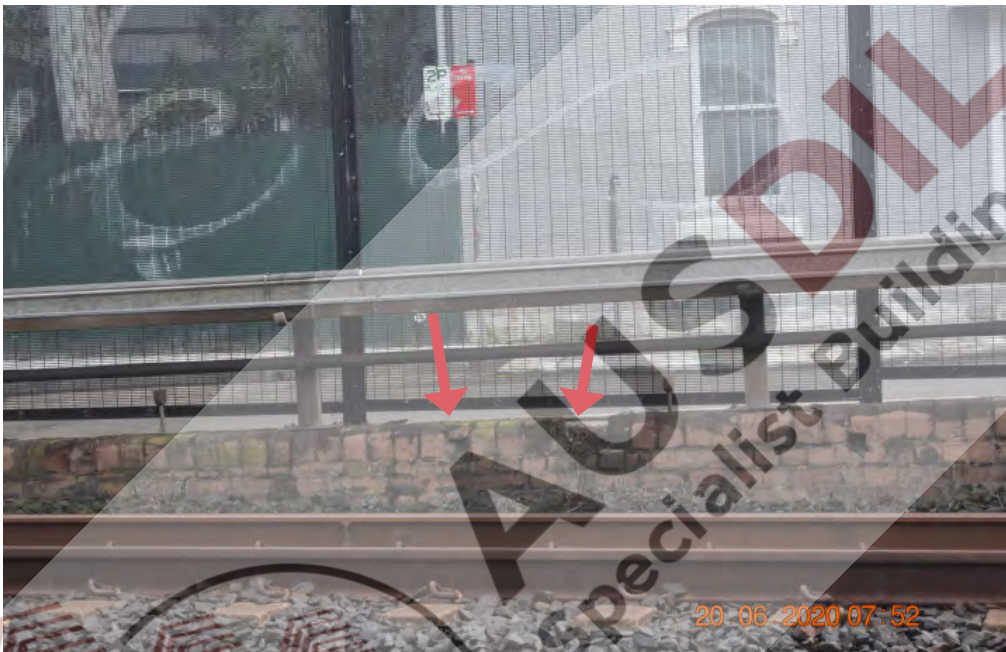
Figure: 0098

Damage in the retaining wall along the main up-track, looking northeast from approximately 15 metres east of chainage 3+382.

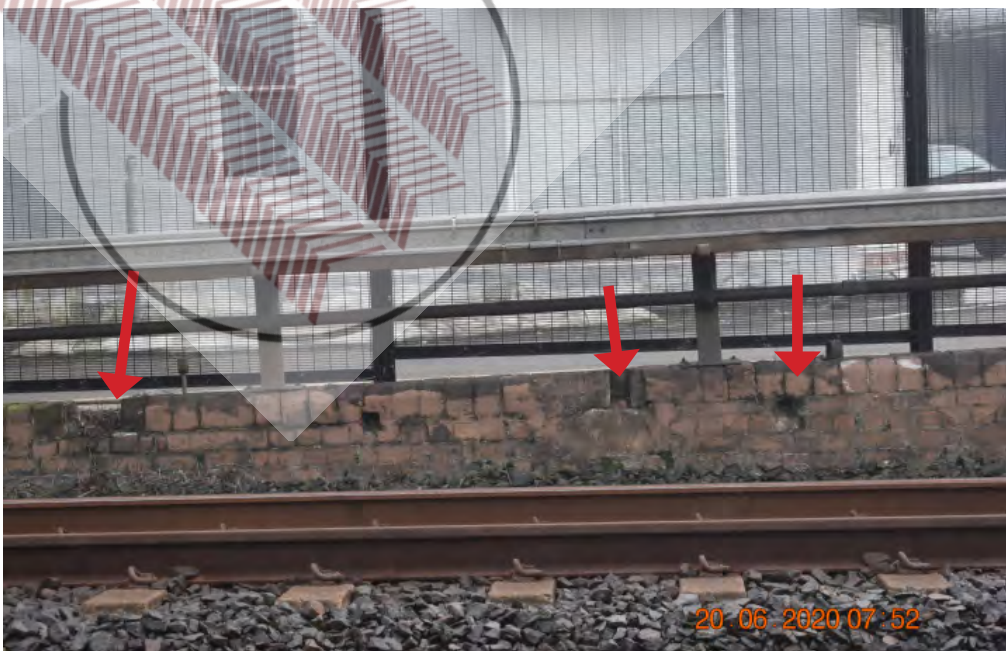
Figure: 0099

Damage in the retaining wall along the main up-track, looking northeast from approximately 15 metres east of chainage 3+382.

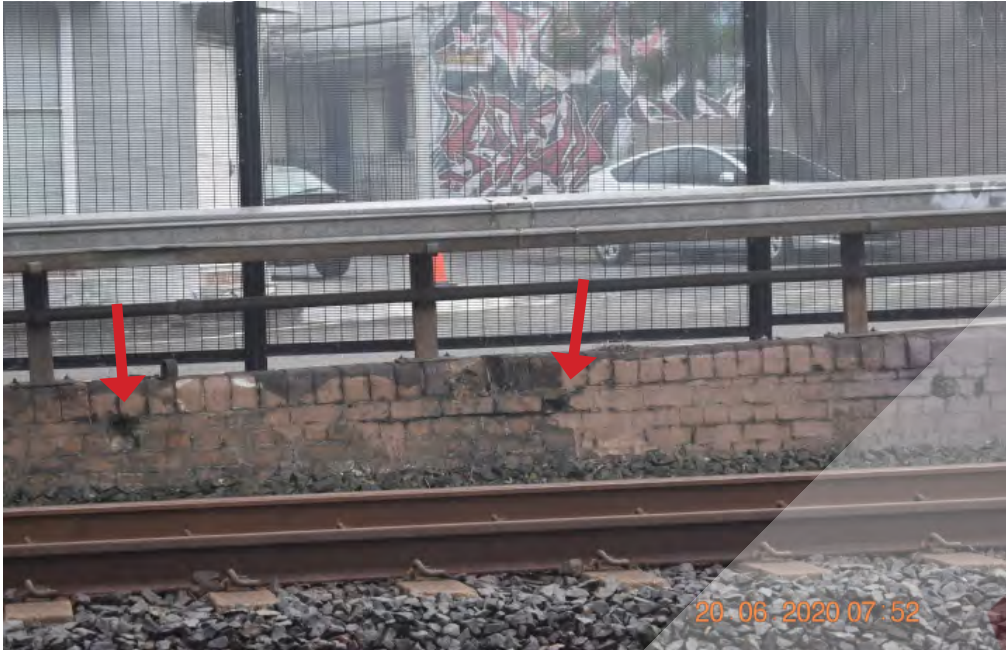
Figure: 0100

Damage in the retaining wall along the main up-track, looking northeast from approximately 15 metres east of chainage 3+382.

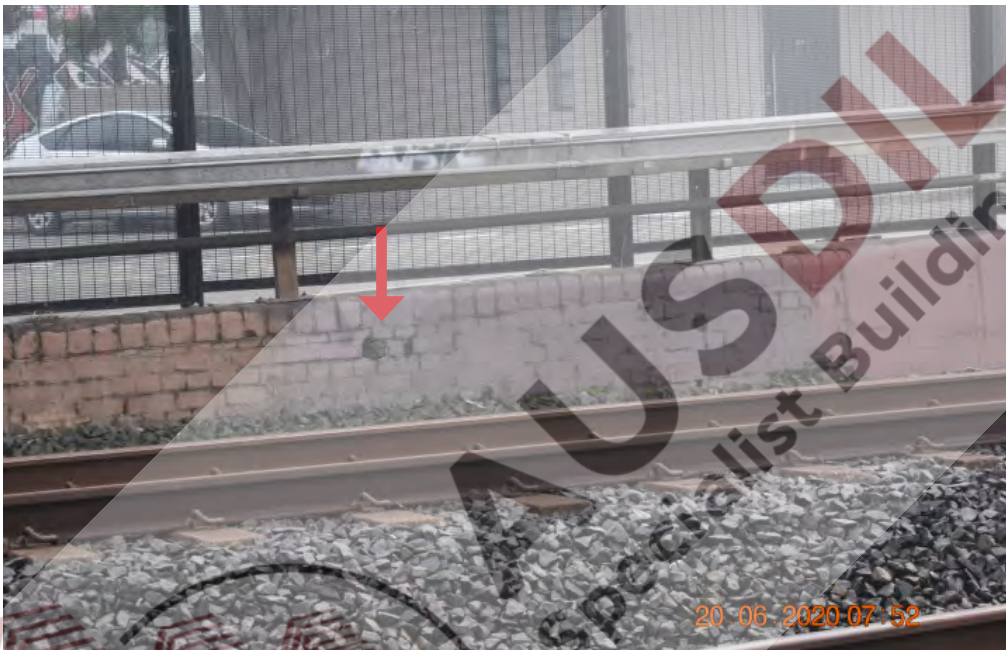
Figure: 0101

Damage in the retaining wall along the main up-track, looking northeast from approximately 15 metres east of chainage 3+382.

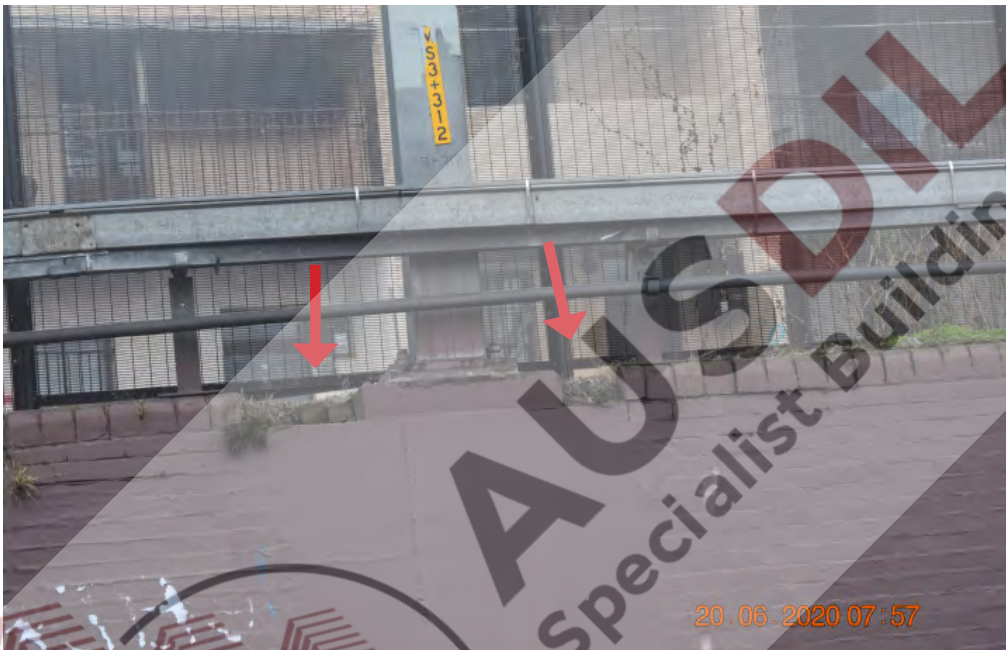
Figure: 0137

| Missing bricks in the retaining wall along the main up-track, looking northeast from chainage 3+312. | 58 |

Missing bricks in the retaining wall along the main up-track, looking northeast from chainage 3+312.

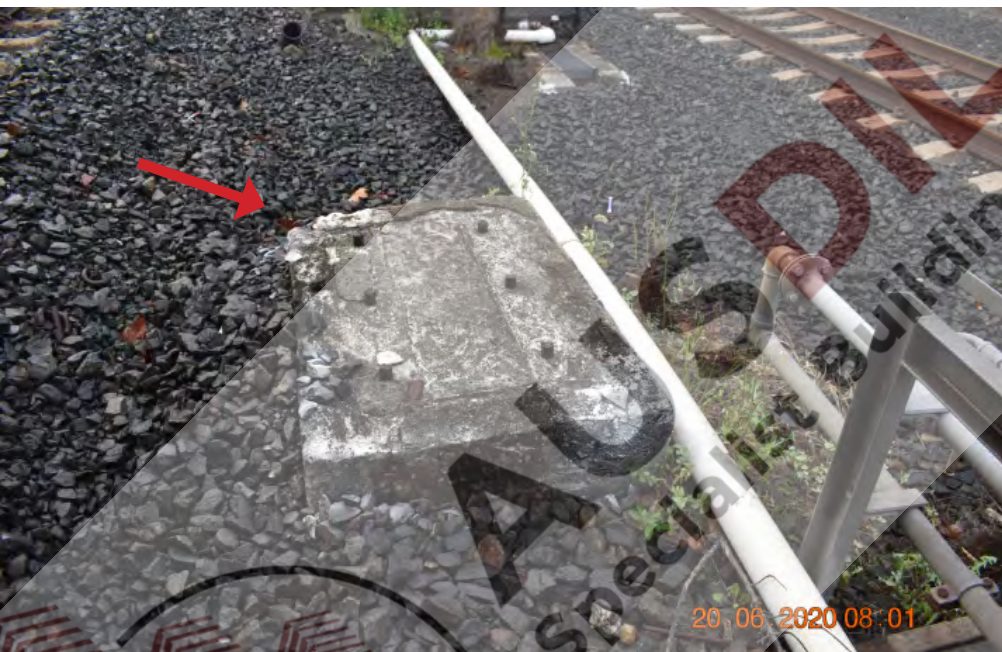
Figure: 0172

Damage in the concrete platform between the suburban down-track and local up-track, at chainage 3+276.

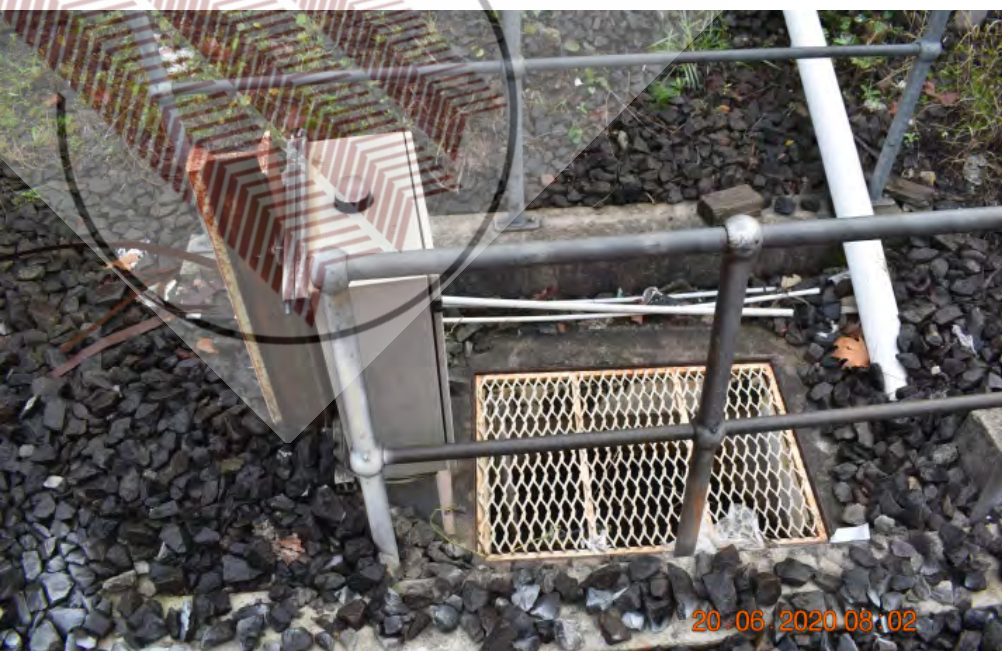
Figure: 0173

Damage in the concrete platform between the suburban down-track and local up-track, at chainage 3+276.

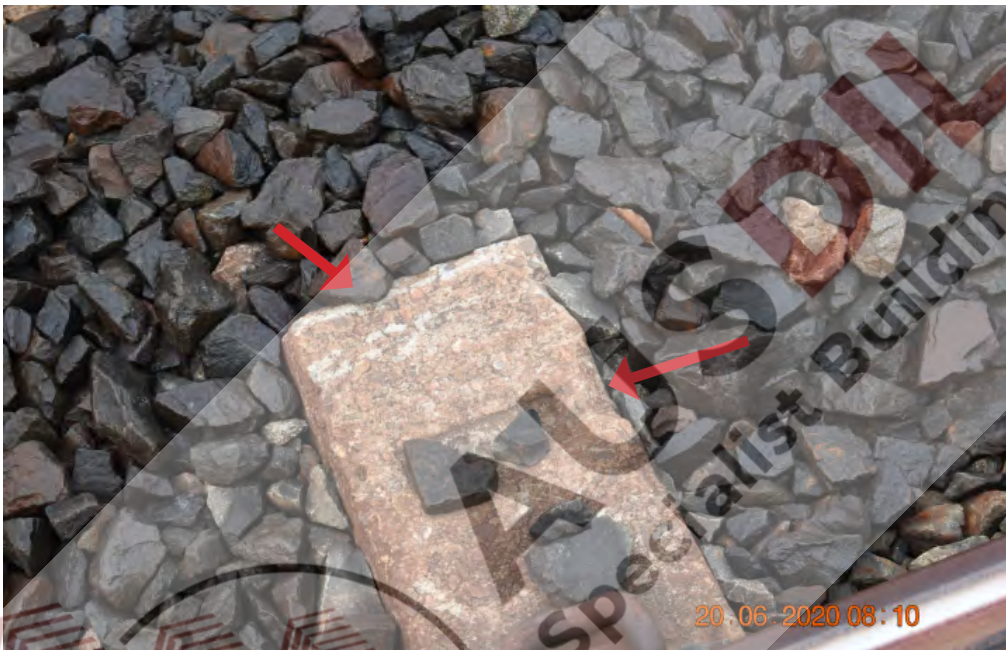
Figure: 0230

Chipping and damage in the concrete sleepers of the suburban down-track, at approximately 15 metres west of chainage 3+456.

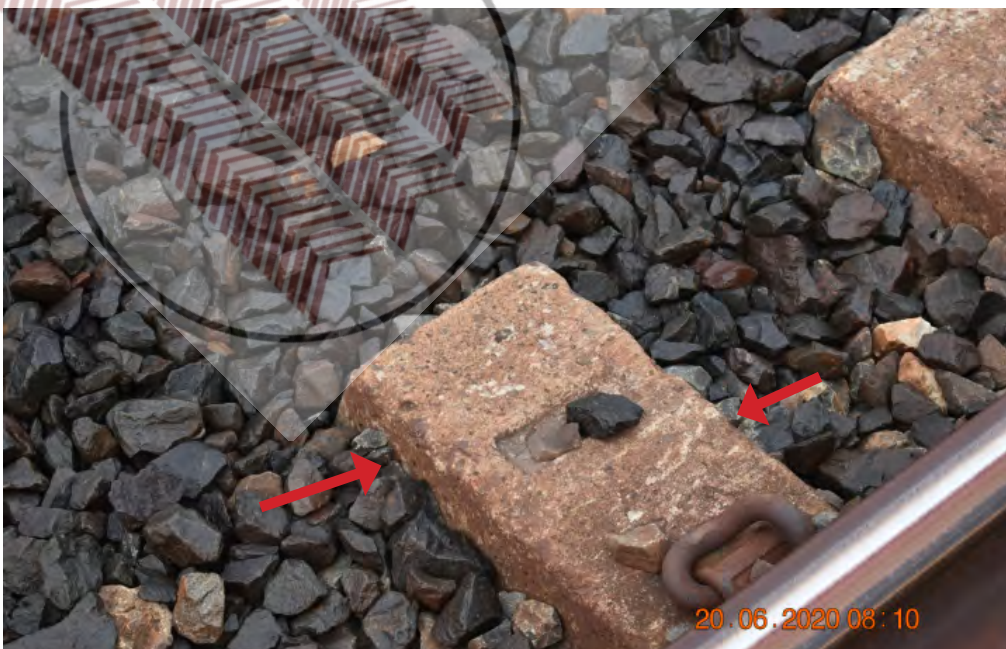
Figure: 0231

Chipping and damage in the concrete sleepers of the suburban down-track, at approximately 15 metres west of chainage 3+456.

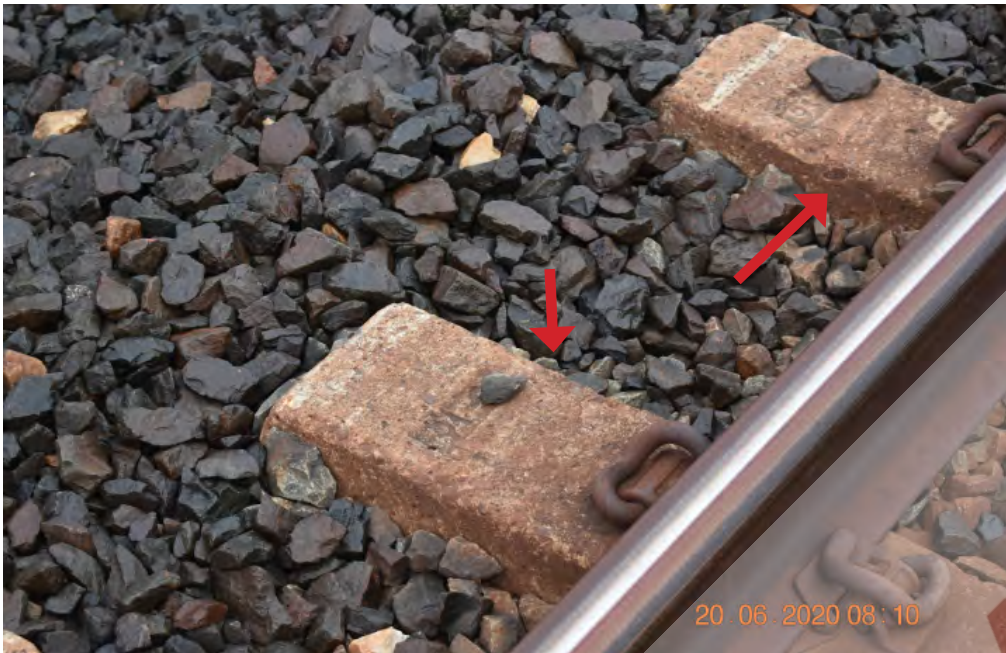
Figure: 0232

Chipping and damage in the concrete sleepers of the suburban down-track, at approximately 15 metres west of chainage 3+456.

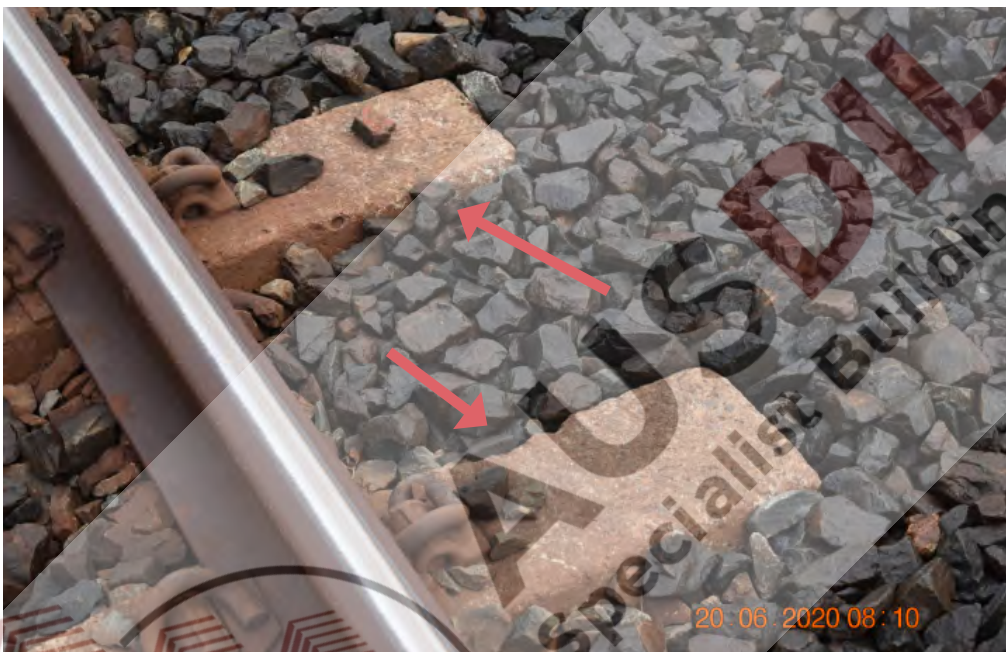
Figure: 0233

Chipping and damage in the concrete sleepers of the suburban down-track, at approximately 15 metres west of chainage 3+456.

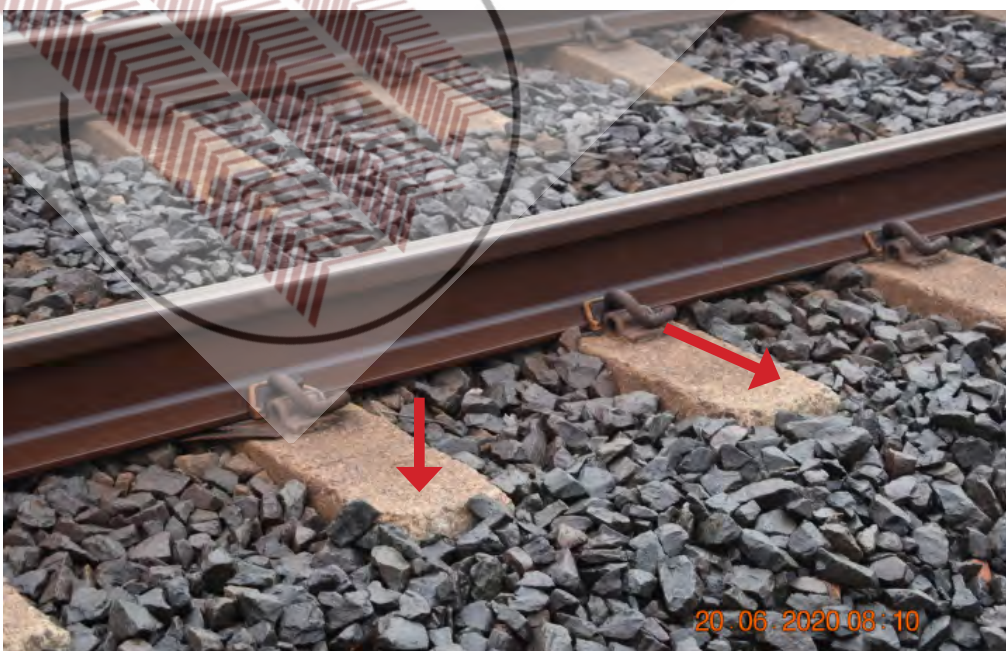
Figure: 0234

Chipping and damage in the concrete sleepers of the suburban up-track, at approximately 15 metres west of chainage 3+456.

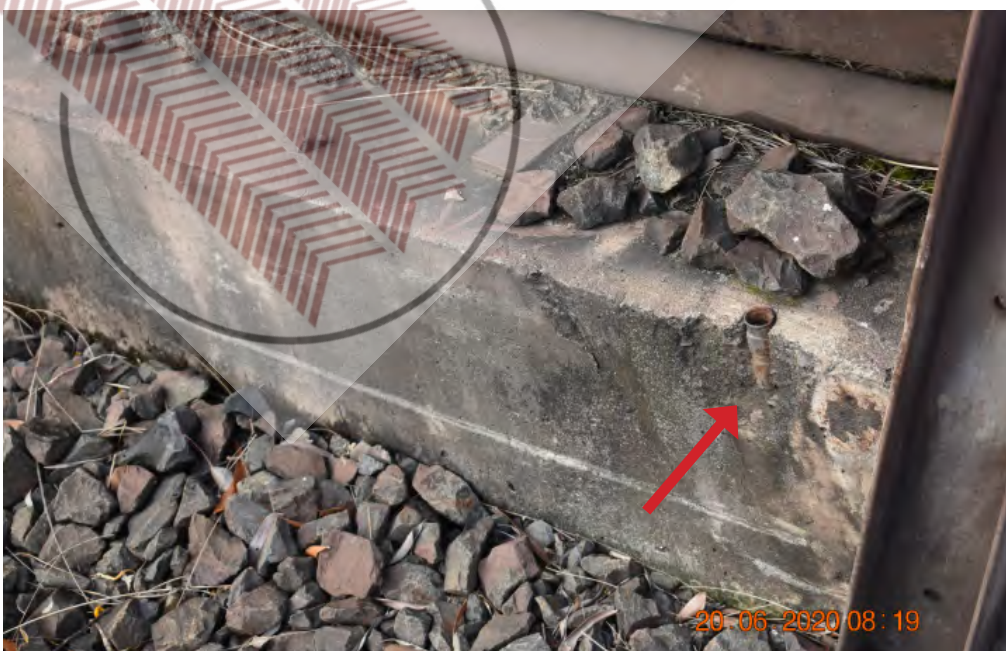
Figure: 0359

Chipping in the base of the overhead power line post along the local down-track, at chainage 3+382.

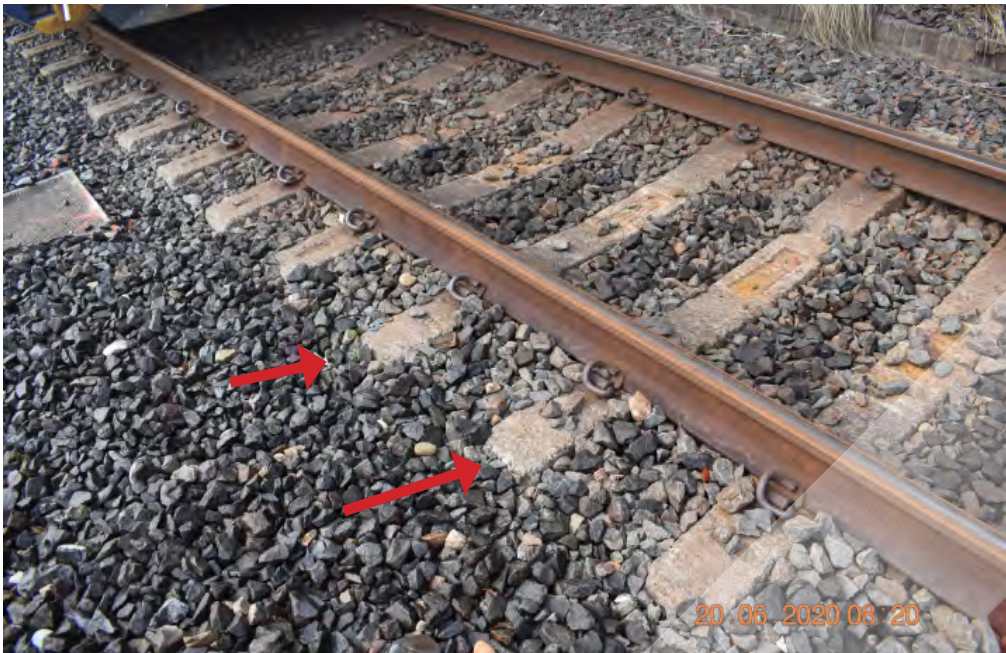
Figure: 0367

| Chipping and damage in the concrete sleepers in the local down-track, at chainage 3+382. | 135 |

Chipping and damage in the concrete sleepers in the local down-track, at chainage 3+382.

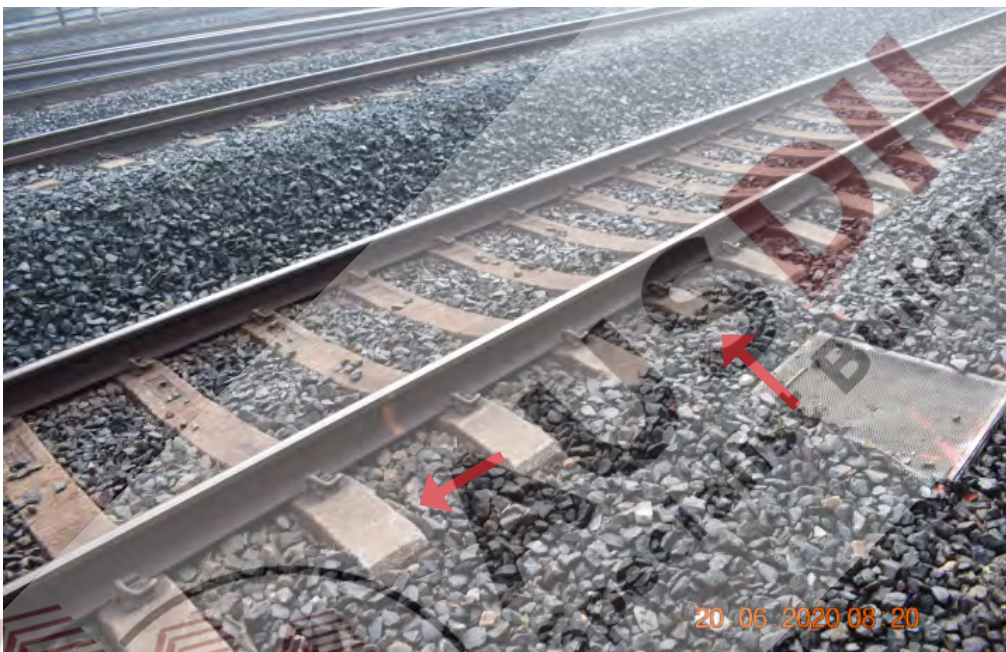
Figure: 0368

| Chipping and damage in the concrete sleepers in the local up-track, at chainage 3+382. | 135 |

Chipping and damage in the concrete sleepers in the local up-track, at chainage 3+382.

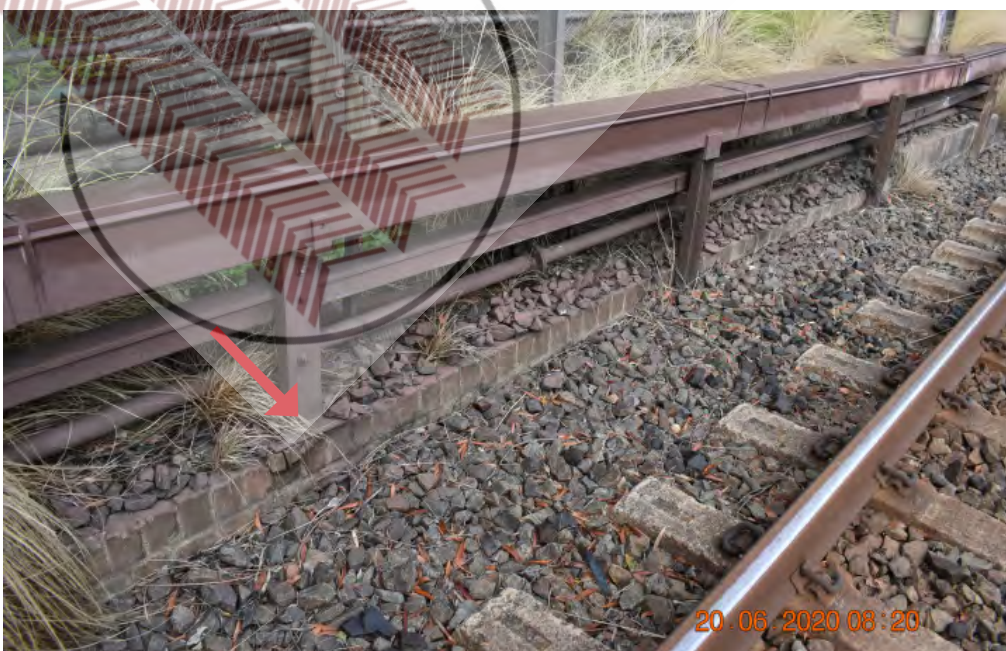
Figure: 0369

| Movement and cracking in the brick base of the services along the local down-track, at approximately 5 metres east of chainage 3+382. | 135 |

Movement and cracking in the brick base of the services along the local down-track, at approximately 5 metres east of chainage 3+382.

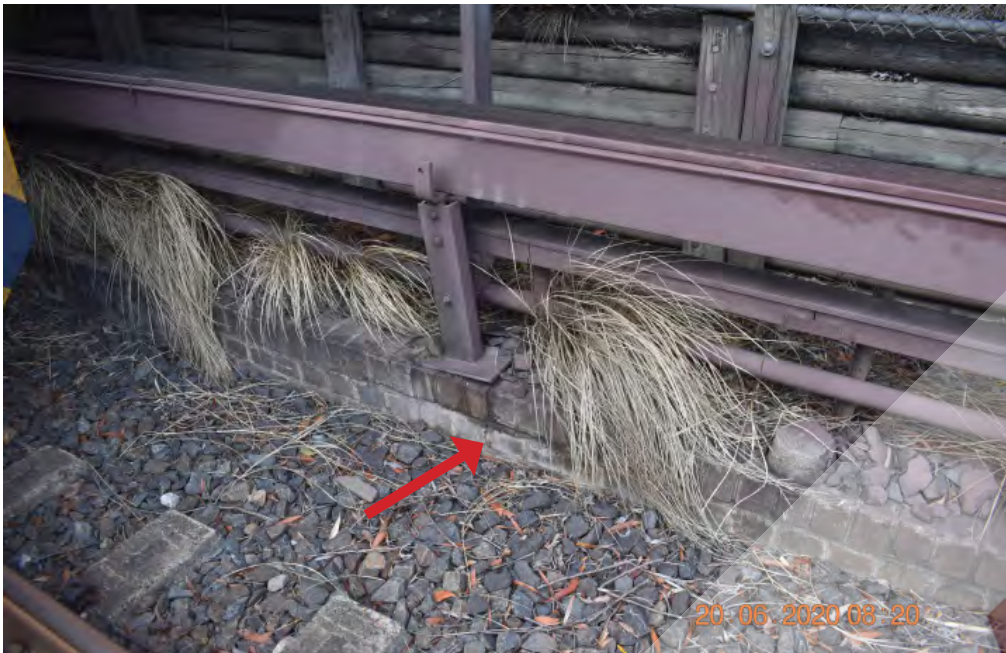
Figure: 0370

Movement and cracking in the brick base of the services along the local down-track, at approximately 5 metres east of chainage 3+382.
