GEOTAGGED PRE CONSTRUCTION SURVEY

OPT-xxxxx [PROJECT NAME]

JOB REFERENCE: ADN23173A

SITE SURVEYED: Council Assets
156 Hargrave Street
PADDINGTON NSW 2021

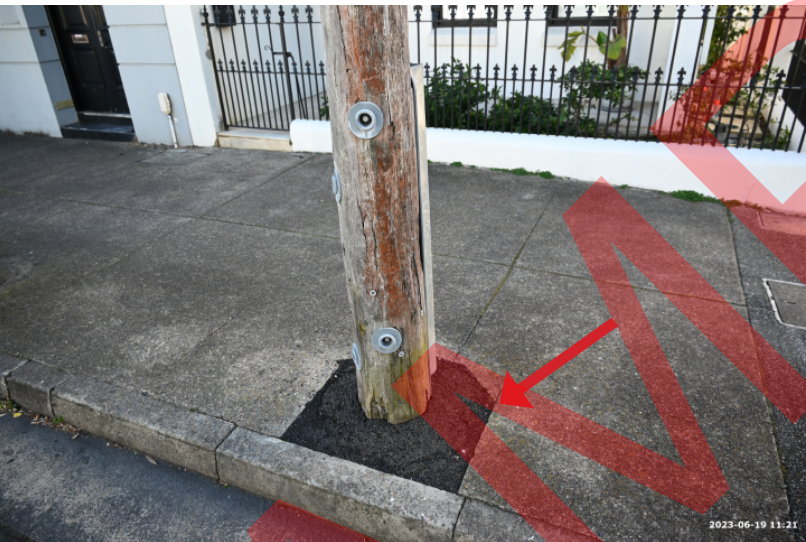
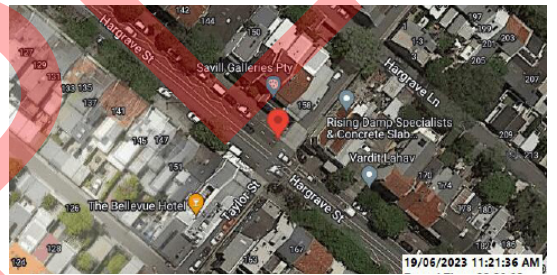
10	Figure: 0004 Severe cracking in the roadway.
10	Figure: 0005 General view of the light pole. Showing patching.
13	Figure: 0014 Cracking in the roadway. Typical throughout.
13	Figure: 0015 Cracking in the kerb and gutter.
14	Figure: 0018 General view of the roadway. Showing cracking.
15	Figure: 0019 Cracking in the roadway. Typical throughout.
15	Figure: 0020 Cracking in the roadway. Typical throughout.
15	Figure: 0021 Cracking in the roadway. Typical throughout.
16	Figure: 0022 Cracking in the roadway. Typical throughout.
17	Figure: 0025 Cracking in the footpath.
18	Figure: 0028 Cracking in the footpath.
18	Figure: 0029 Cracking in the kerb and gutter.
19	Figure: 0032 General view of the roadway. Showing cracking.
20	Figure: 0034 Cracking and patching in the footpath.
20	Figure: 0035 Leaning street sign.
20	Figure: 0036 Cracking in the footpath and kerb.
21	Figure: 0037 Cracking in the footpath.
21	Figure: 0038 Cracking in the roadway. Typical throughout.

Figure: 0005
General view of the light pole. Showing patching.

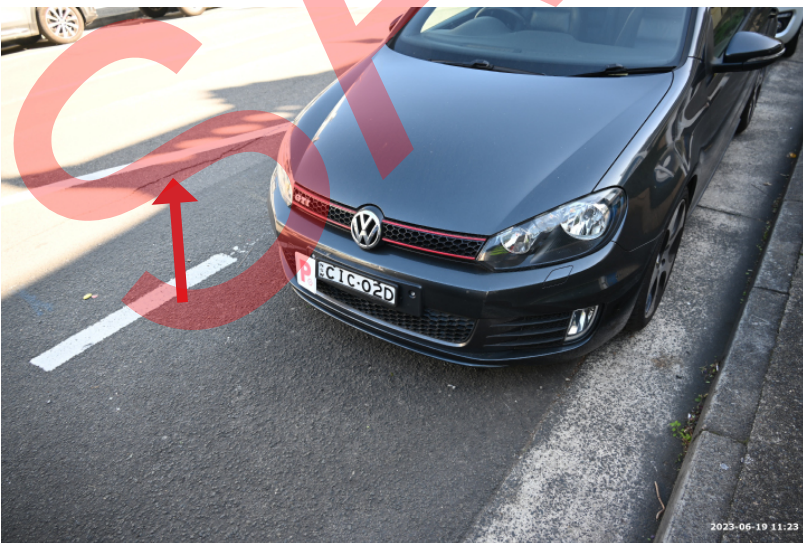
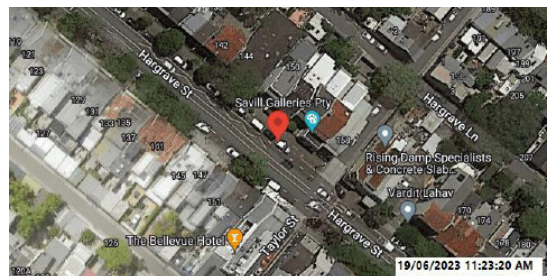
Figure: 0018
General view of the roadway. Showing cracking.

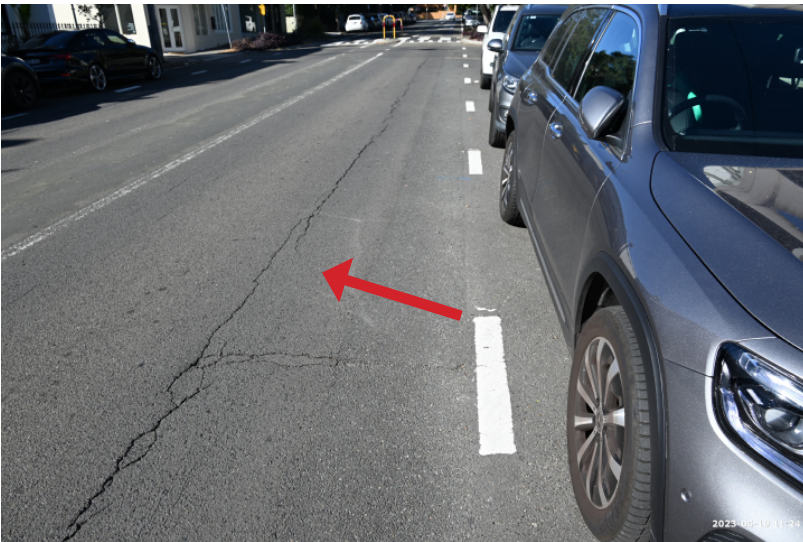
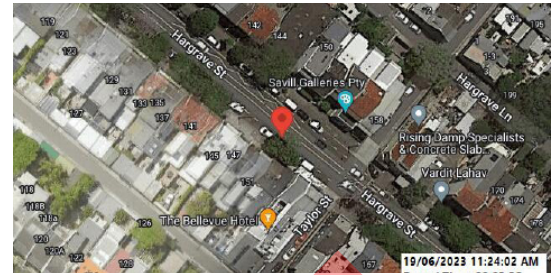
Figure: 0022
Cracking in the roadway. Typical throughout.

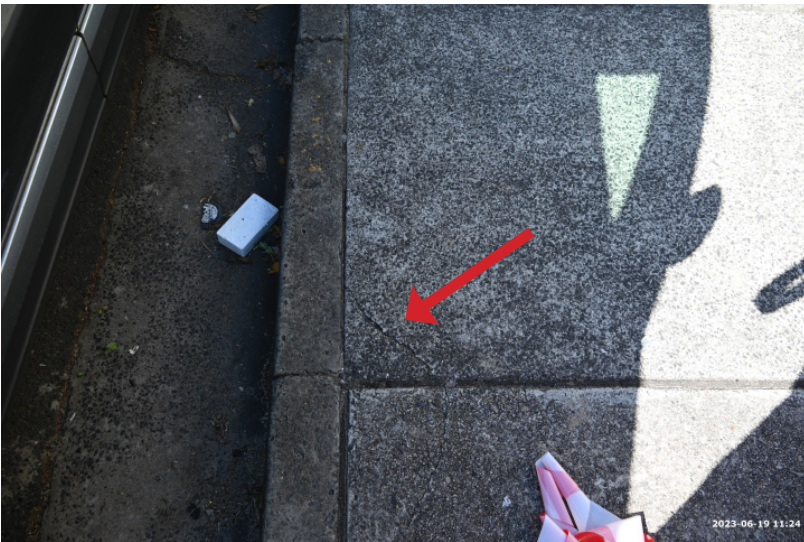
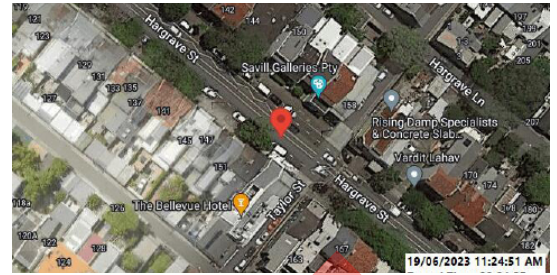
Figure: 0028
Cracking in the footpath.

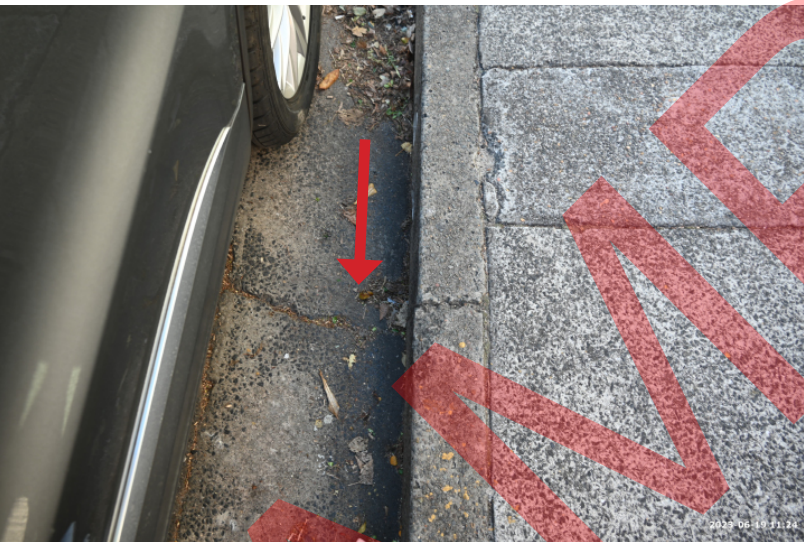
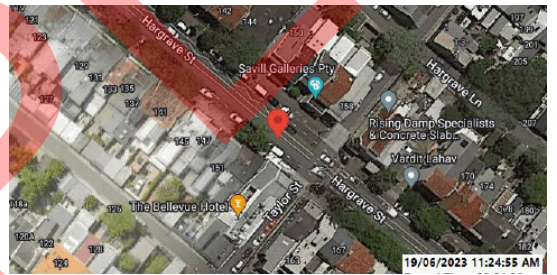
Figure: 0029
Cracking in the kerb and gutter.

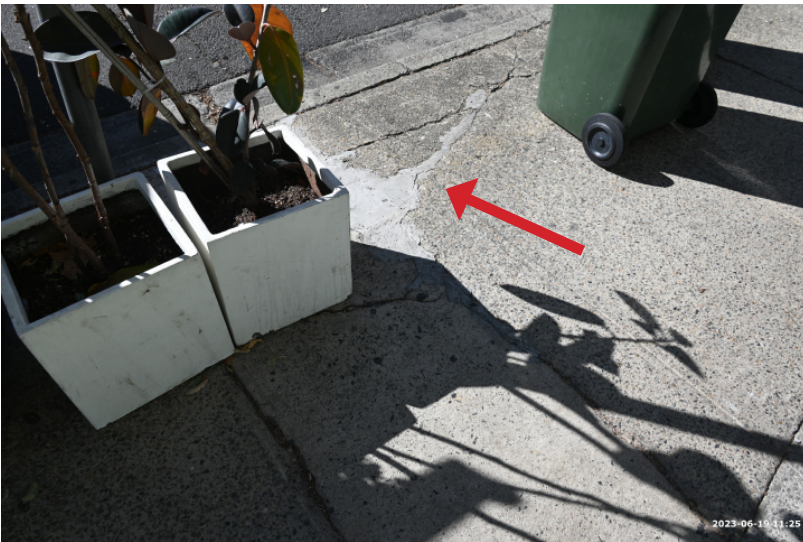
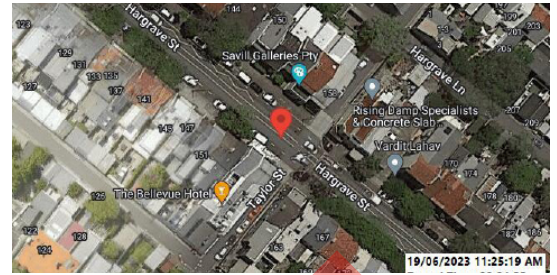
Figure: 0034
Cracking and patching in the footpath.

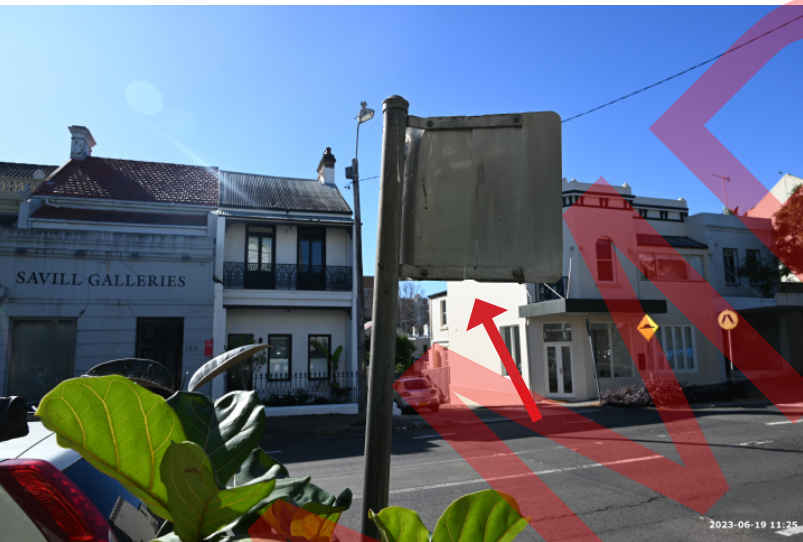
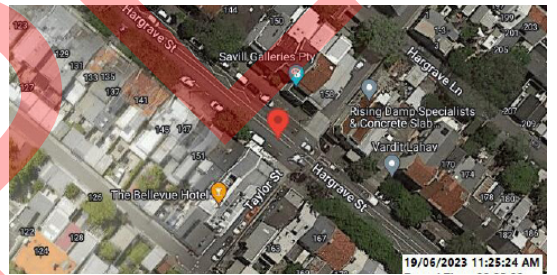
Figure: 0035
Leaning street sign.

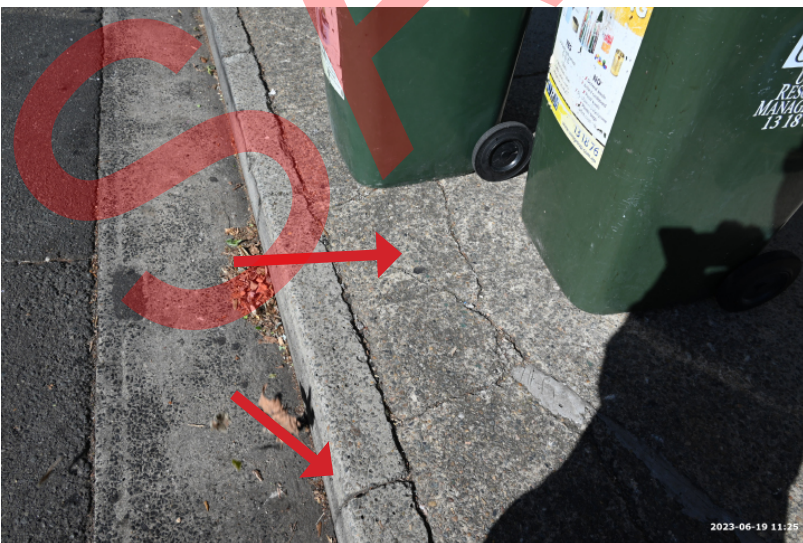
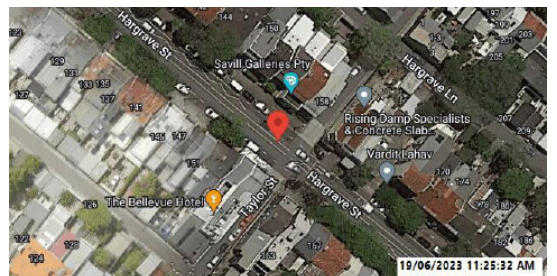
Figure: 0036
Cracking in the footpath and kerb.

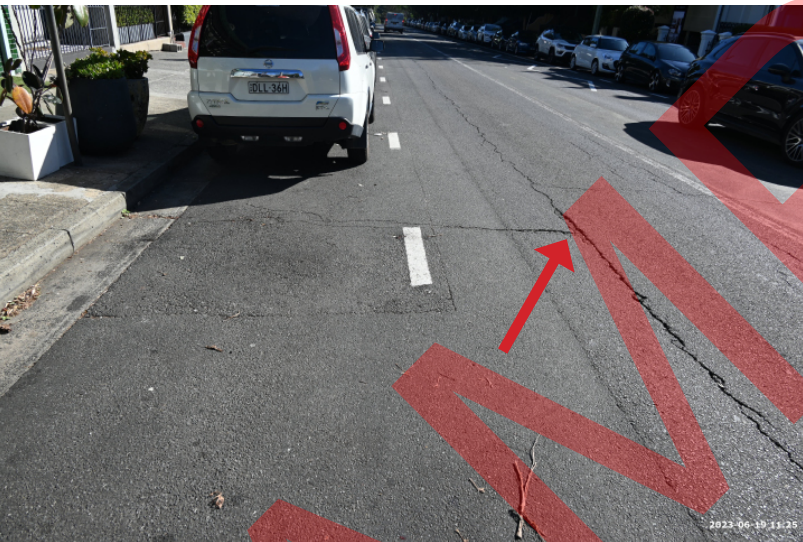
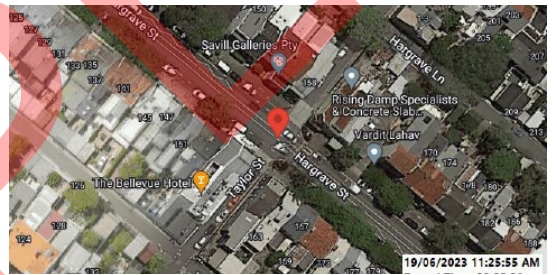
21	Figure: 0039 Cracking in the roadway. Typical throughout.
22	Figure: 0041 General view of the roadway. Showing cracking.
23	Figure: 0045 General view of the laneway crossover. Showing scratching and chipping in the posts.
25	Figure: 0050 Cracking in the laneway crossover.
25	Figure: 0051 Cracking in the laneway crossover.
29	Figure: 0063 Damage in the kerb in the laneway.
30	Figure: 0064 Damage in the kerb in the laneway.

Figure: 0041
General view of the roadway. Showing cracking.

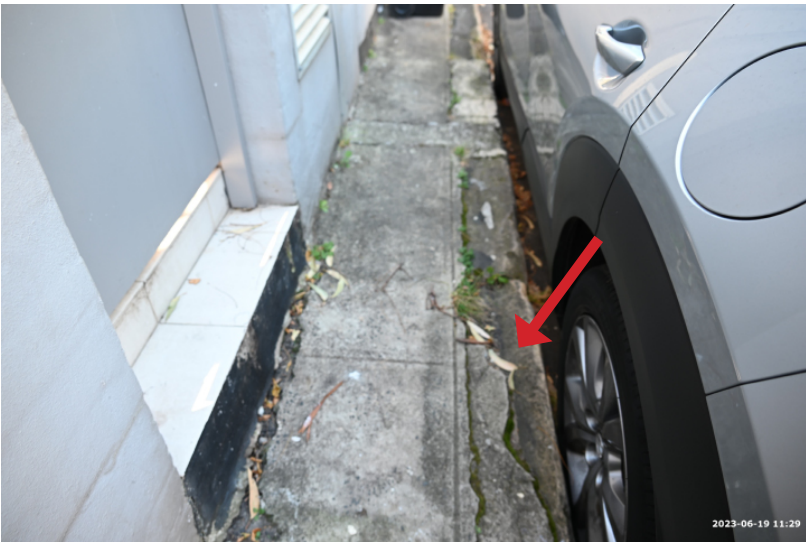
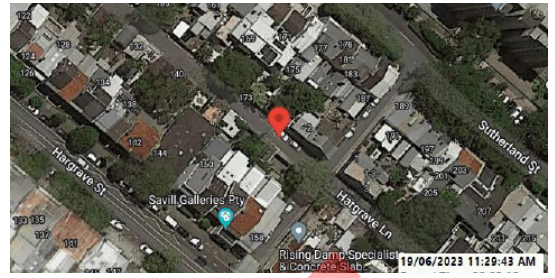
Figure: 0064
Damage in the kerb in the laneway.
