## **PRE CONSTRUCTION CONDITION SURVEY**

OPT-XXXX PROJECT NAME

INSPECTION DATE: 30 March 2023  
WEATHER: Sunny, 28°C  
JOB REFERENCE: ADXXXXX  
INSPECTOR: Akshay Raj Padmanaban  
Civil Engineer  
M.Eng  
SITE SURVEYED: SITE ADDRESS

AusDilaps was commissioned by  
**JK Williams Contracting (Qld) Pty Ltd T/A DAC Constructions**  
to carry out a pre-construction condition inspection and report in accordance with AS.4349.0 for the  
**24-32 Hamish Street, Calamvale QLD** project.

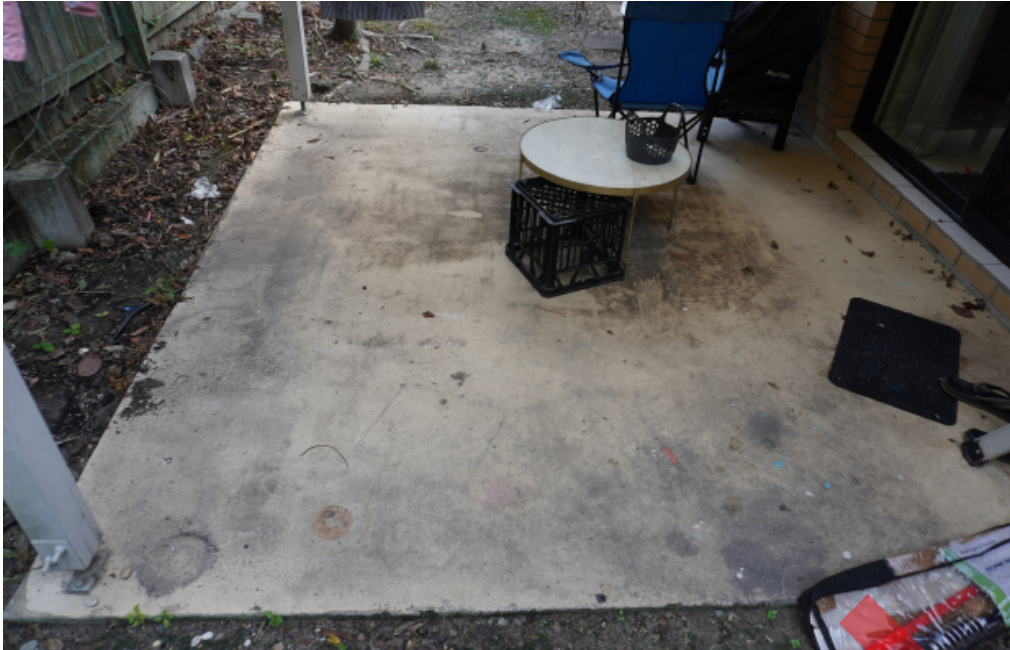
Figure: 0073

Paving on the south verandah.

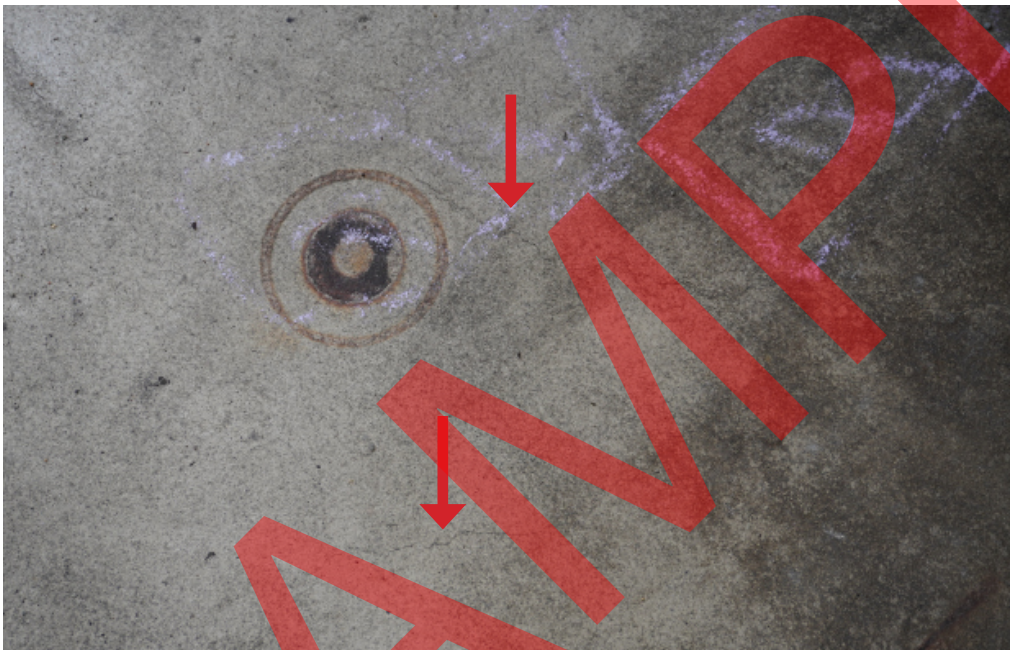
Figure: 0074

25	Patching in the west wall in the living room.
33	Hairline cracking in the paving on the south verandah.
33	Hairline cracking in the paving on the south verandah.

Hairline cracking in the paving on the south verandah.

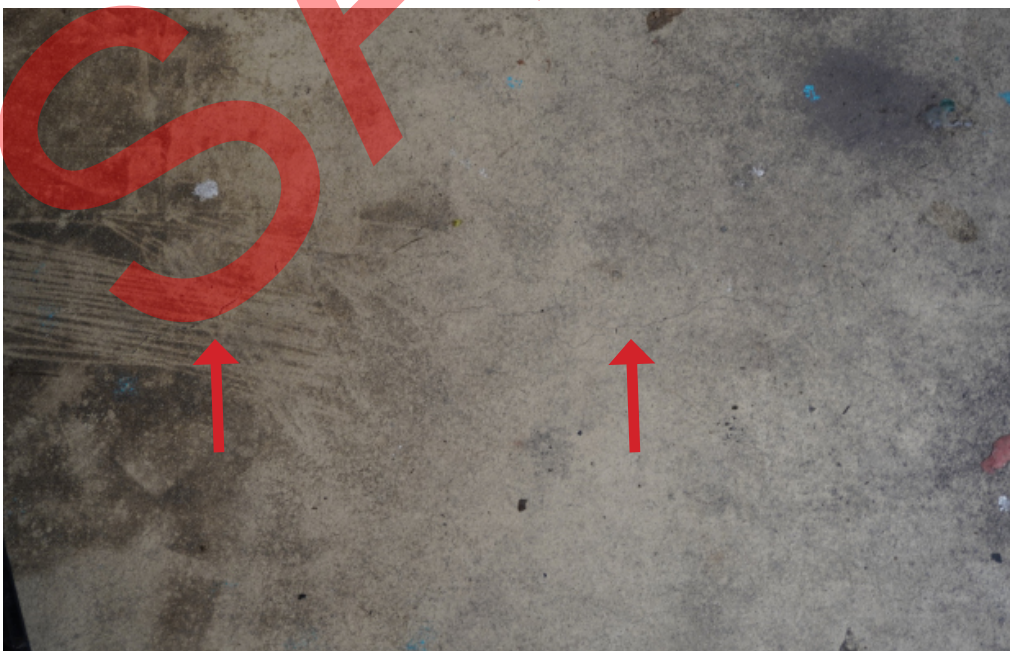
Figure: 0075

Hairline cracking in the paving on the south verandah.
