AUSDILAPS

PROPERTY CONDITION SURVEY - RESIDENTIAL

Australian Dilapidations was commissioned by The (Client) to carry out a post construction condition inspection and report in accordance with AS.4349.1 for the (Project Name) project.

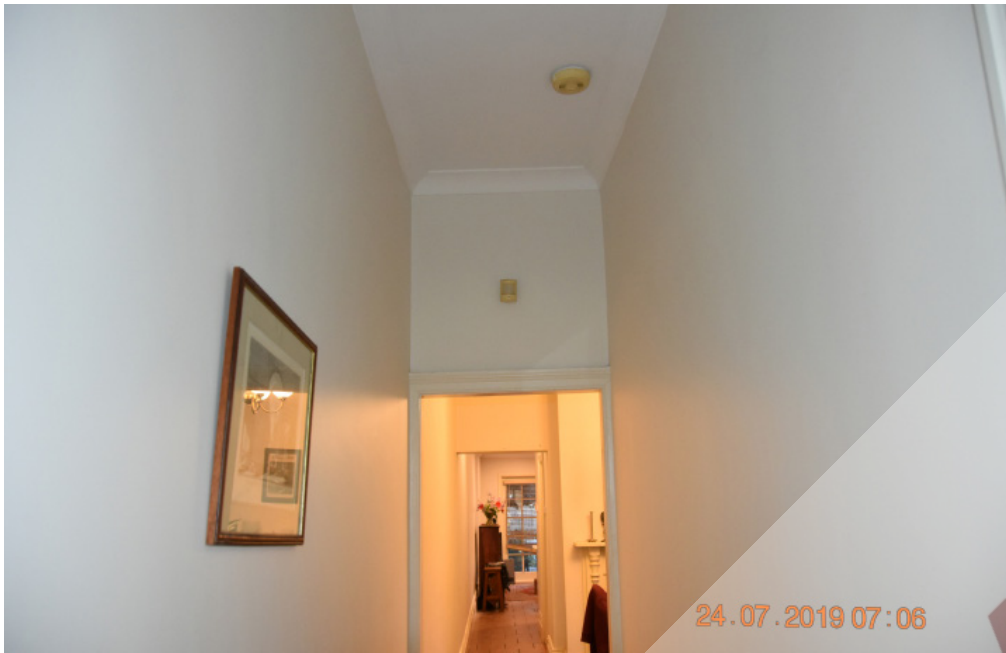
Figure: 0040

General view in the hallway, outside bedroom 2.

No changes noted.

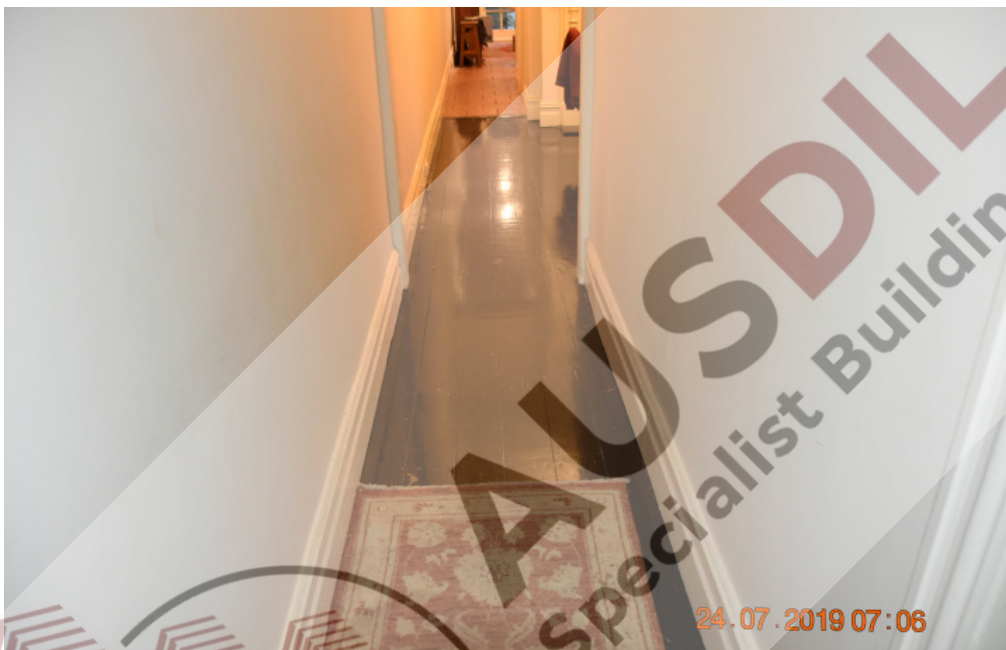
Figure: 0041

General view in the hallway, outside bedroom 2.

No changes noted.

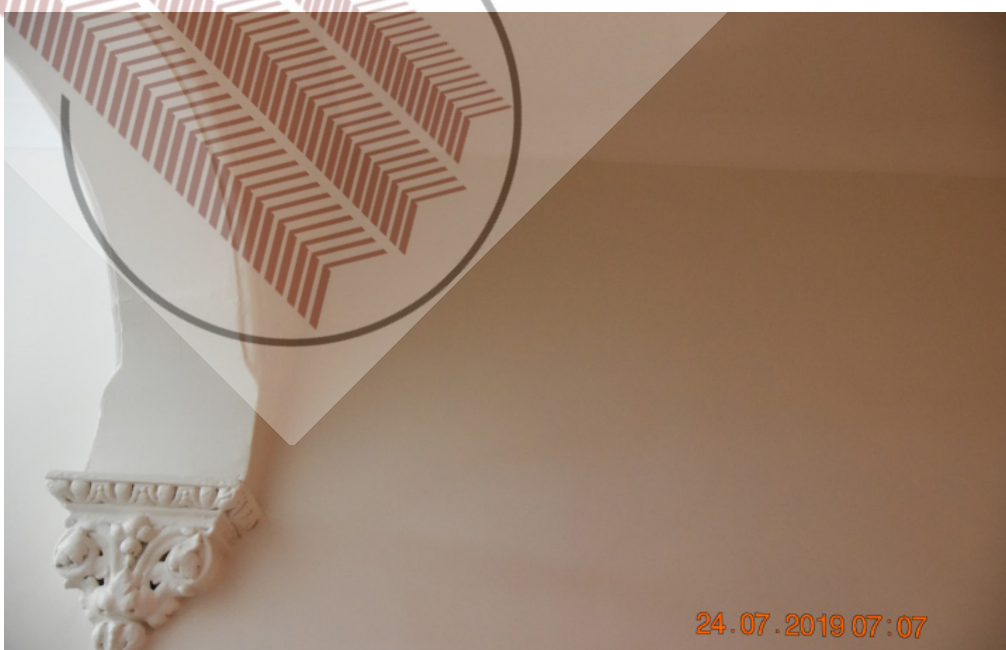
Figure: 0042

Left wall in the hallway, outside bedroom 2.

No changes noted.

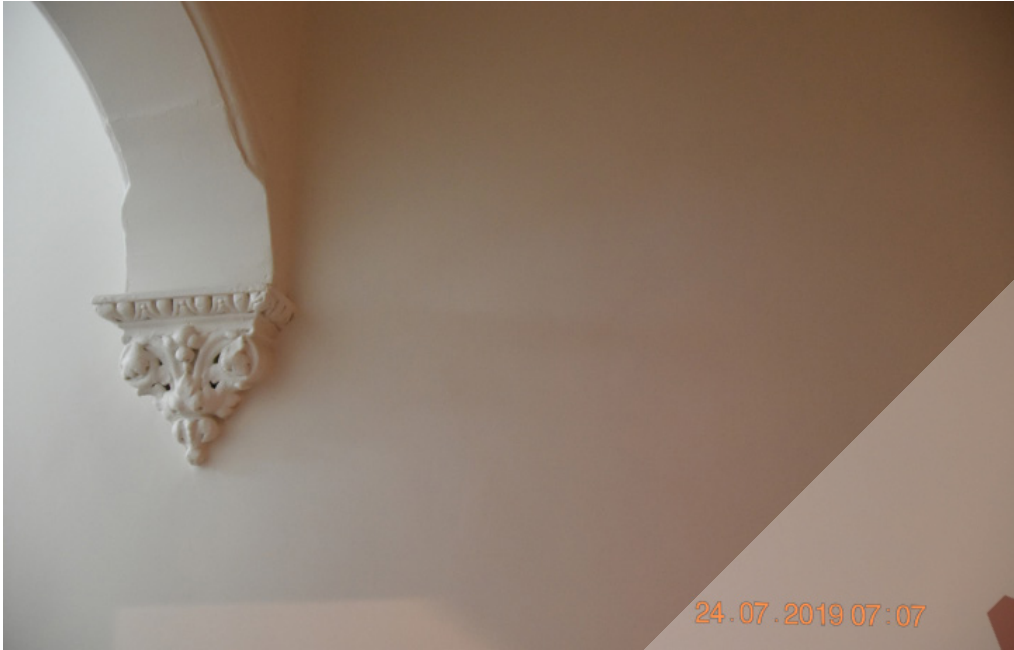
Figure: 0043

Left wall in the hallway, outside bedroom 2.

No changes noted.

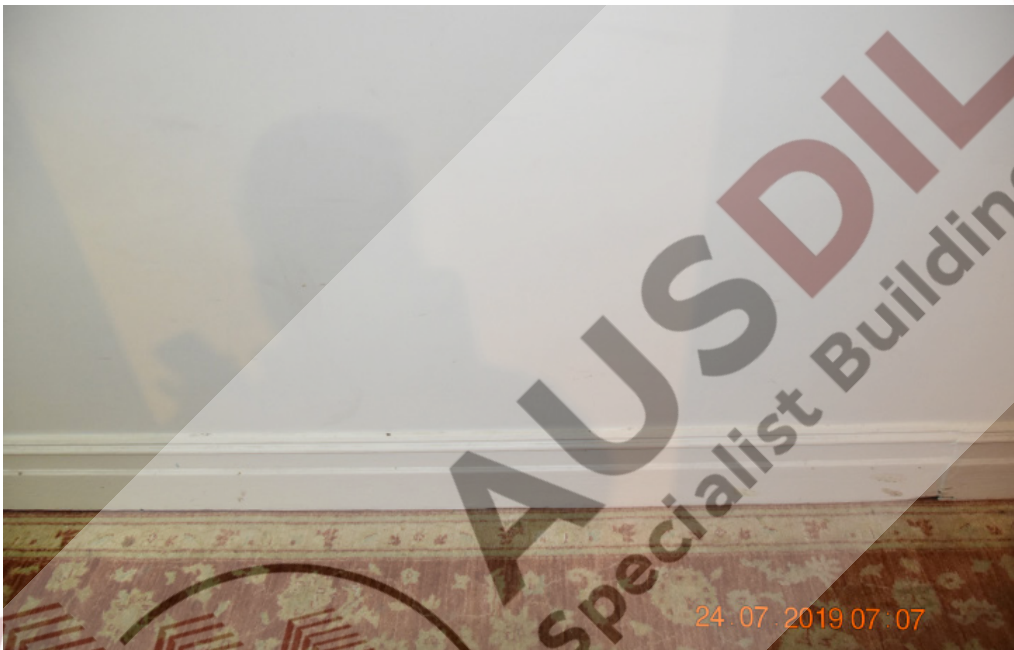
Figure: 0044

Left wall in the hallway, outside bedroom 2.

No changes noted.

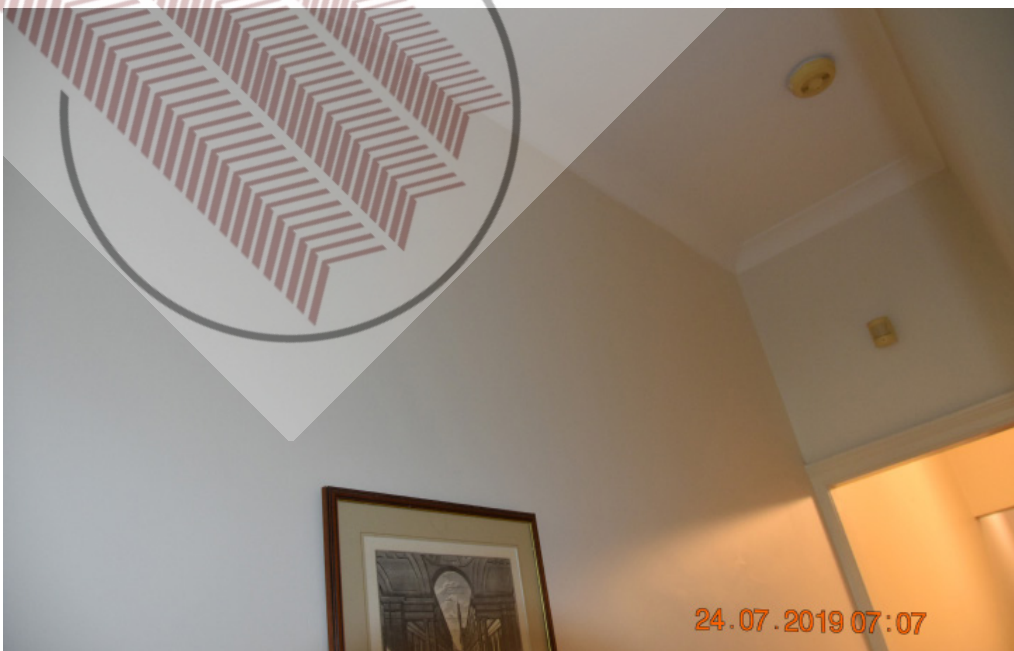
Figure: 0045

Left wall in the hallway, outside bedroom 2.

No changes noted.

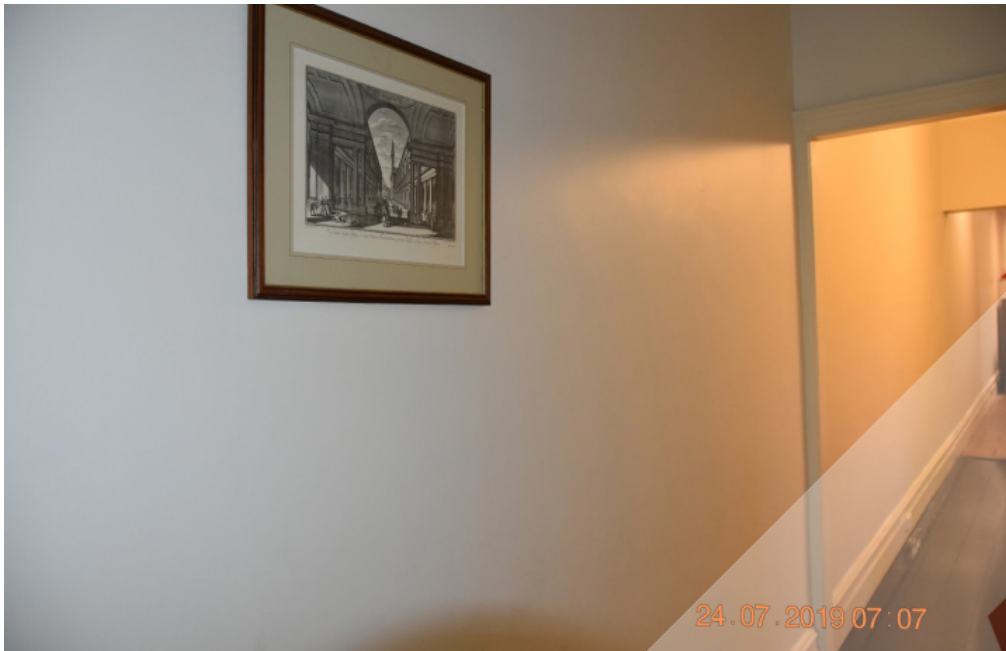
Figure: 0046

Left wall in the hallway, outside bedroom 2.

No changes noted.

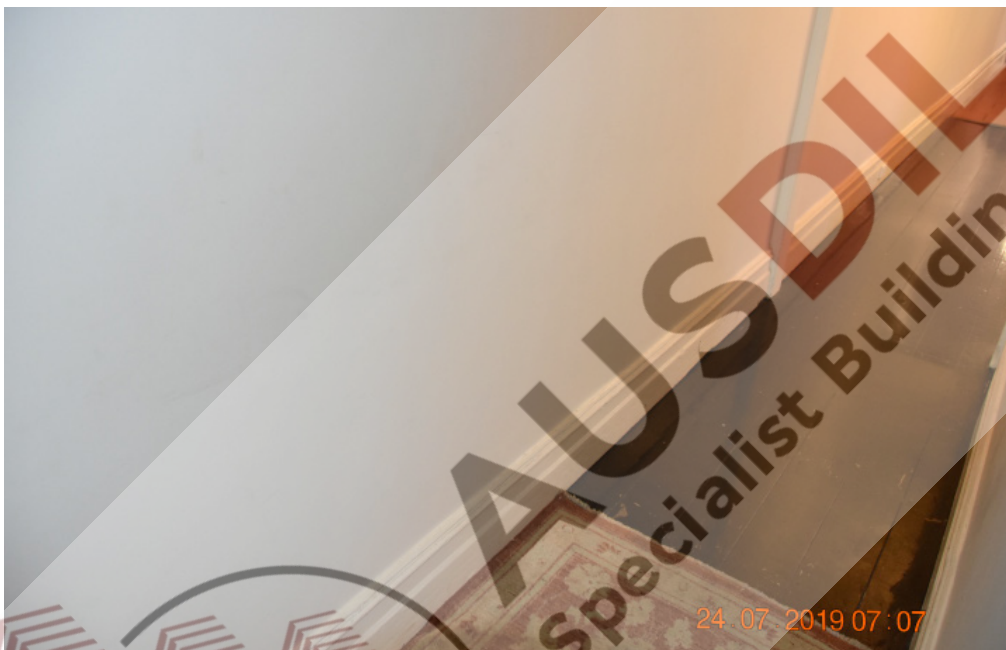
Figure: 0047

Left wall in the hallway, outside bedroom 2.

No changes noted.

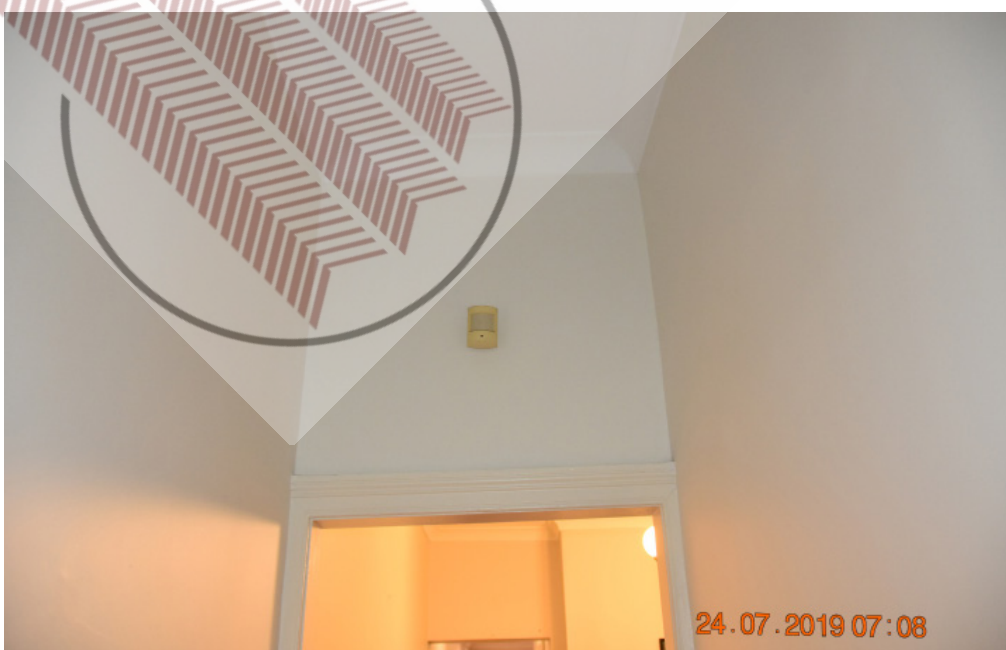
Figure: 0048

Rear wall in the hallway, outside bedroom 2.

No changes noted.

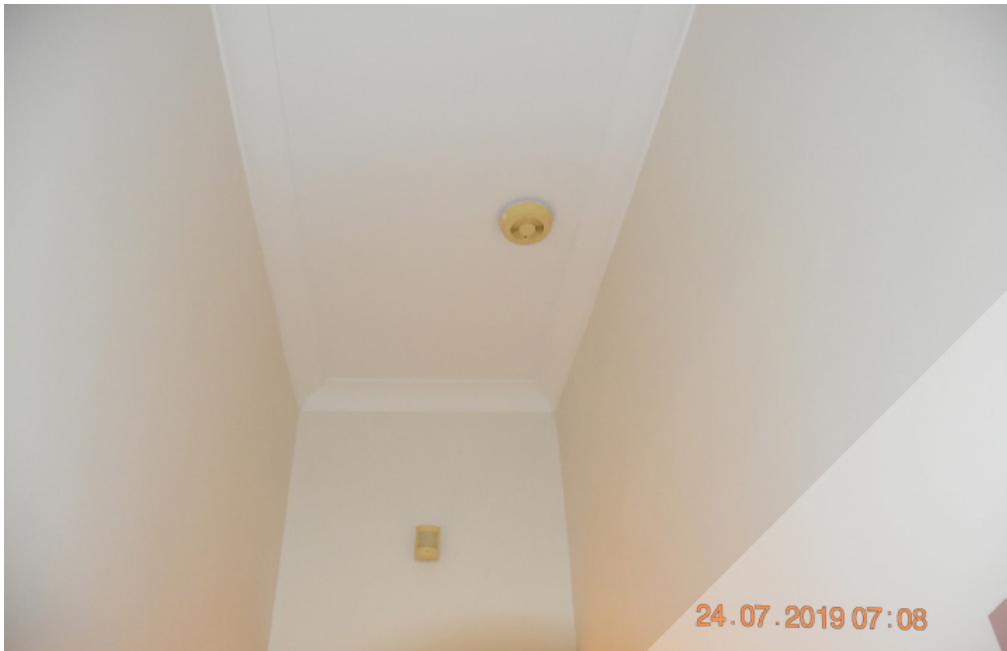
Figure: 0049

General view of the ceiling in the hallway, outside bedroom 2.

No changes noted.

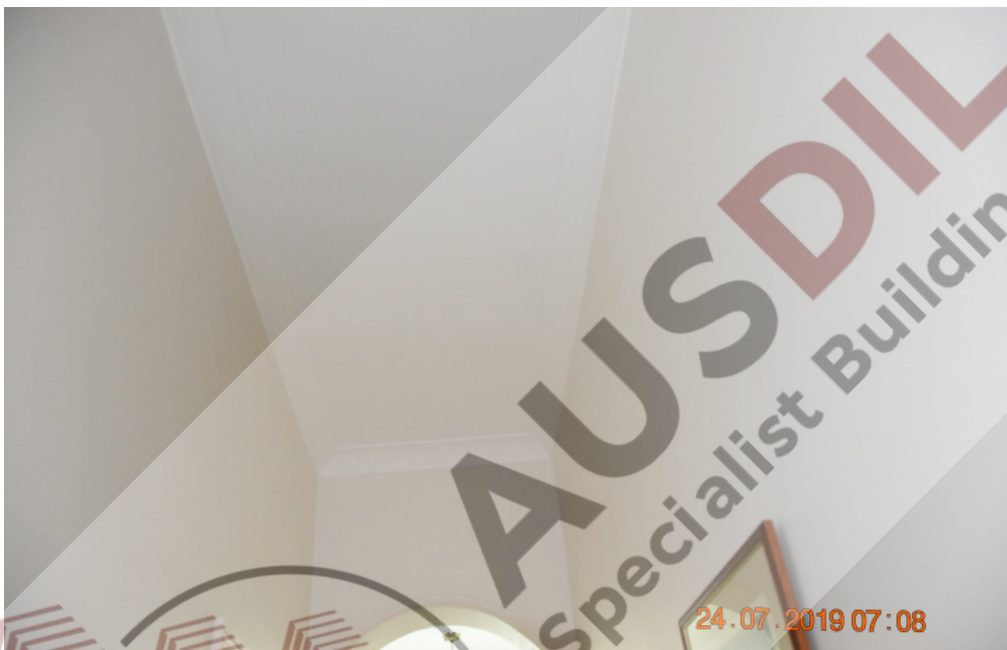
Figure: 0050

General view of the ceiling in the hallway, outside bedroom 2.

No changes noted.

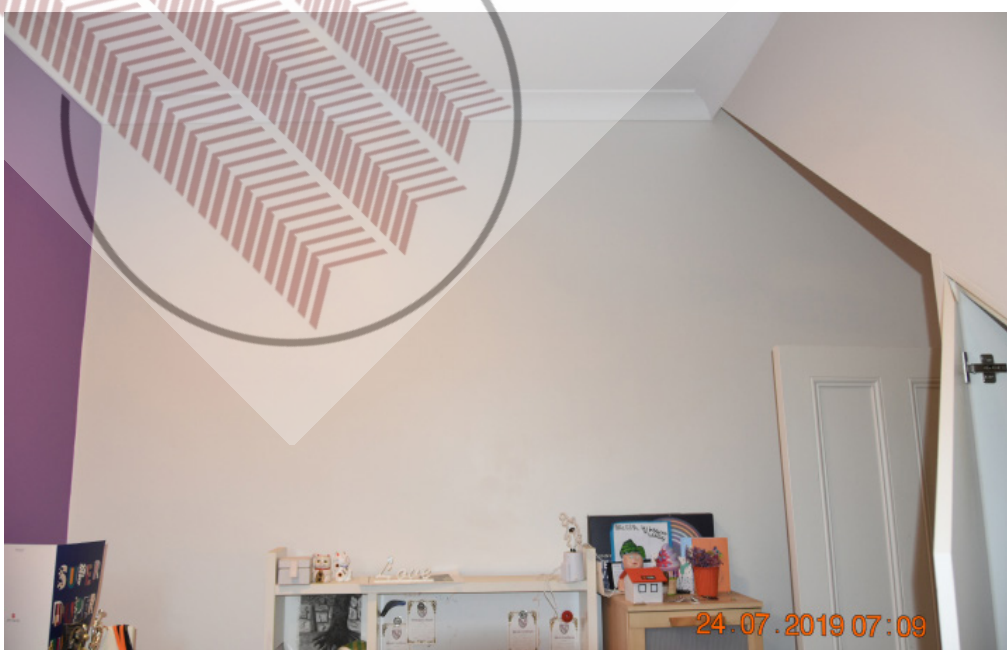
Figure: 0051

Front wall in bedroom 2.

No changes noted.

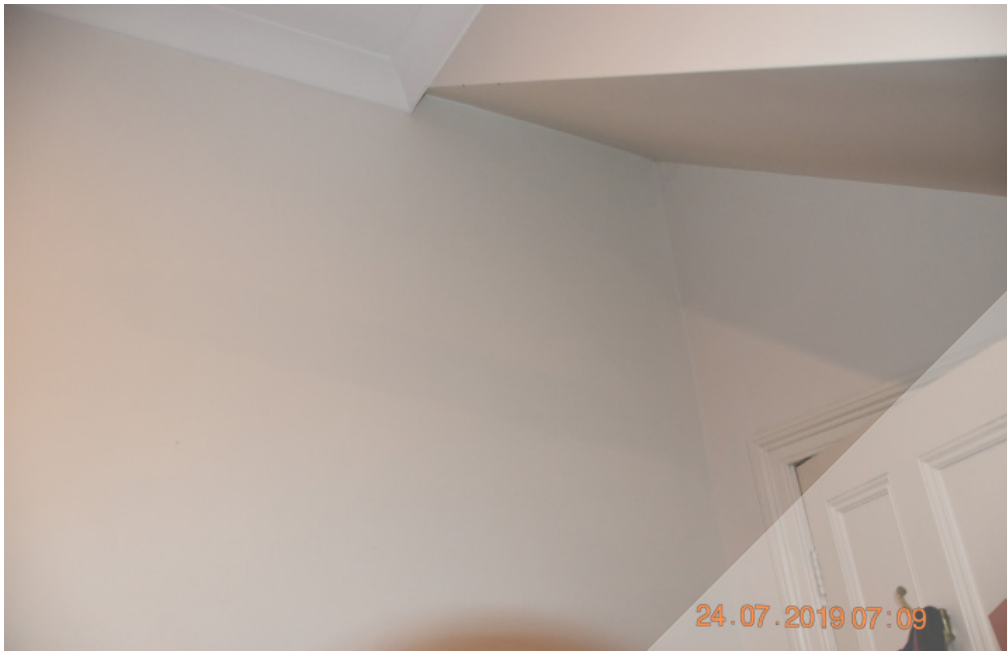
Figure: 0052

Front wall in bedroom 2.

No changes noted.

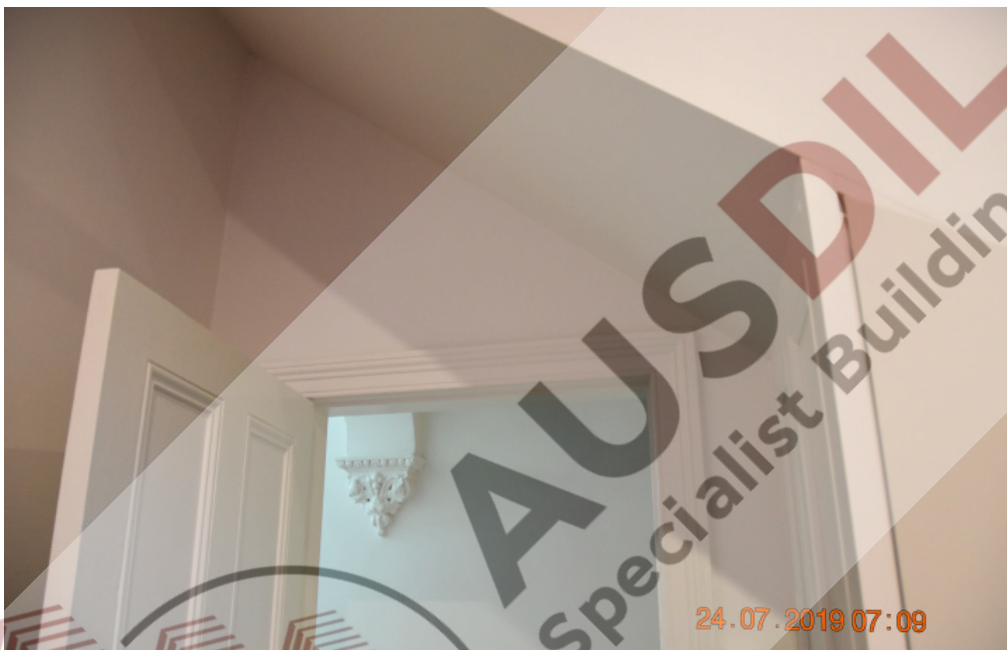
Figure: 0053

Left wall in bedroom 2.

No changes noted.

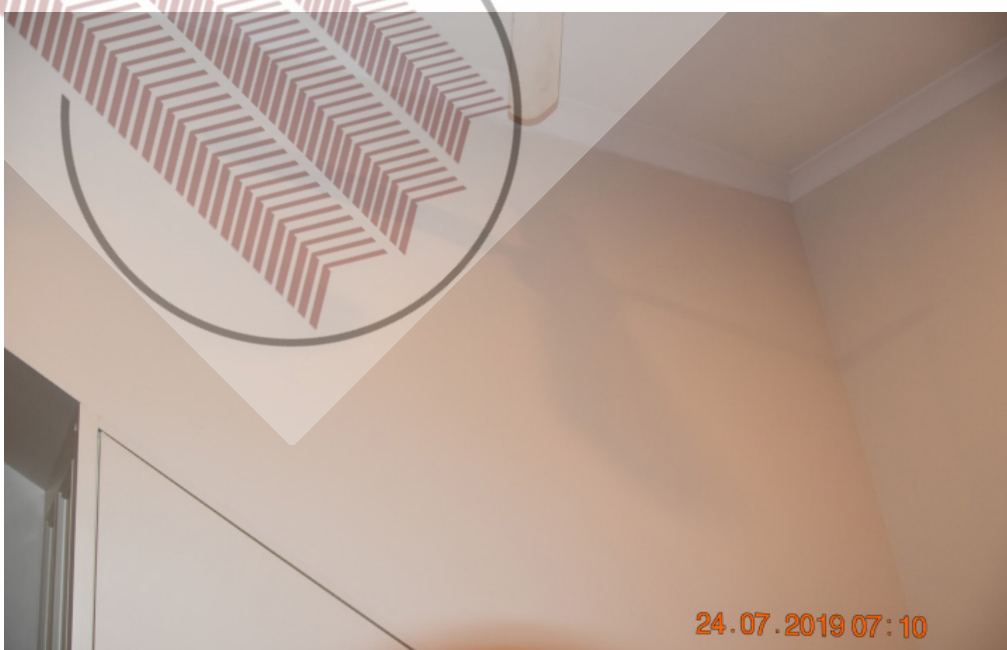
Figure: 0054

Left wall in bedroom 2.

No changes noted.

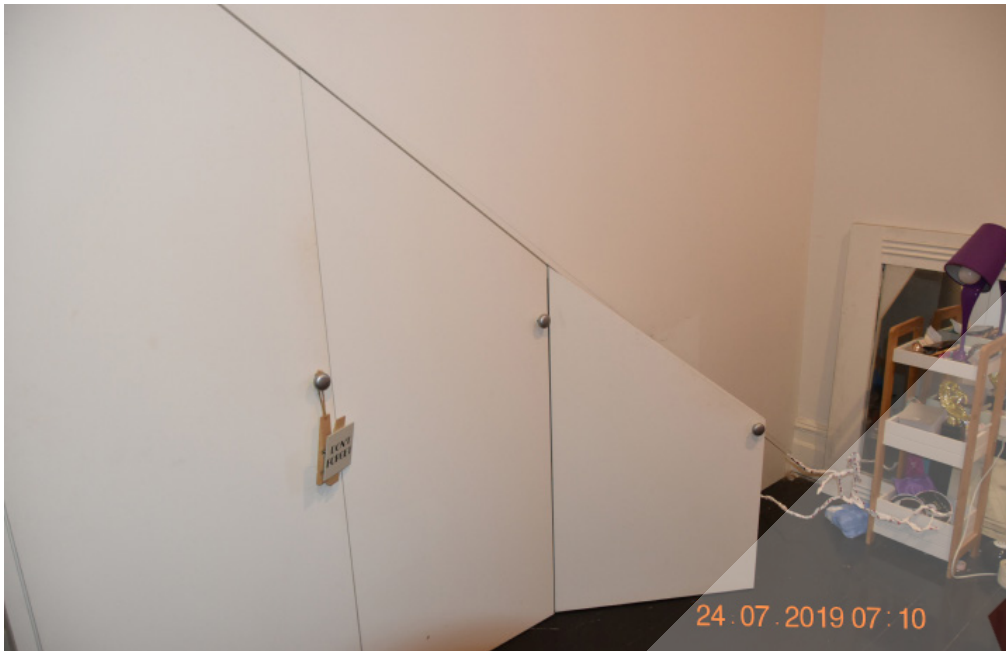
Figure: 0055

Left wall in bedroom 2.

No changes noted.

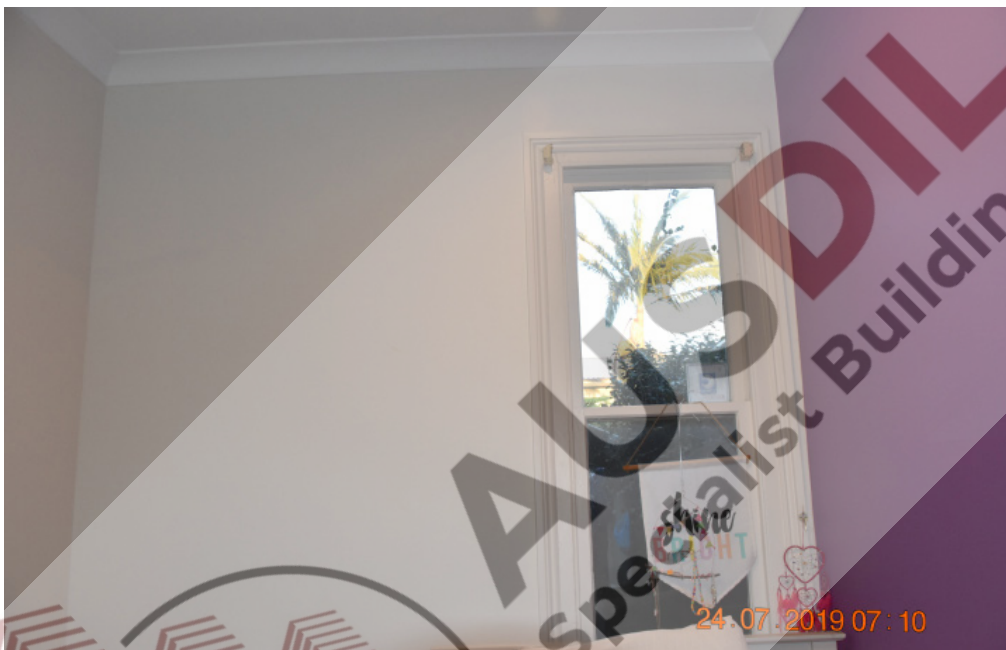
Figure: 0056

Rear wall in bedroom 2.

No changes noted.

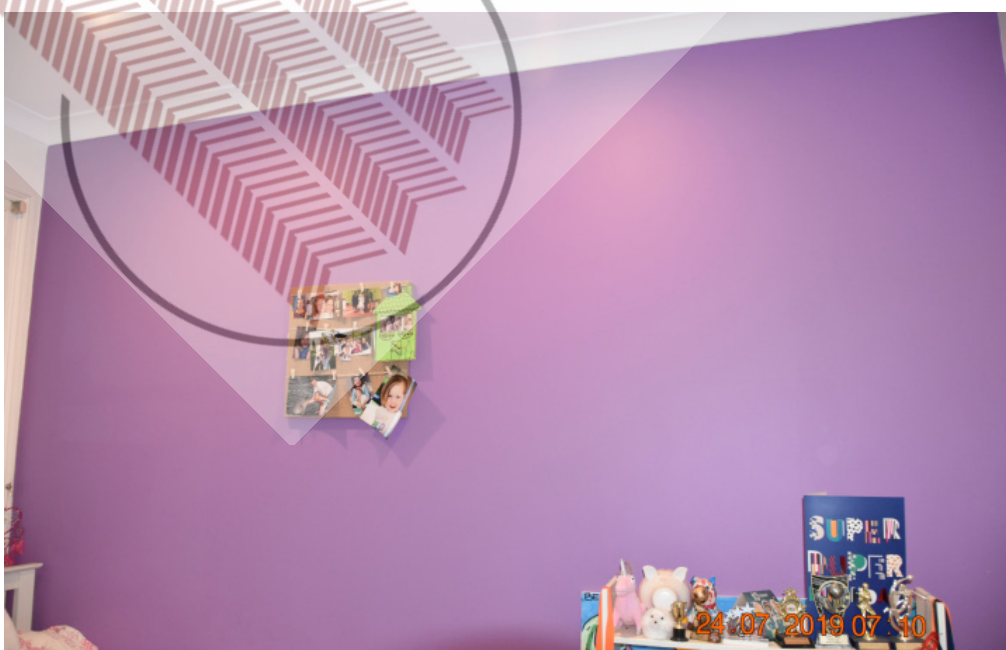
Figure: 0057

Right wall in bedroom 2.

No changes noted.

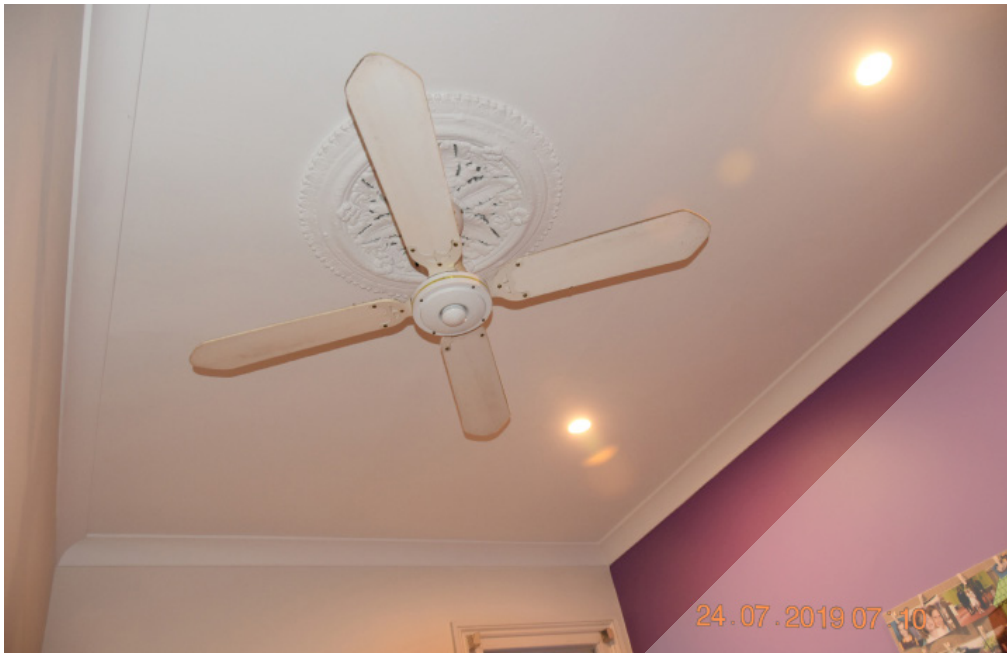
Figure: 0058

General view of the ceiling in bedroom 2.

No changes noted.

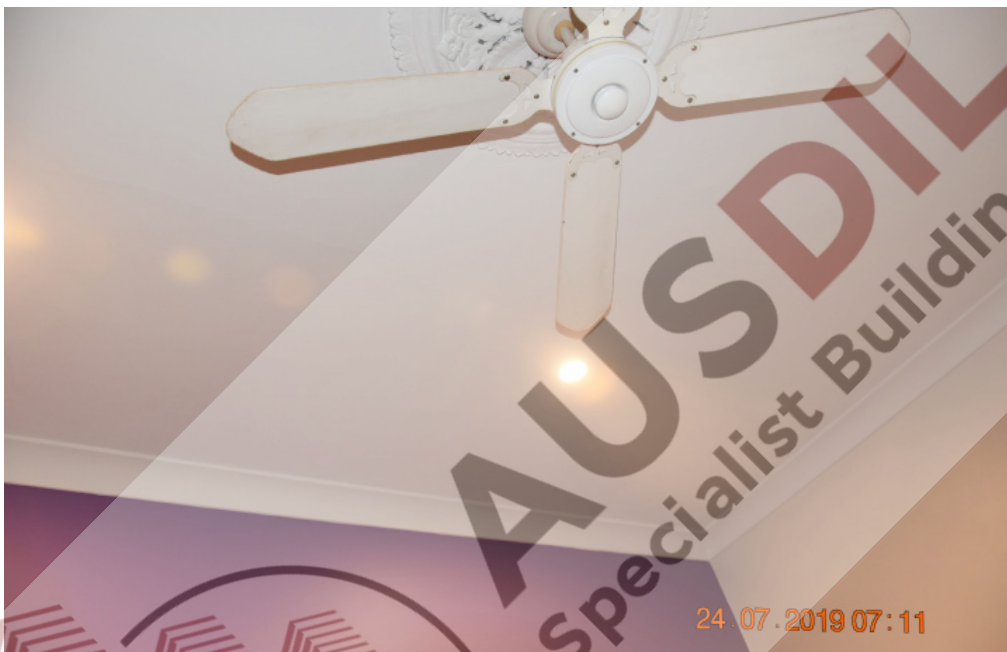
Figure: 0059

General view of the ceiling in bedroom 2.

No changes noted.

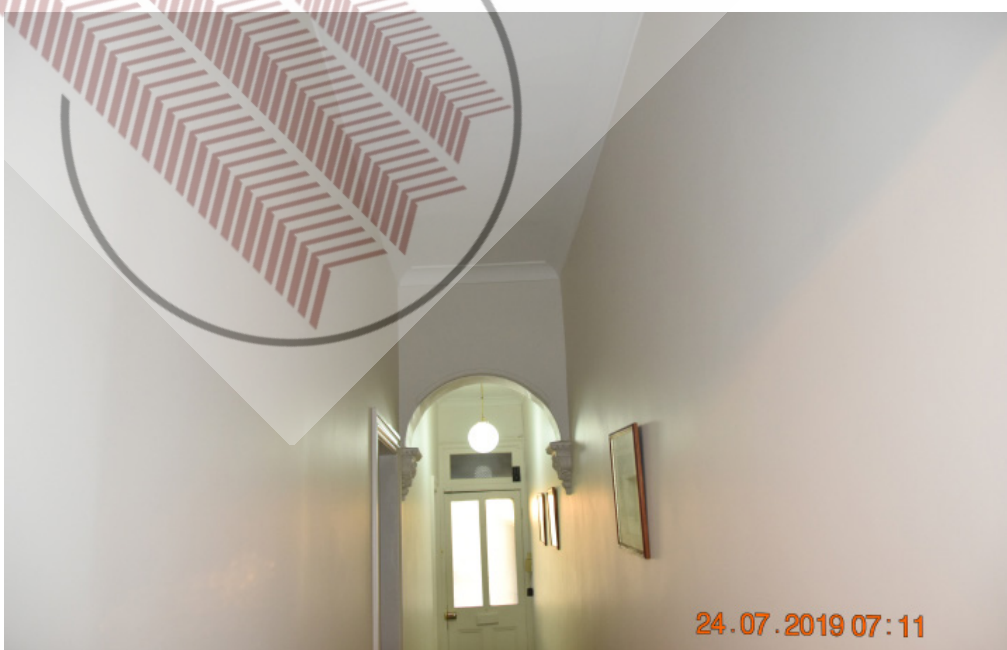
Figure: 0060

General view in the hallway, outside the dining room.

No changes noted.

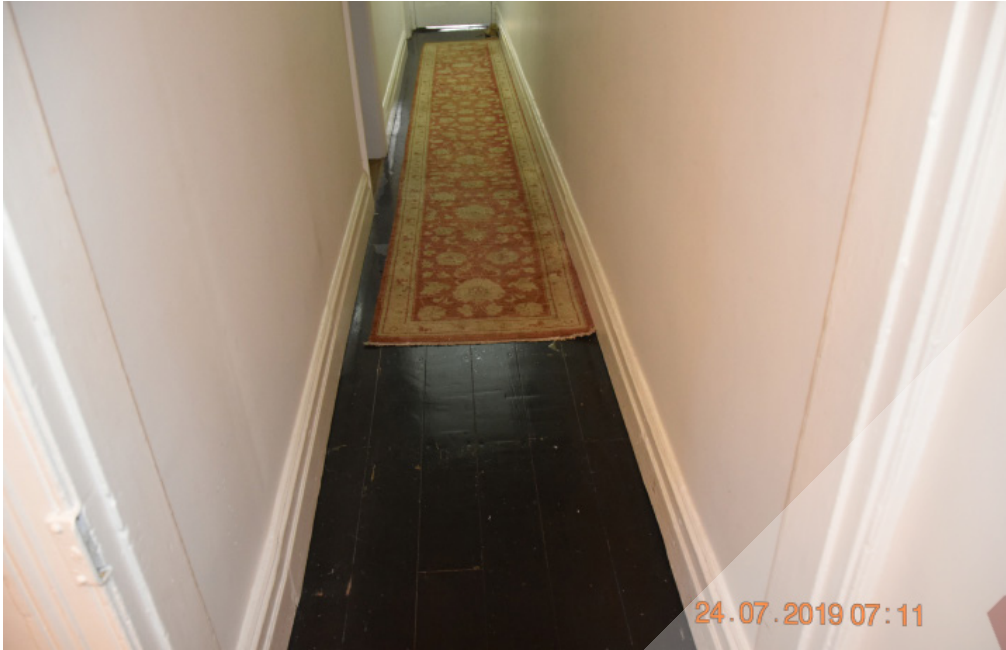
Figure: 0061

General view in the hallway, outside the dining room.

No changes noted.

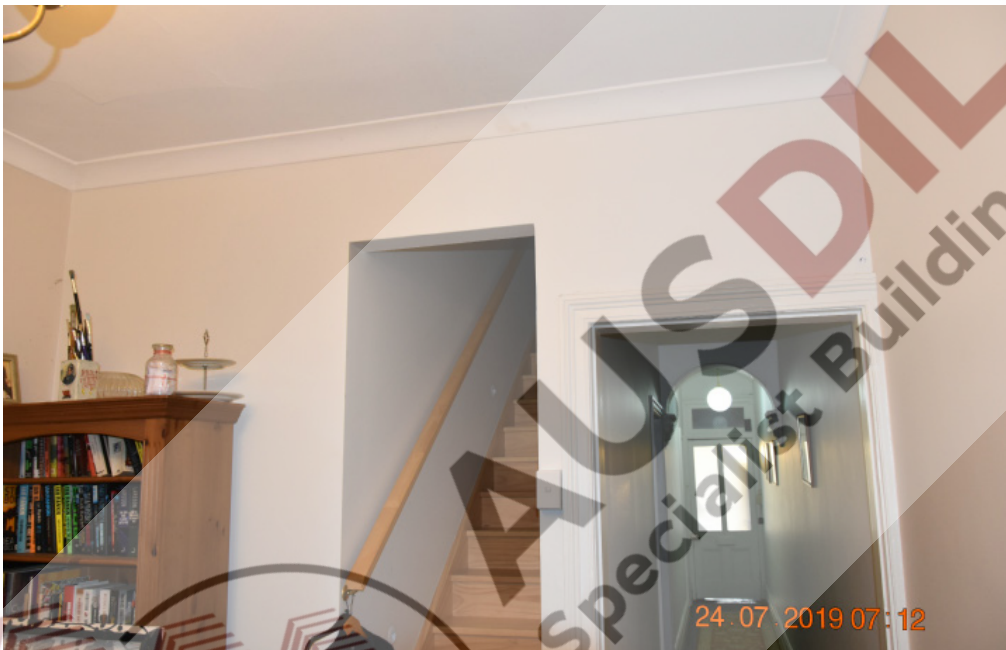
Figure: 0062

Front wall in the dining room.

No changes noted.

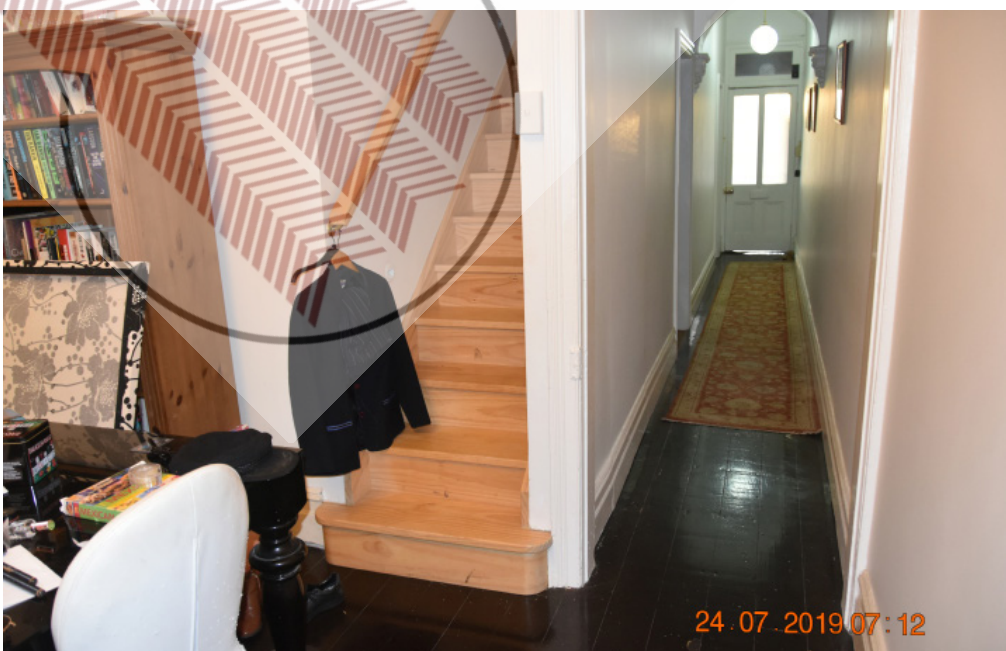
Figure: 0063

Front wall in the dining room.

No changes noted.

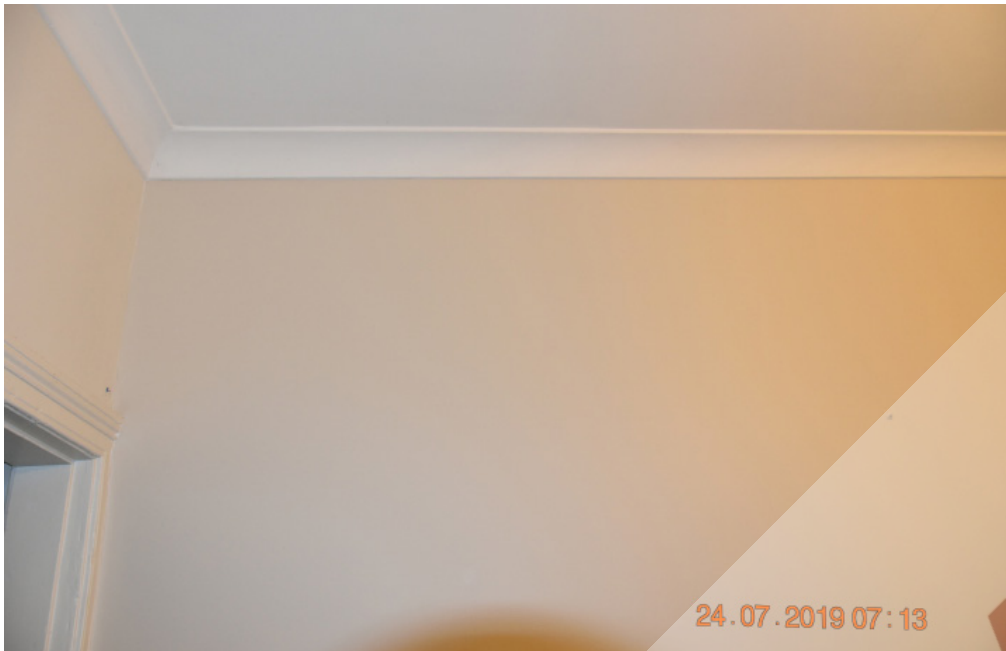
Figure: 0064

Left wall in the dining room, front side.

No changes noted.

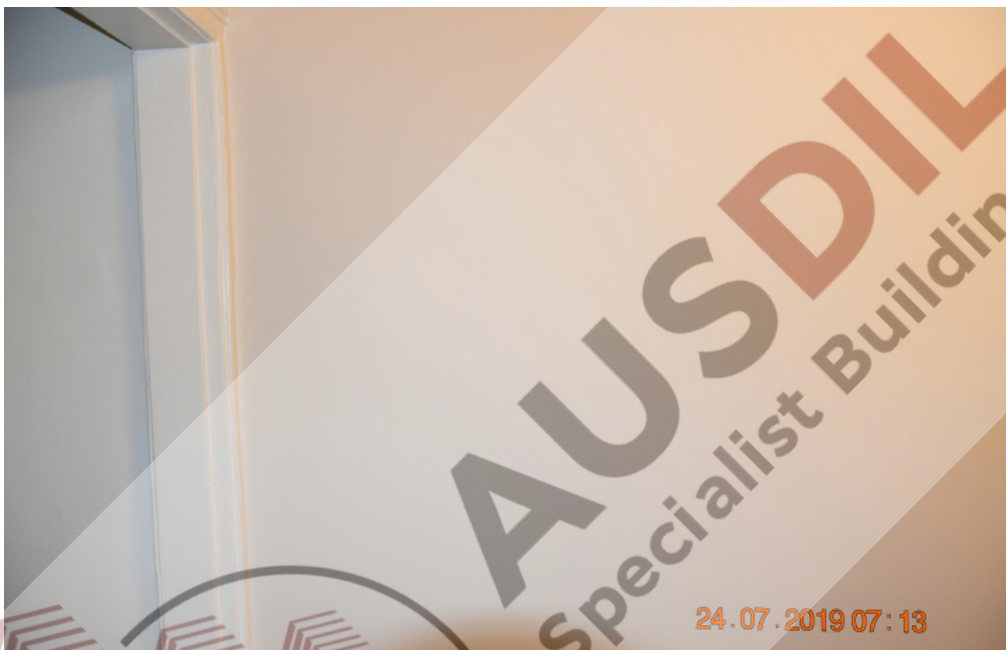
Figure: 0065

Left wall in the dining room, front side.

No changes noted.

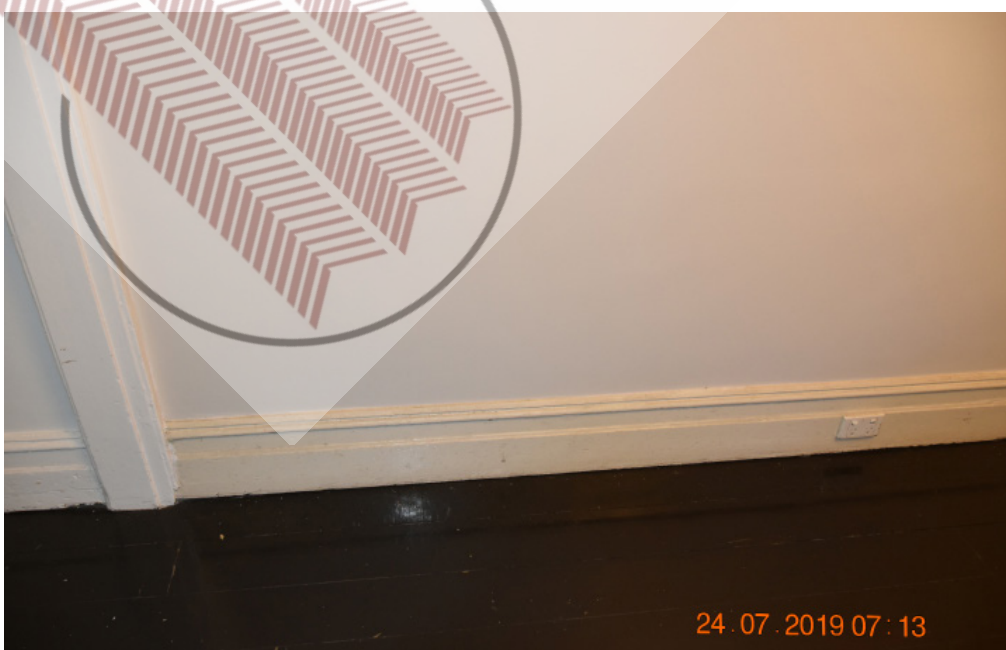
Figure: 0066

Left wall in the dining room, front side.

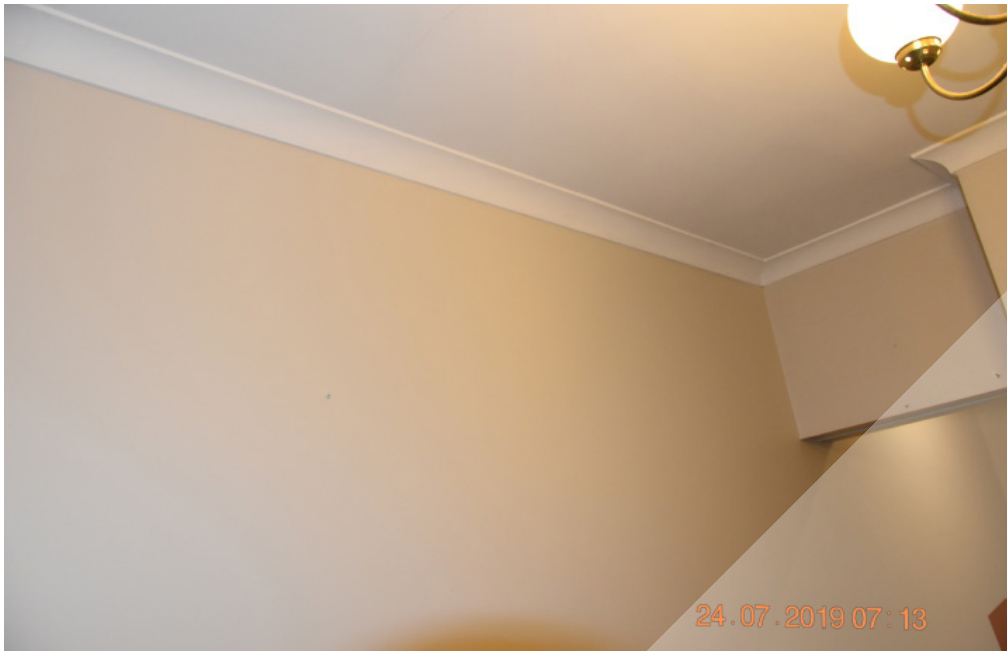
Figure: 0067

Left wall in the dining room.

No changes noted.

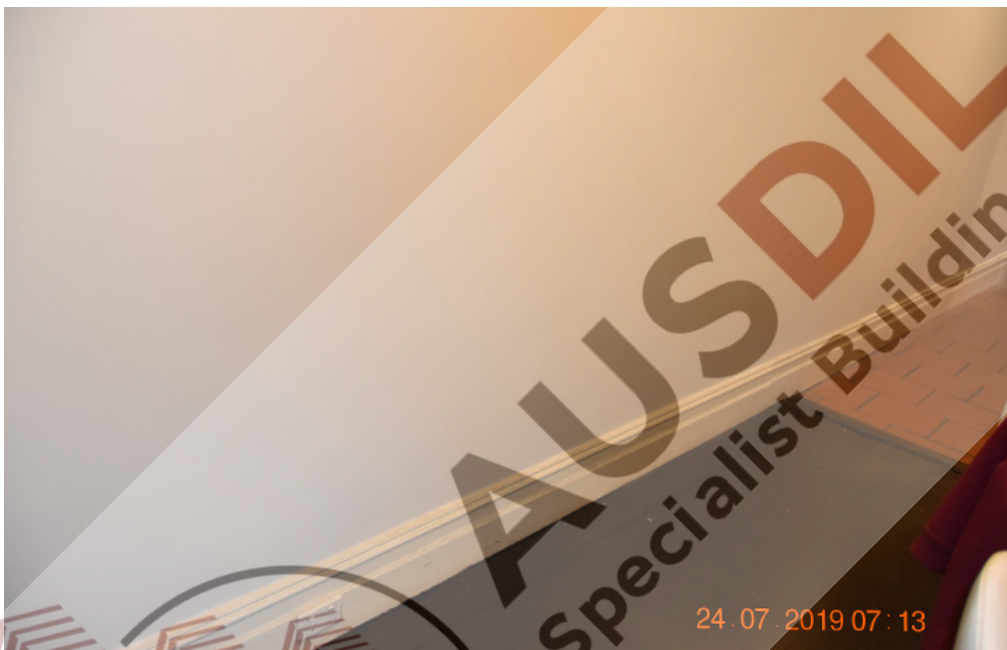
Figure: 0068

Left wall in the dining room.

No changes noted.

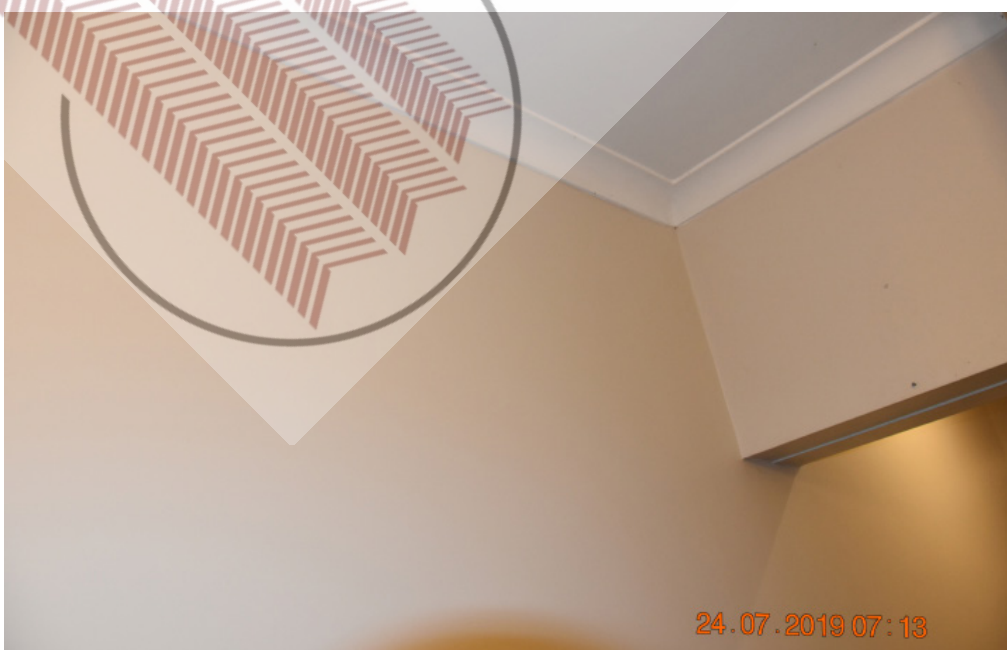
Figure: 0069

Left wall in the dining room, rear side.

No changes noted.

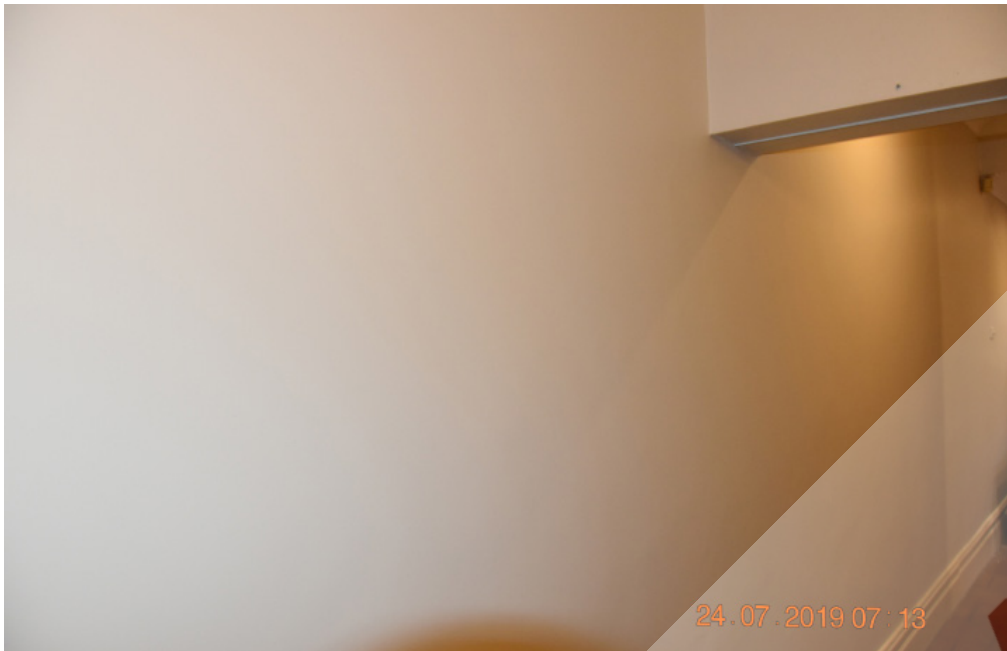
Figure: 0070

Left wall in the dining room, rear side.

No changes noted.

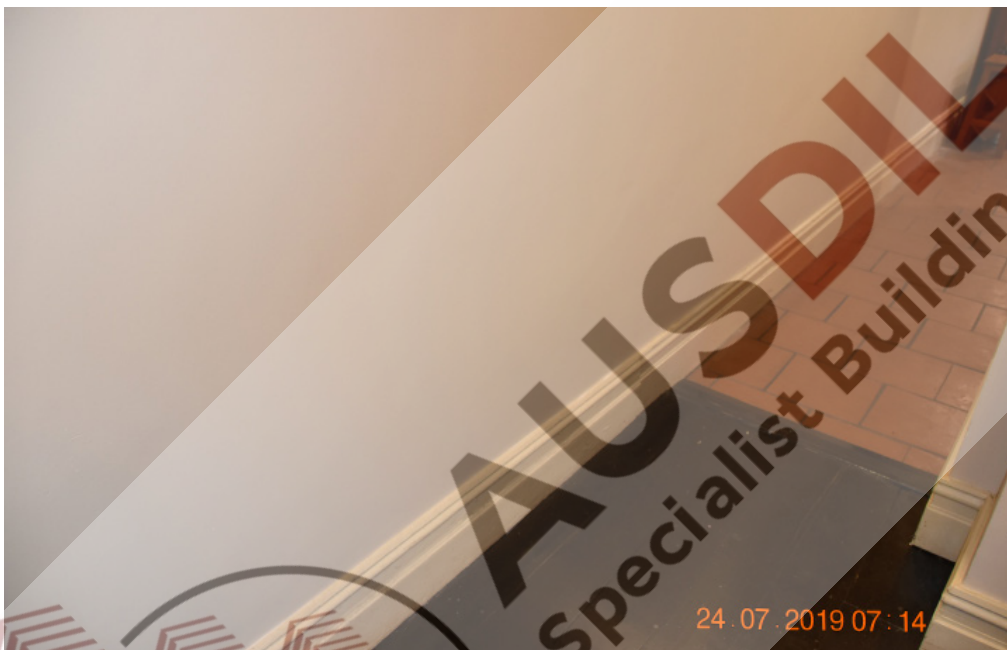
Figure: 0071

Left wall in the dining room, rear side.

No changes noted.

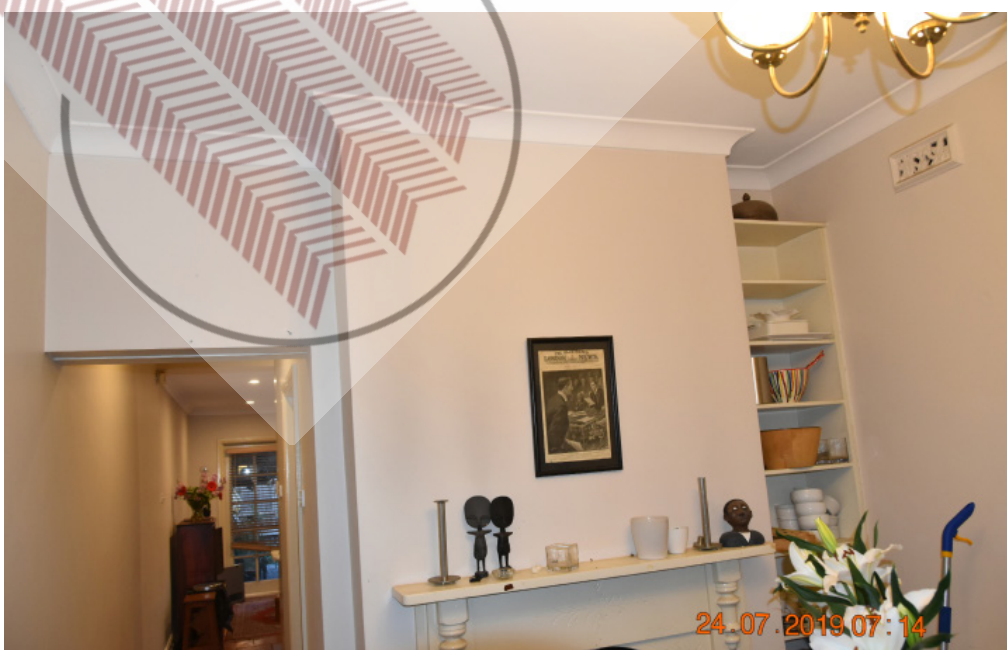
Figure: 0072

Rear wall in the dining room.

No changes noted.

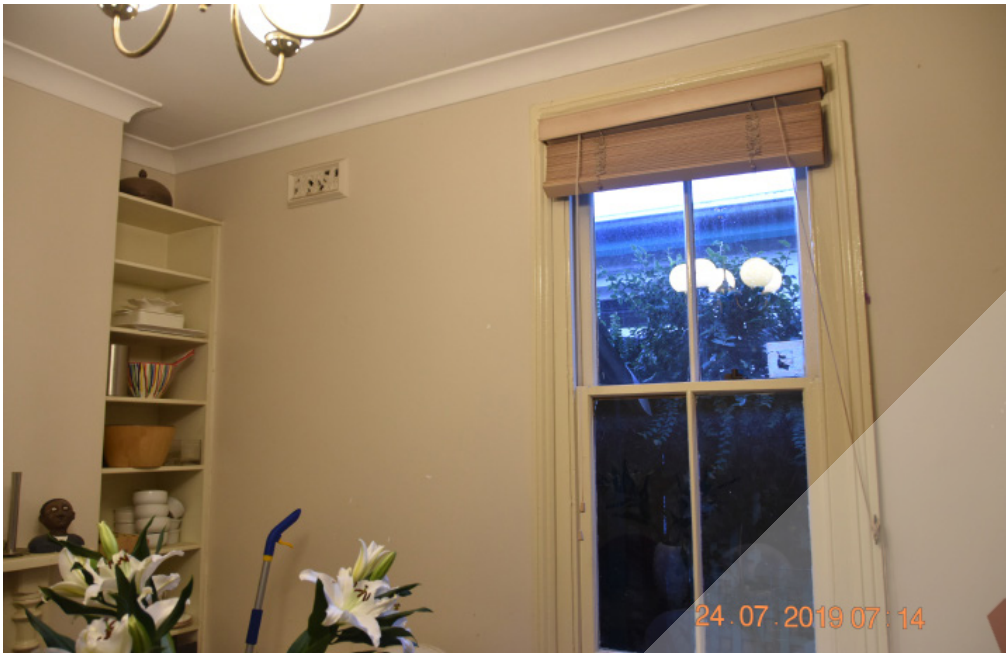
Figure: 0073

Right wall in the dining room, rear side.

No changes noted.
