AUSDILAPS

PROPERTY CONDITION SURVEY - RESIDENTIAL

Australian Dilapidations was commissioned by The (Client) to carry out a post construction condition inspection and report in accordance with AS.4349.1 for the (Project Name) project.

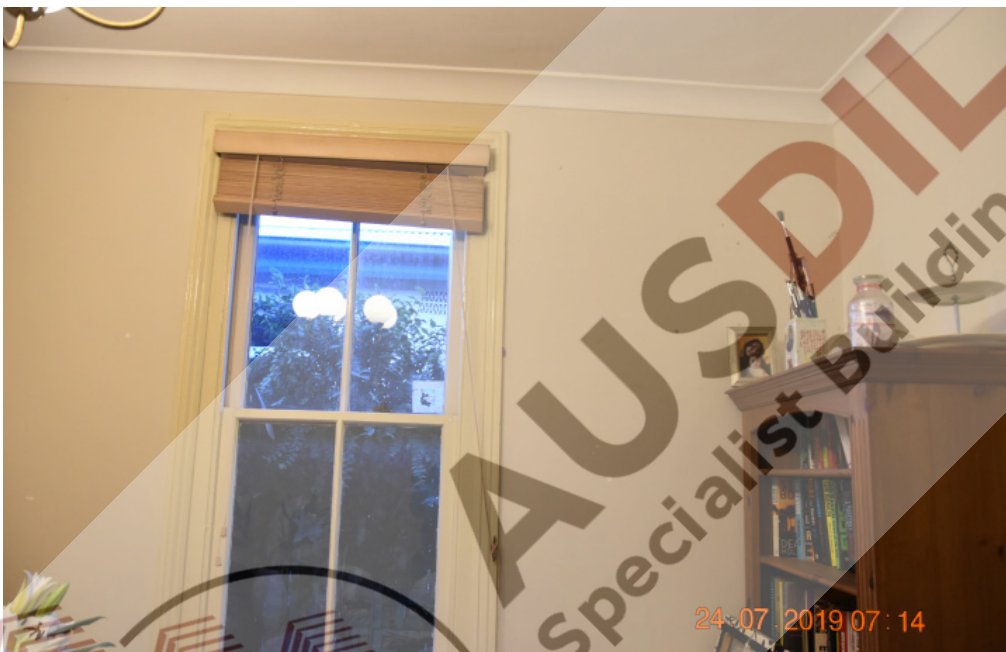
Figure: 0074

Right wall in the dining room, front side.

No changes noted.

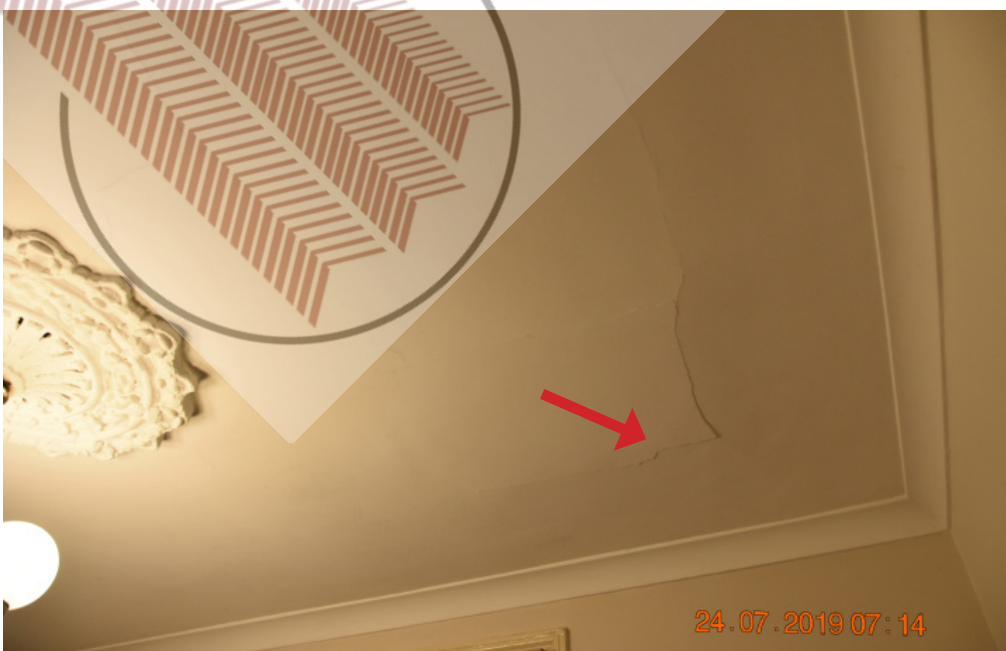
Figure: 0075

General view of the ceiling in the dining room, looking from the front. Showing cracking. Typical throughout.

No changes noted.

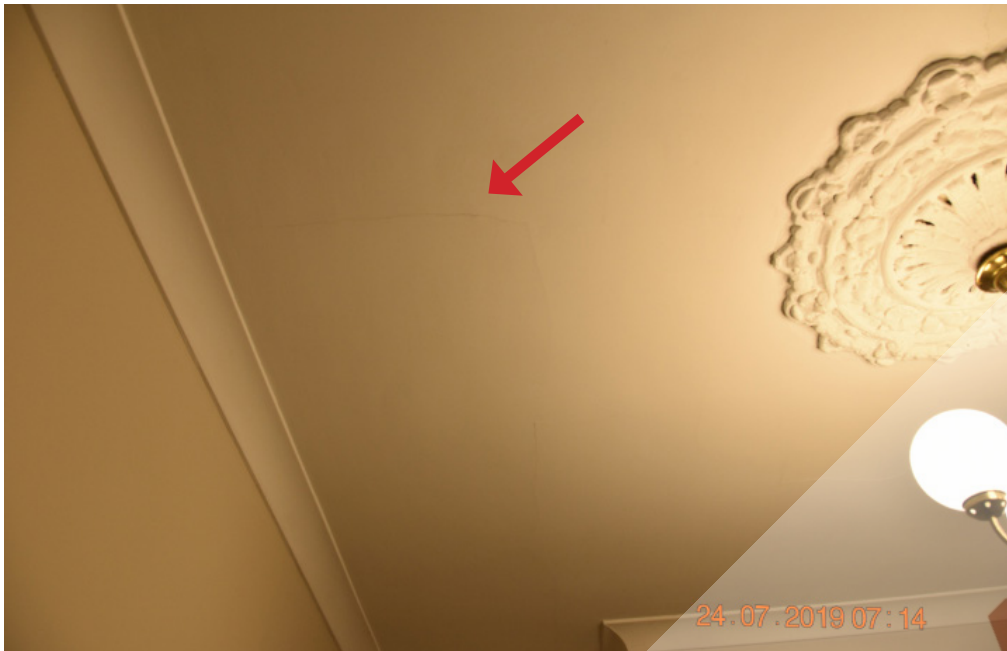
Figure: 0076

General view of the ceiling in the dining room, looking from the front. Showing cracking.

No changes noted.

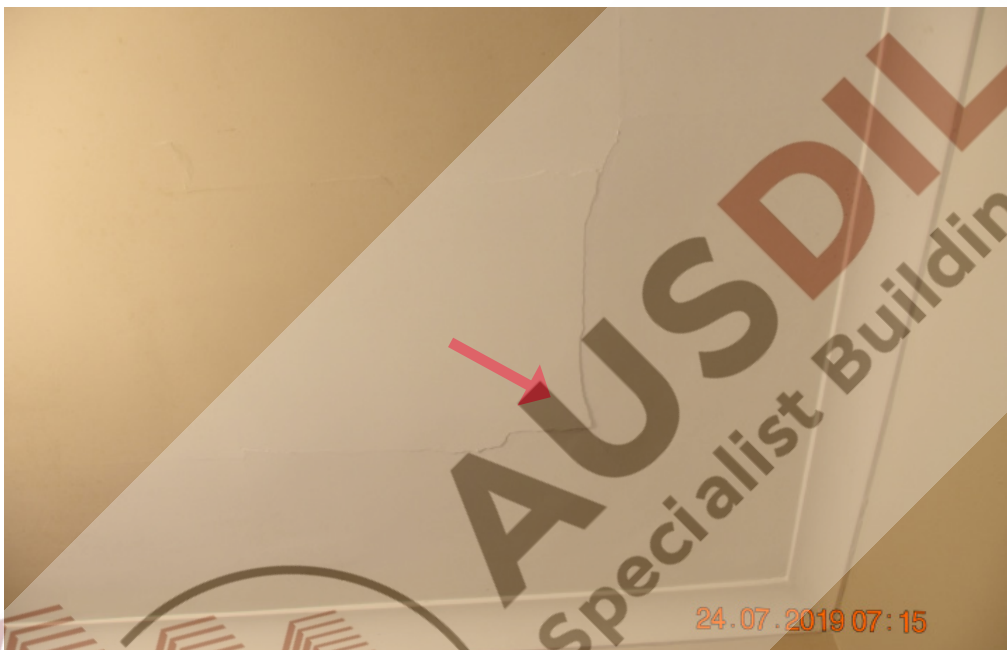
Figure: 0077

Cracking in the ceiling in the dining room, front side.

No changes noted.

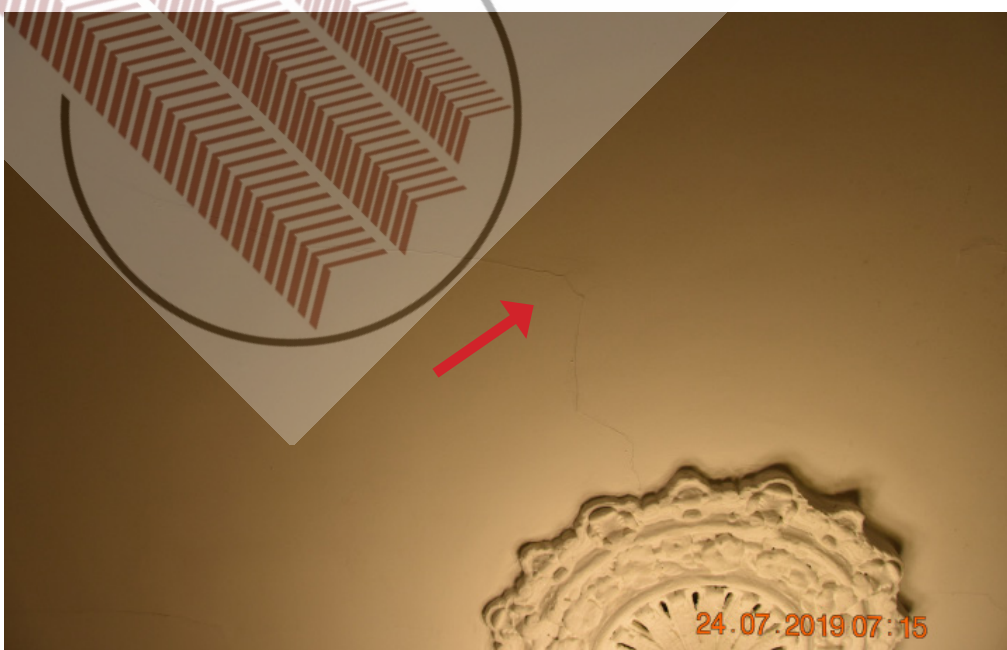
Figure: 0078

Cracking in the ceiling in the dining room.

No changes noted.

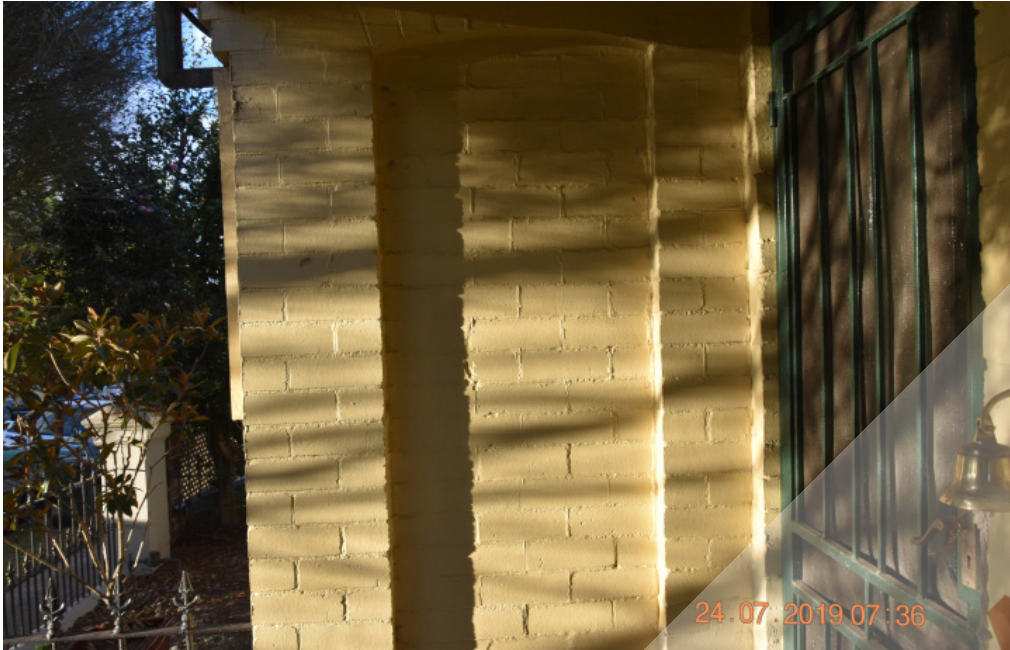
Figure: 0175

Left wall on the front porch.

No changes noted.

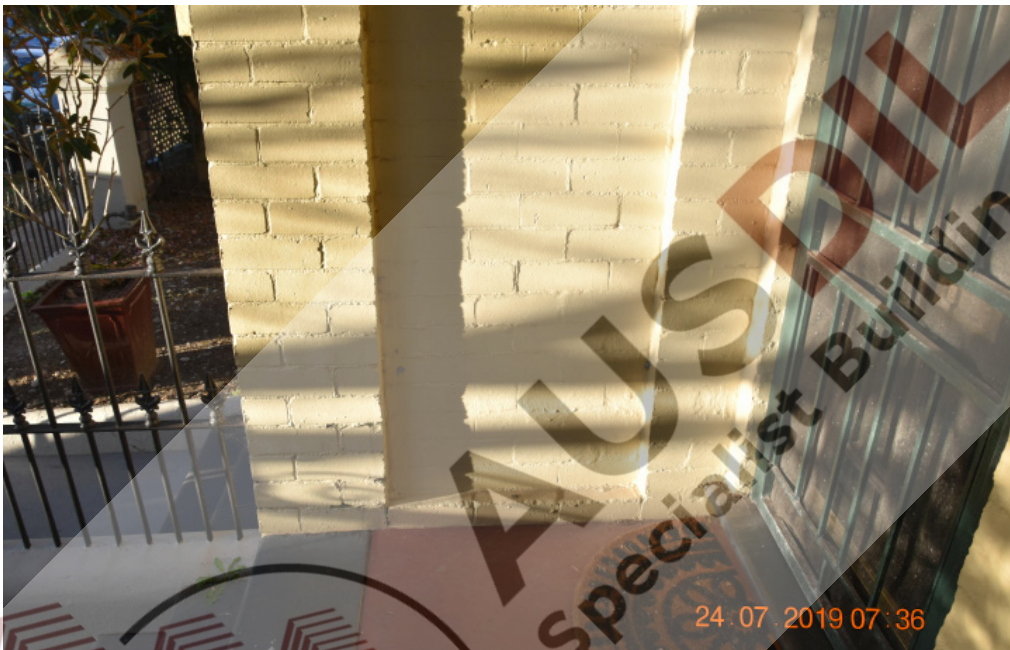
Figure: 0176

Left wall on the front porch.

No changes noted.

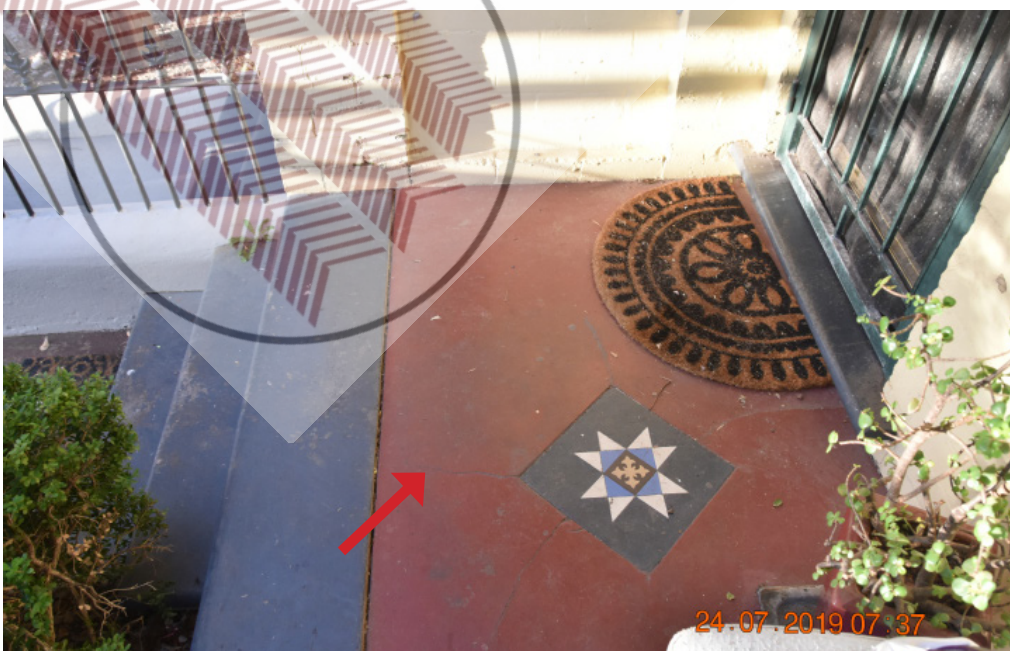
Figure: 0177

General view of the paving on the front porch, left side. Showing cracking.

No changes noted.

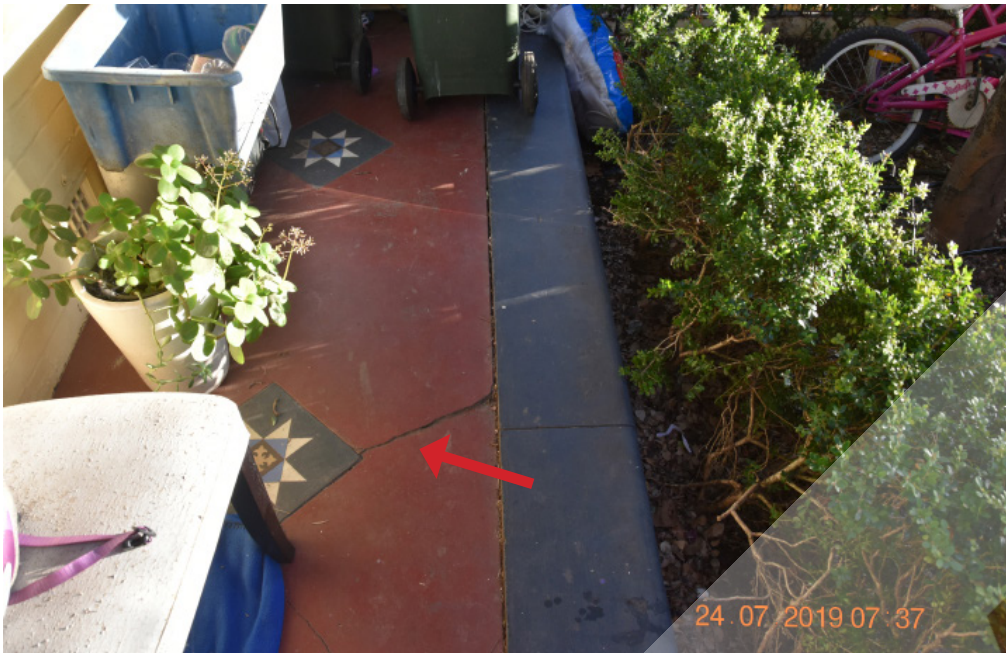
Figure: 0178

General view of the paving on the front porch, right side. Showing cracking.

No changes noted.

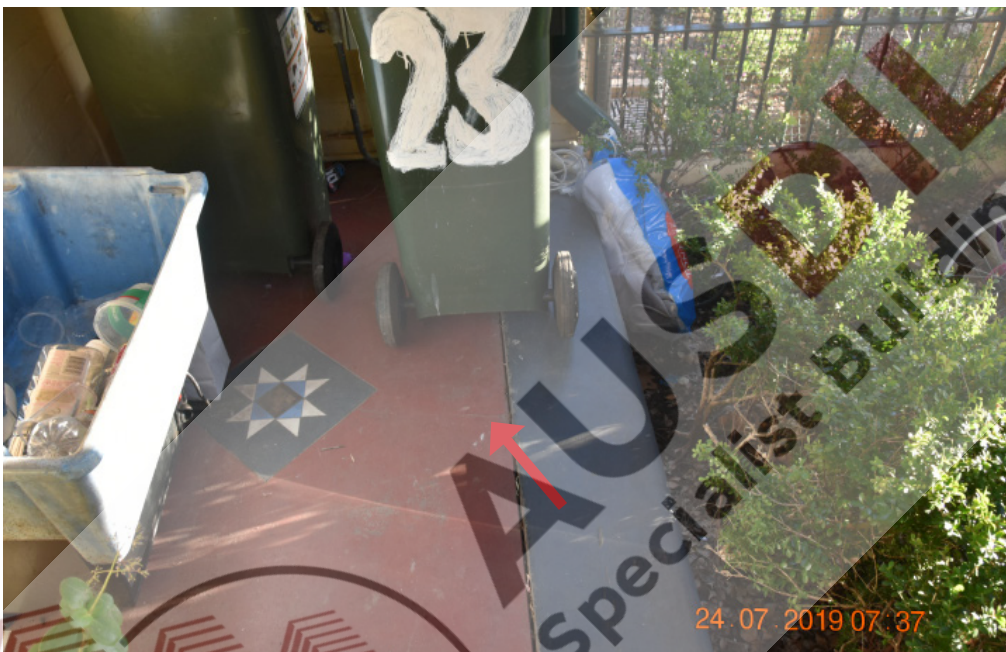
Figure: 0179

General view of the paving on the front porch, right side. Showing cracking.

No changes noted.

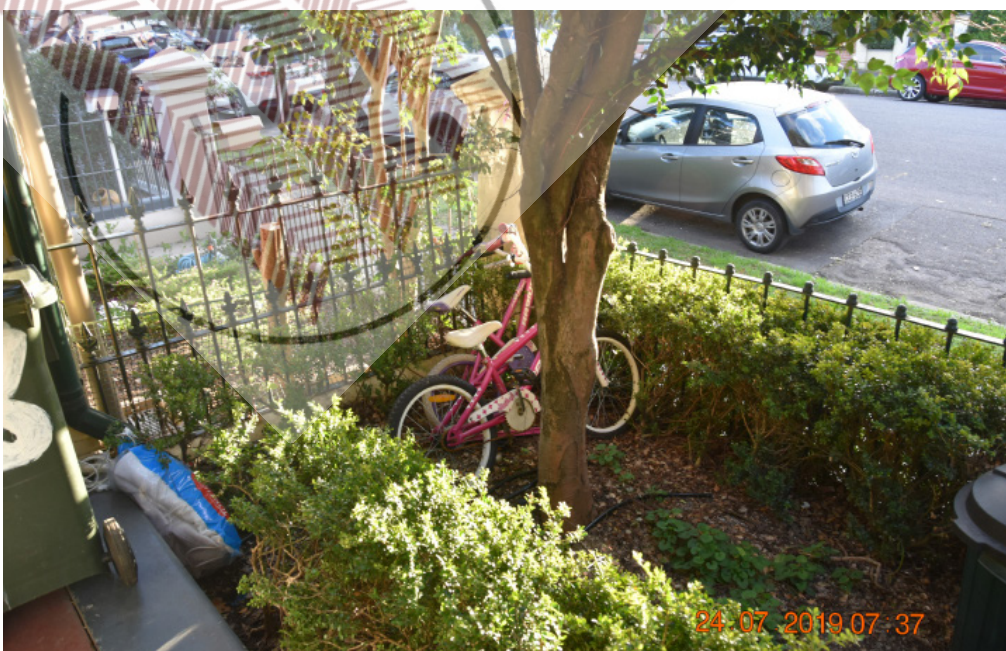
Figure: 0180

General view of the front yard.

No changes noted.

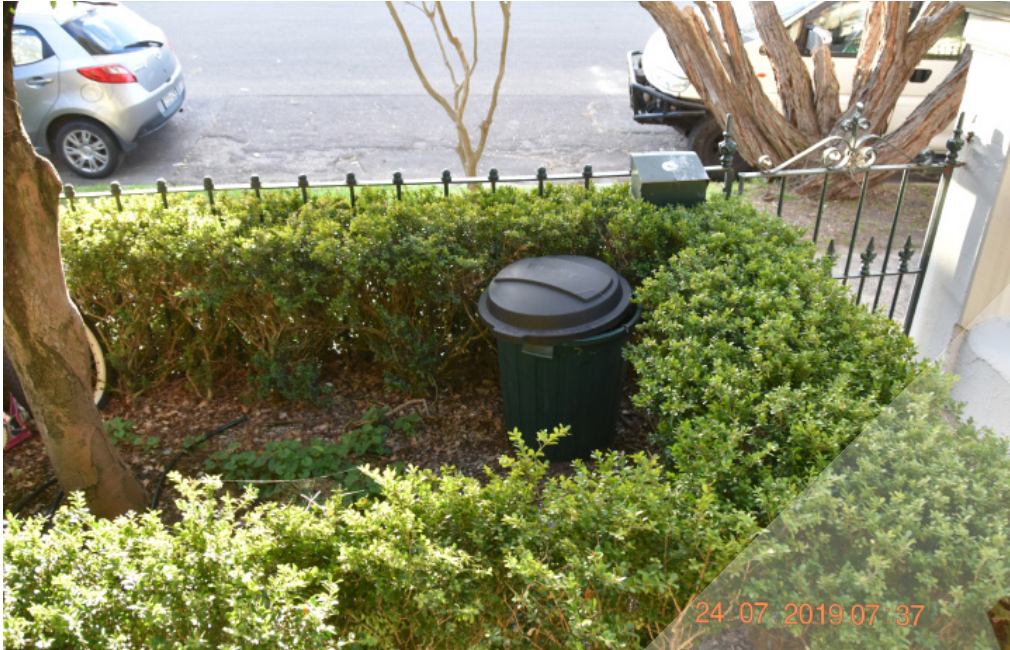
Figure: 0181

General view of the front yard.

No changes noted.

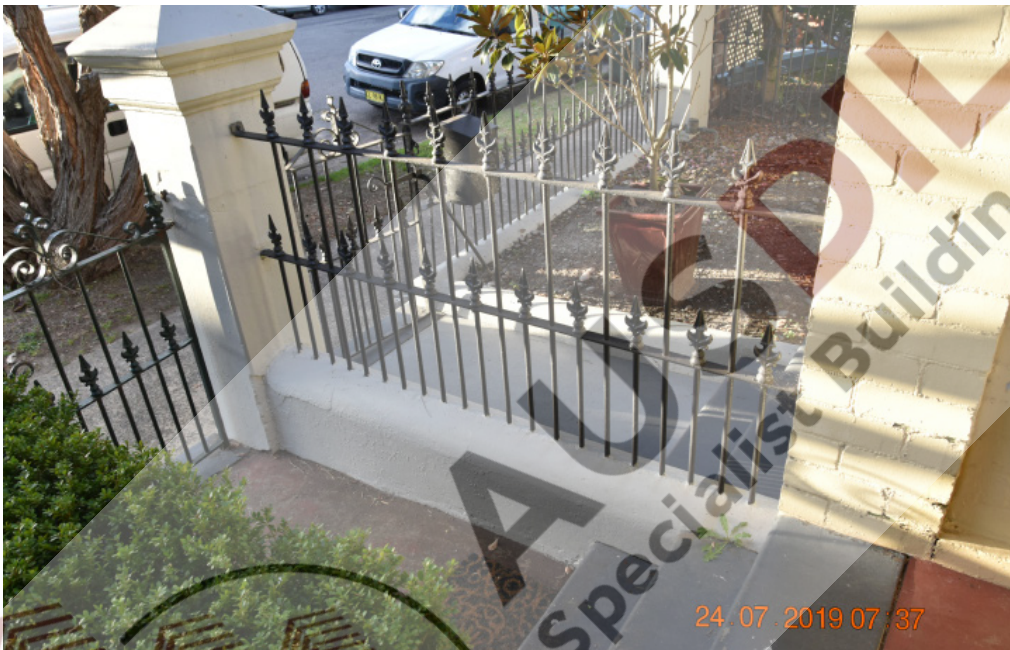
Figure: 0182

Left boundary fence.

No changes noted.

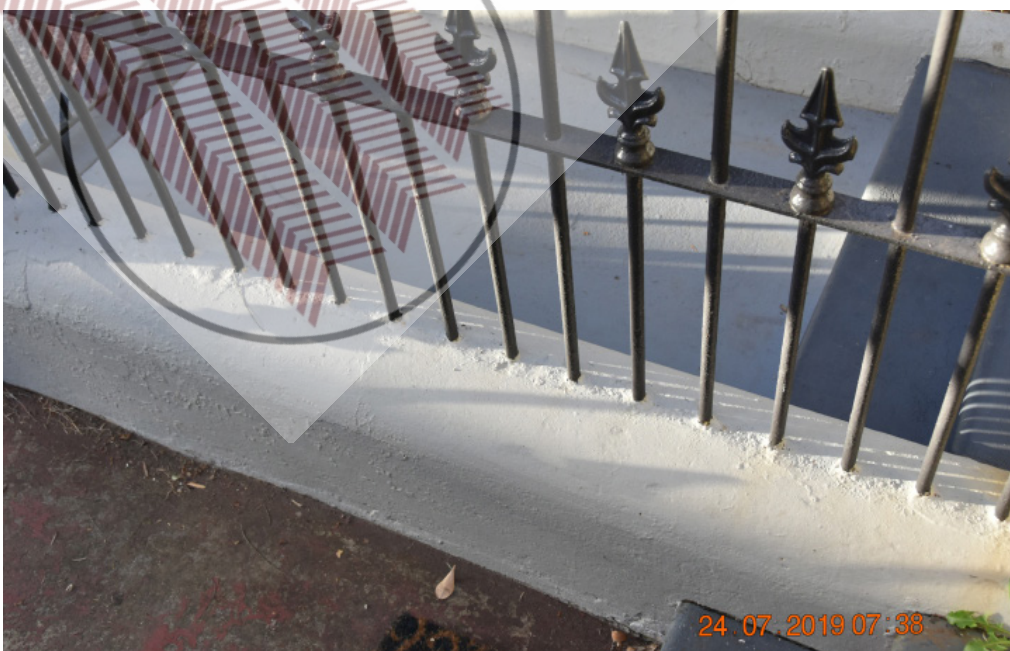
Figure: 0183

Cracking in the base of the left boundary fence.

Showing cracking has been repaired.

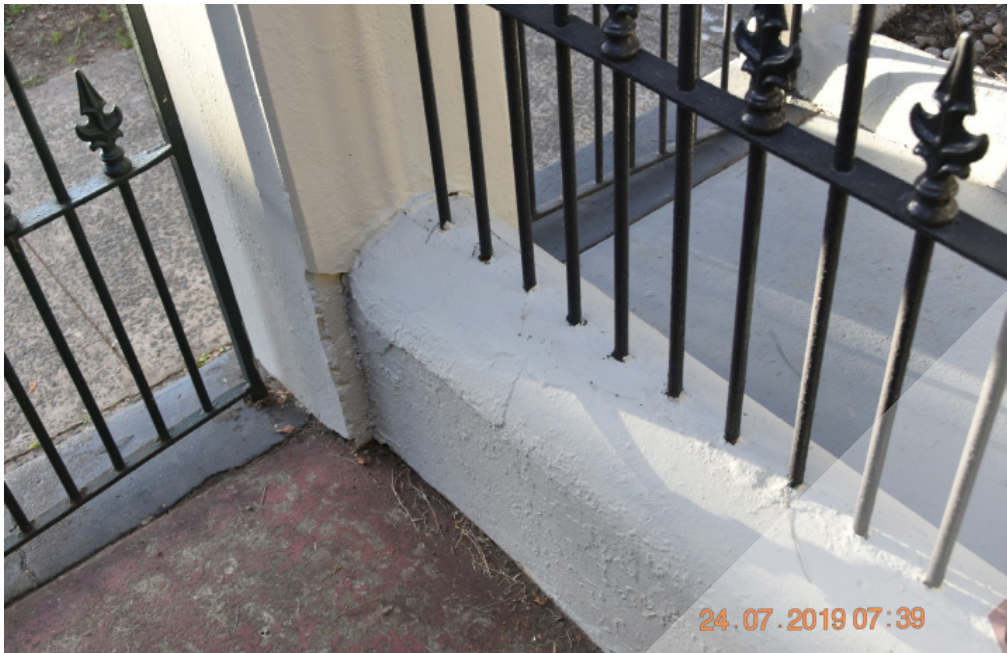
Figure: 0184

Mould and bubbling paint in the base of the left boundary fence.

Showing damage has been repaired.

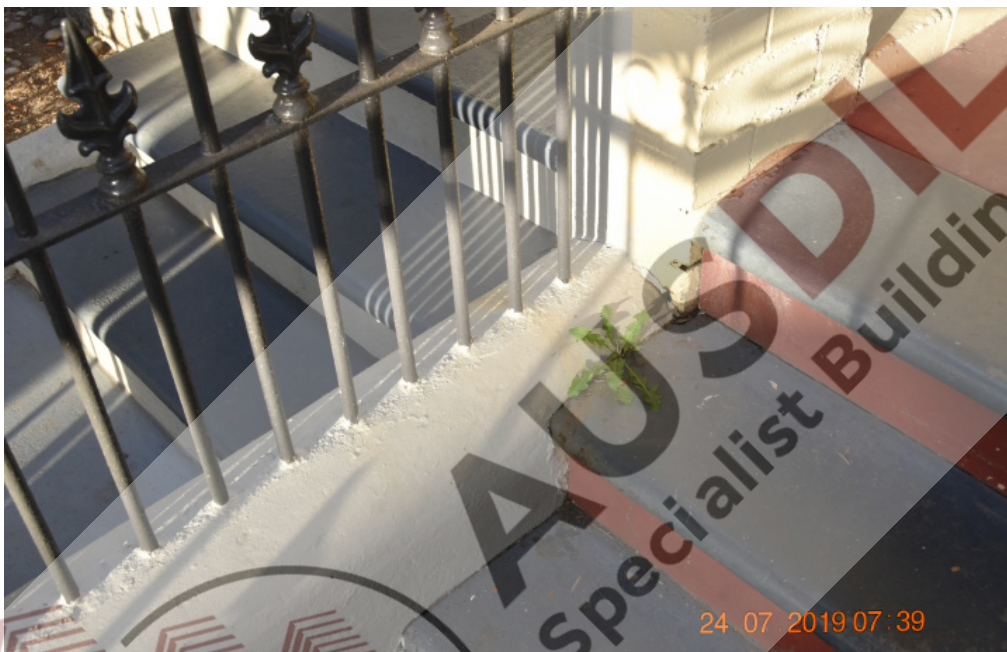
Figure: 0185

Left boundary fence. Showing rusting.

Showing rusting has been repaired.

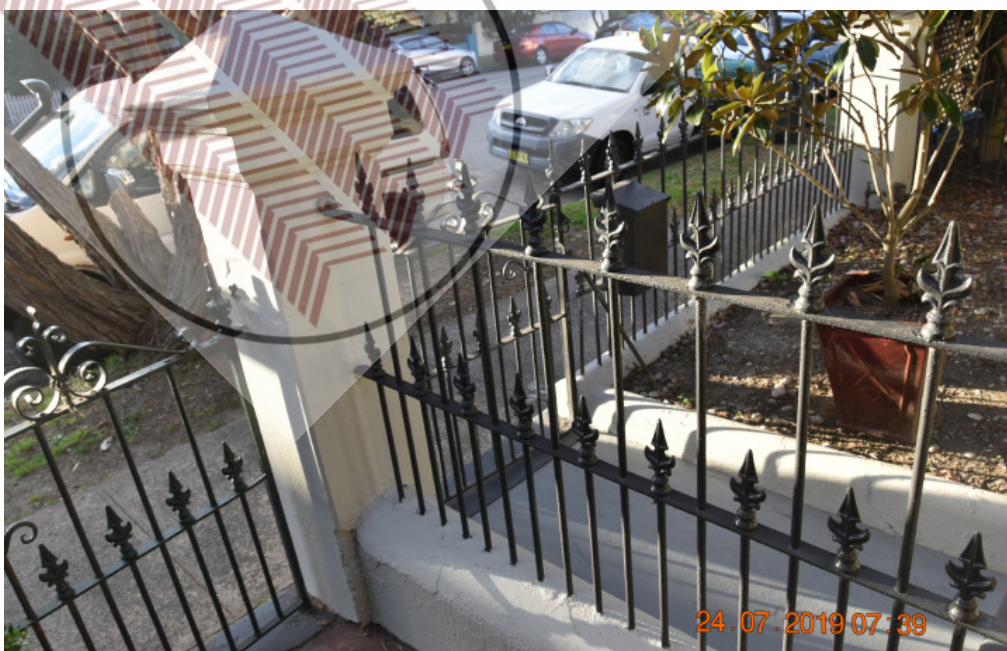
Figure: 0186

Left boundary fence.

No changes noted.

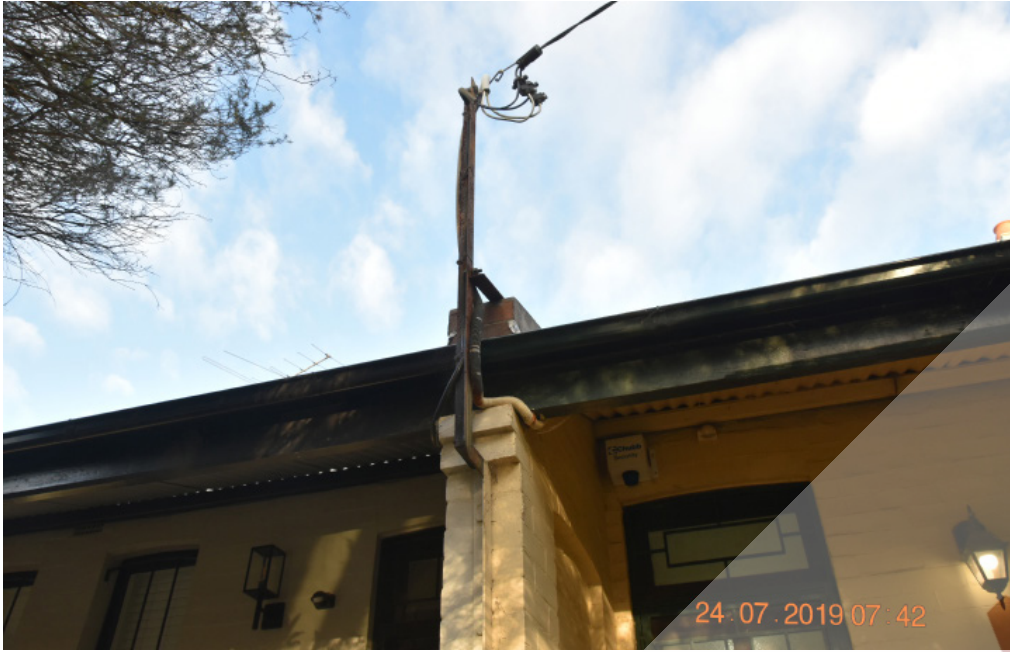
Figure: 0202

General view of the electricity port between 23 and 25 The Boulevard.

No changes noted.

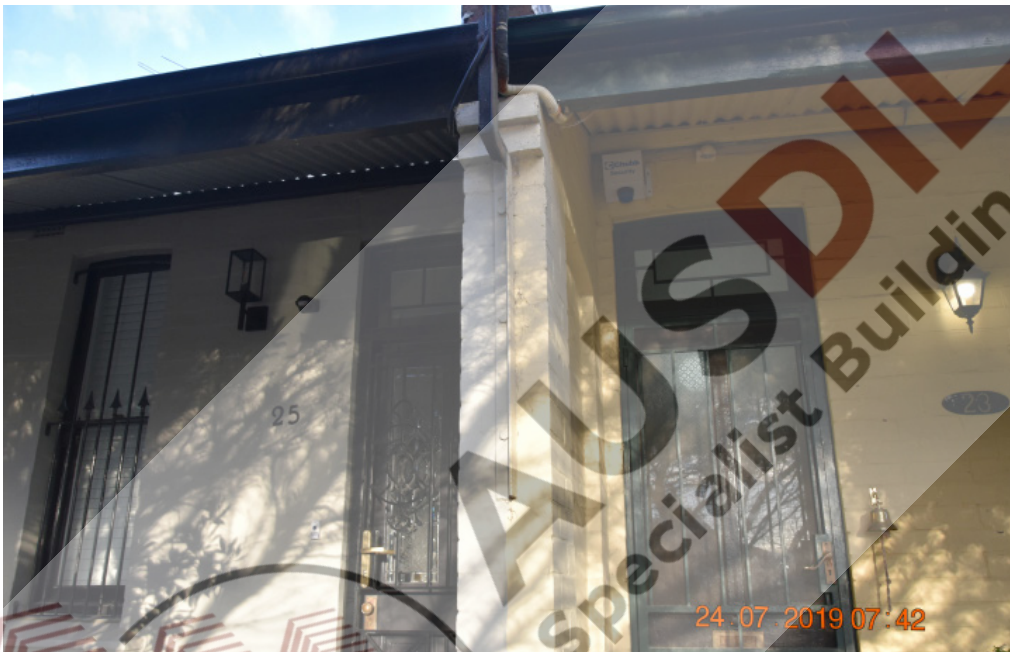
Figure: 0203

General view of the wall between 23 and 25 The Boulevard.

No changes noted.

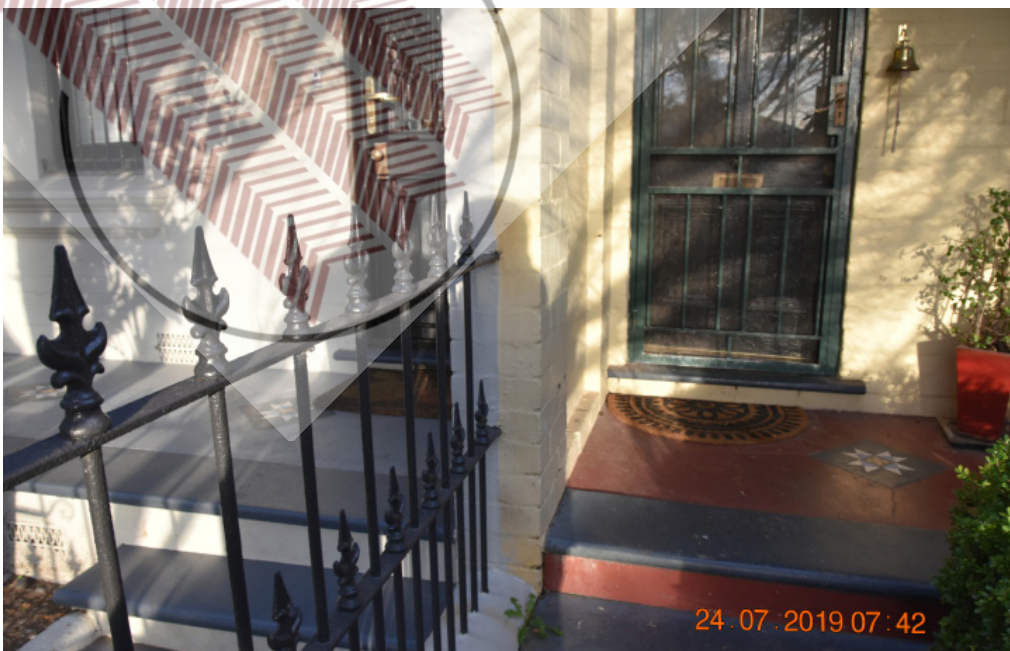
Figure: 0204

General view of the wall between 23 and 25 The Boulevard.

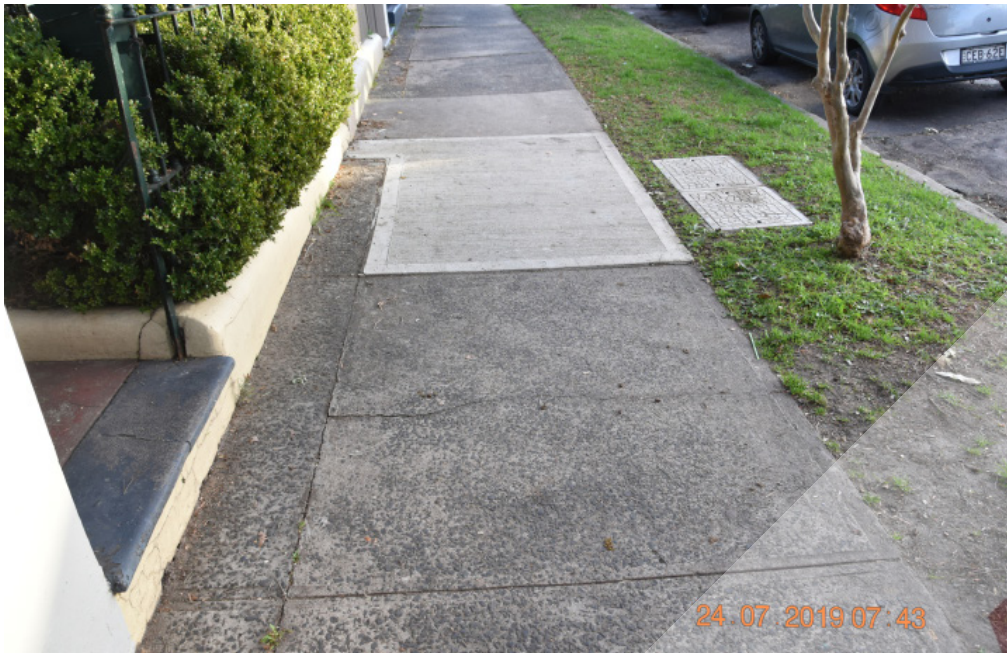
Figure: 0205

General view of the footpath outside 25 The Boulevard.

No changes noted.

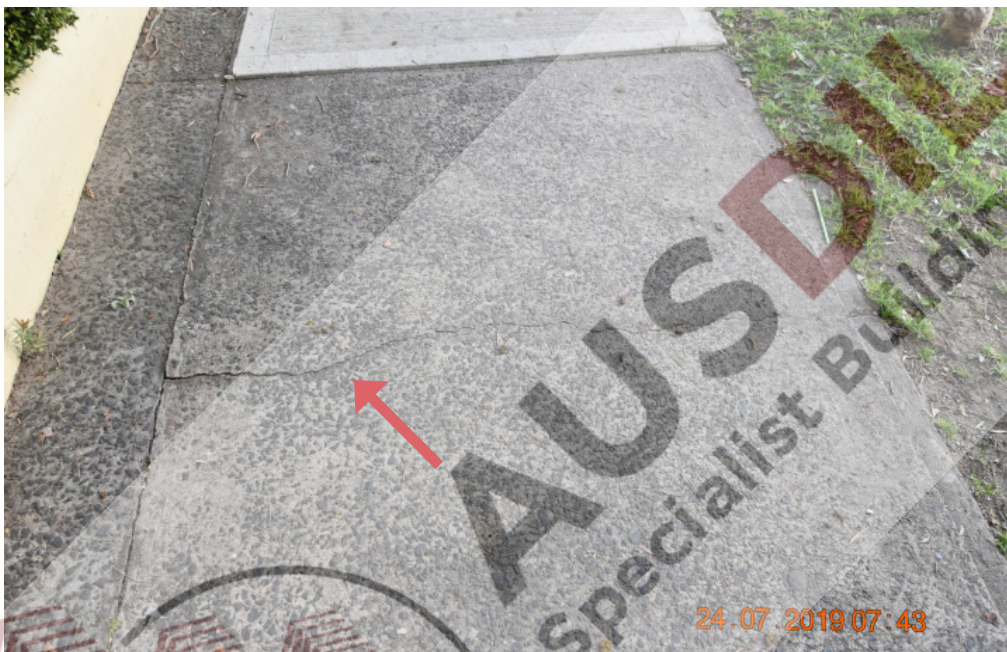
Figure: 0206

Cracking in the post between 23 and 25 The Boulevard, front side.	82	73	No changes noted.
Cracking in the footpath outside 25 The Boulevard.	84	75	No changes noted.

Cracking in the footpath outside 25 The Boulevard.

No changes noted.

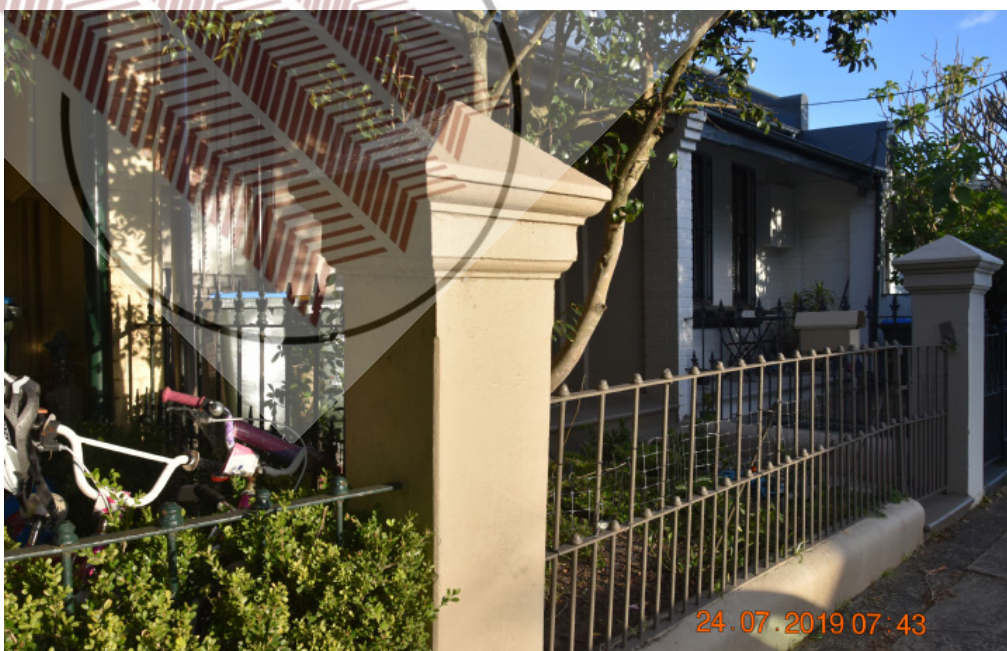
Figure: 0207

General view of the post near the front right corner of the property.

No changes noted.

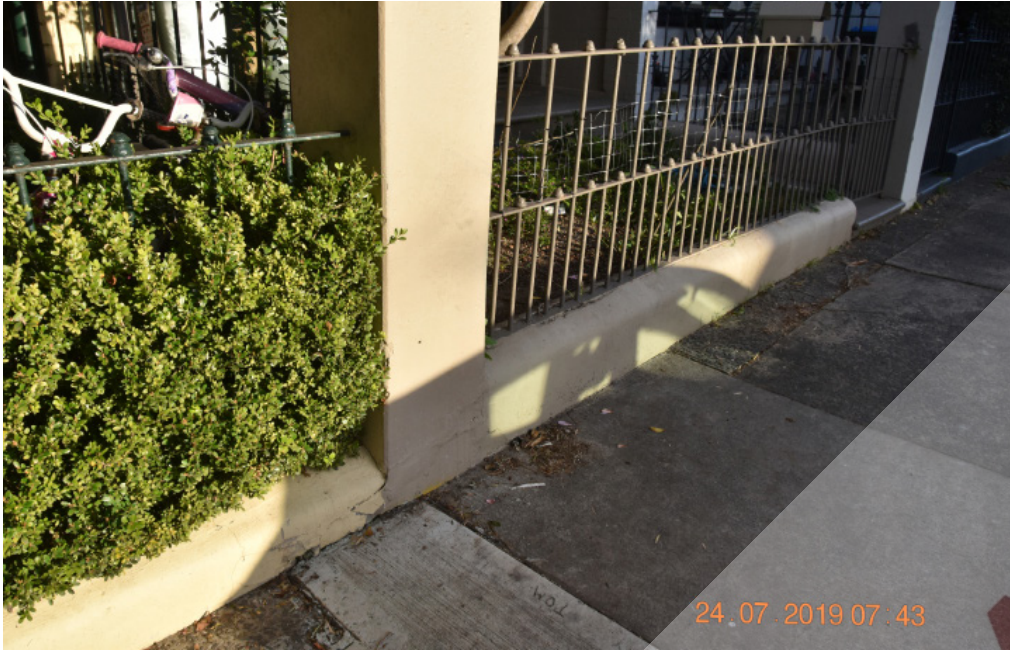
Figure: 0208

General view of the post near the front right corner of the property.

No changes noted.

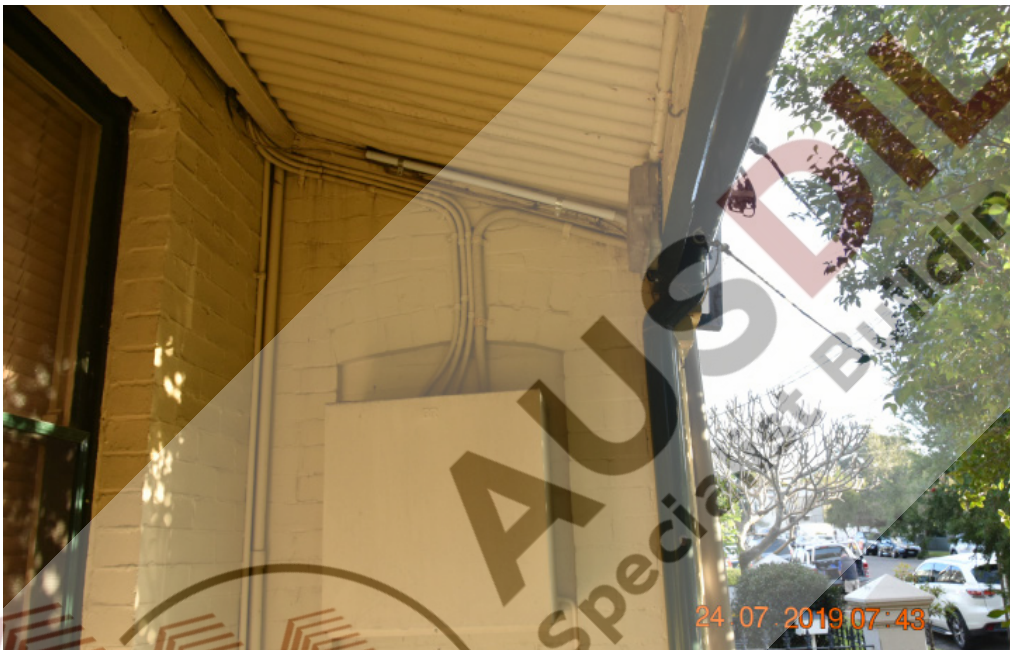
Figure: 0209

Right wall on the front porch.

No changes noted.

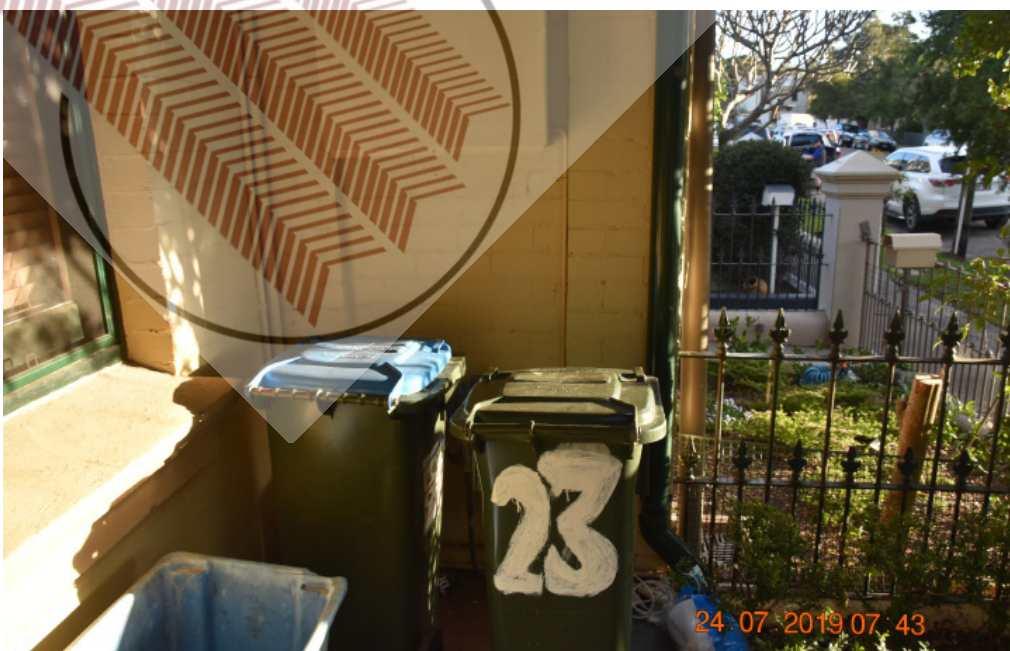
Figure: 0210

Right wall on the front porch.

No changes noted.
