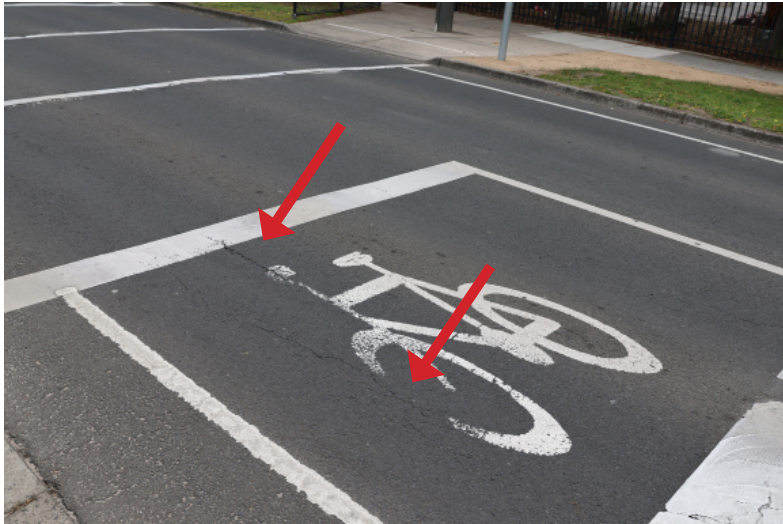
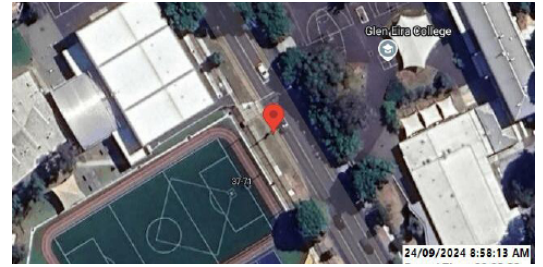
Figure: 0043
Slight cracking in the roadway on Booran Road.

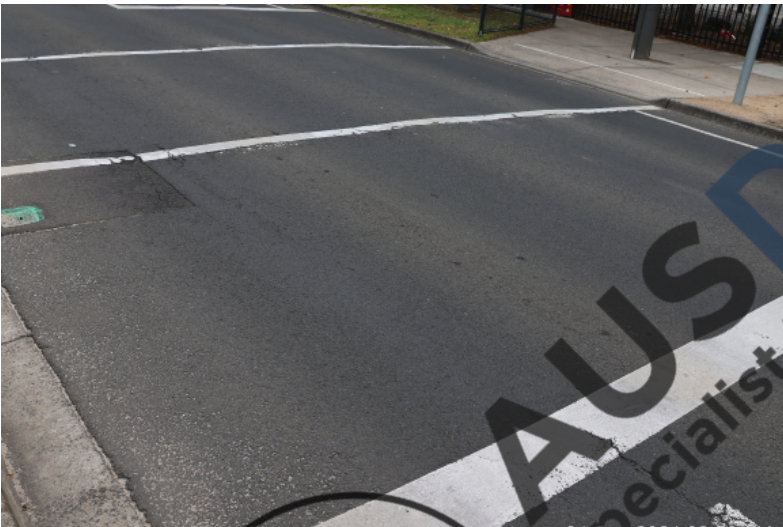
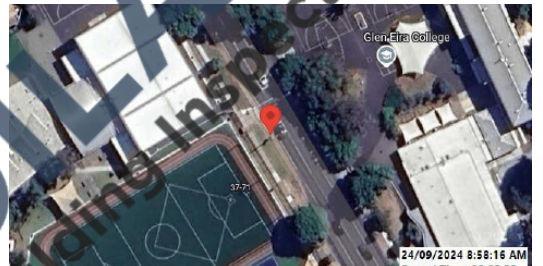
Figure: 0044
General view of the roadway on Booran Road.

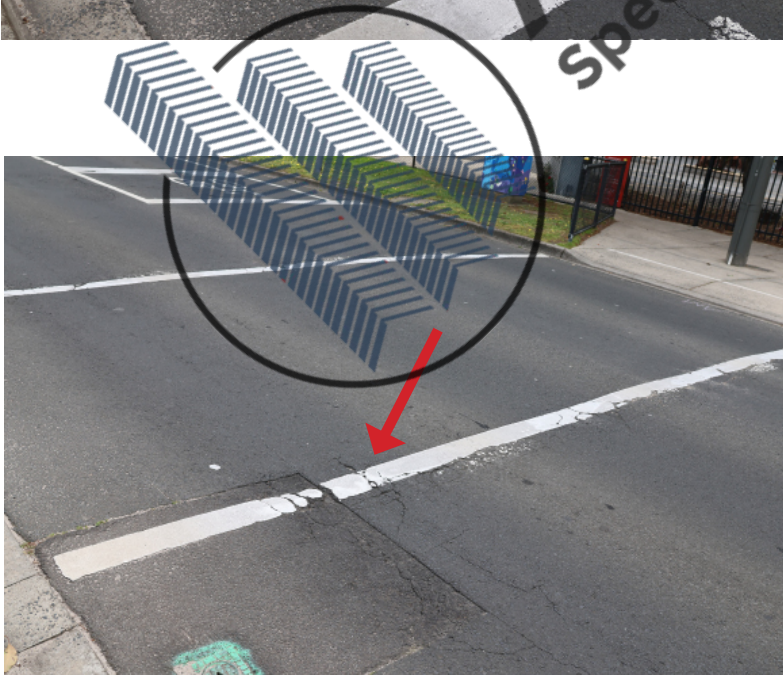
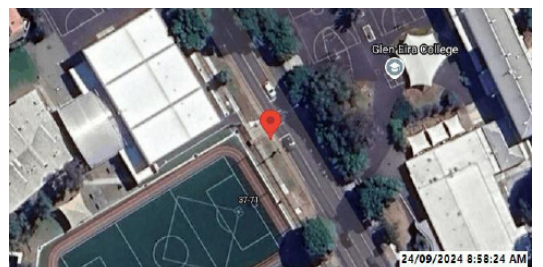
Figure: 0045
Slight cracking in the roadway on Booran Road.

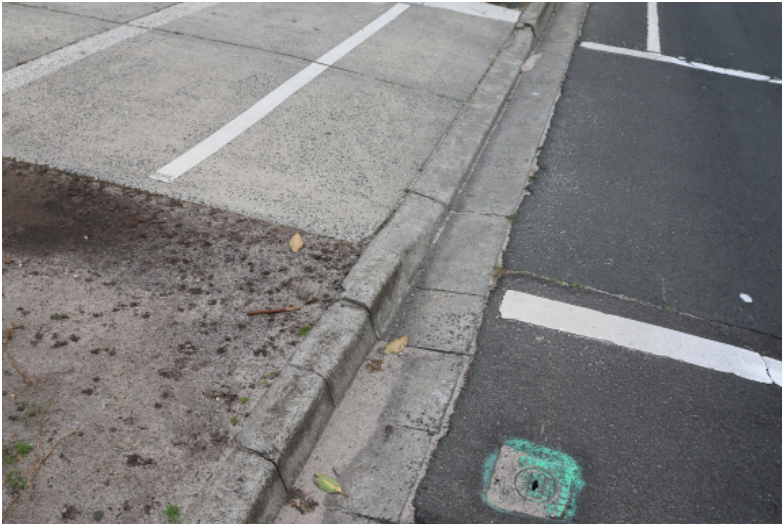
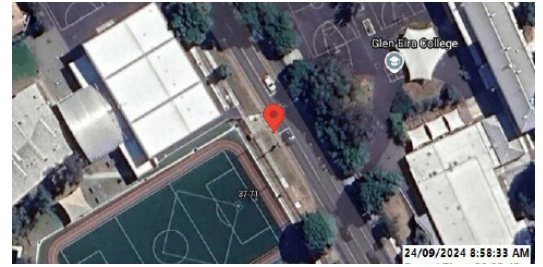
Figure: 0046
General view of the kerb and gutter on Booran Road.

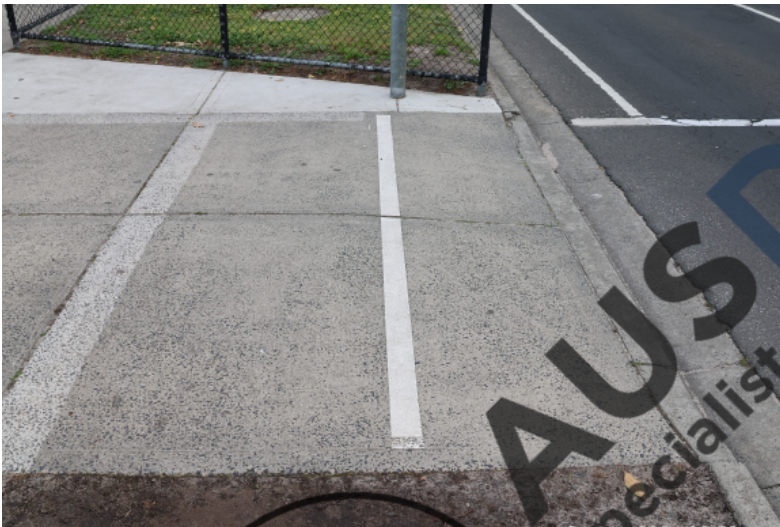
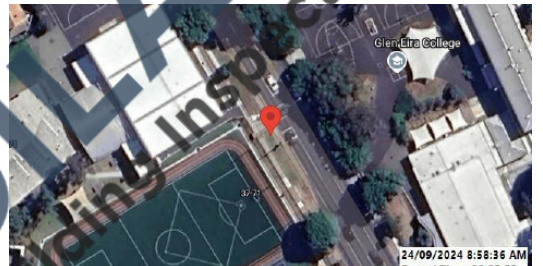
Figure: 0047
General view of the crossover on Booran Road.

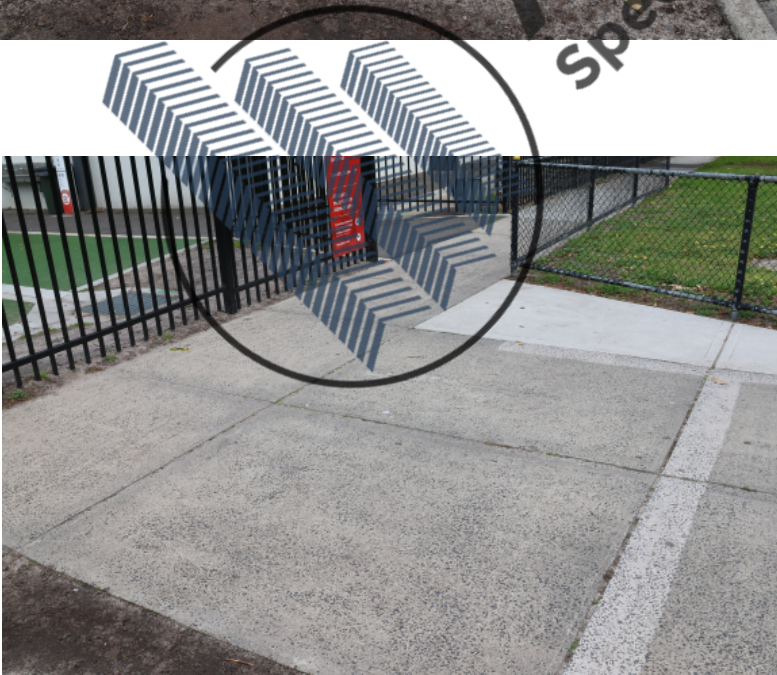
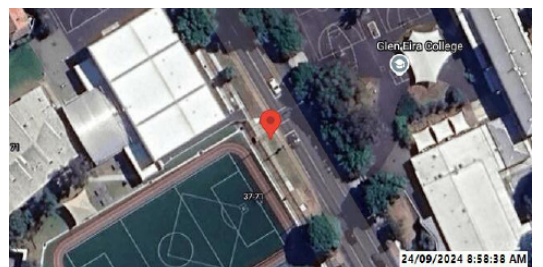
Figure: 0048
General view of the crossover on Booran Road.

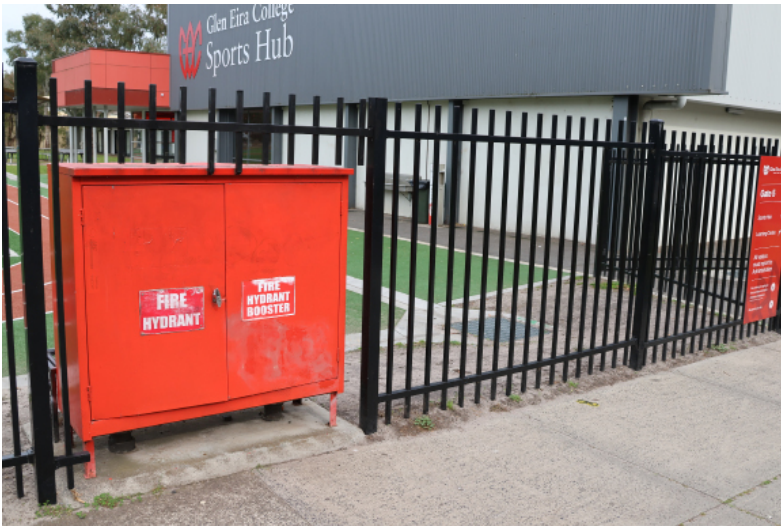
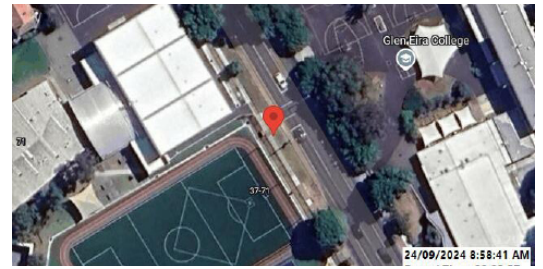
Figure: 0049
General view of the substation and boundary fence on Booran Road.

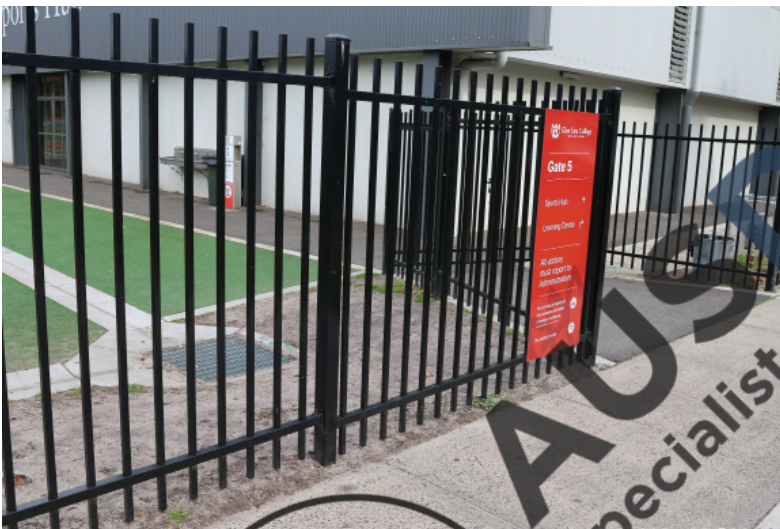
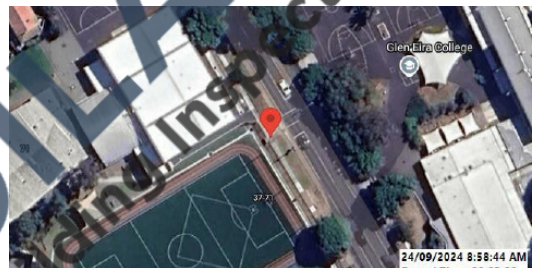
Figure: 0050
General view of the boundary fence on Booran Road.

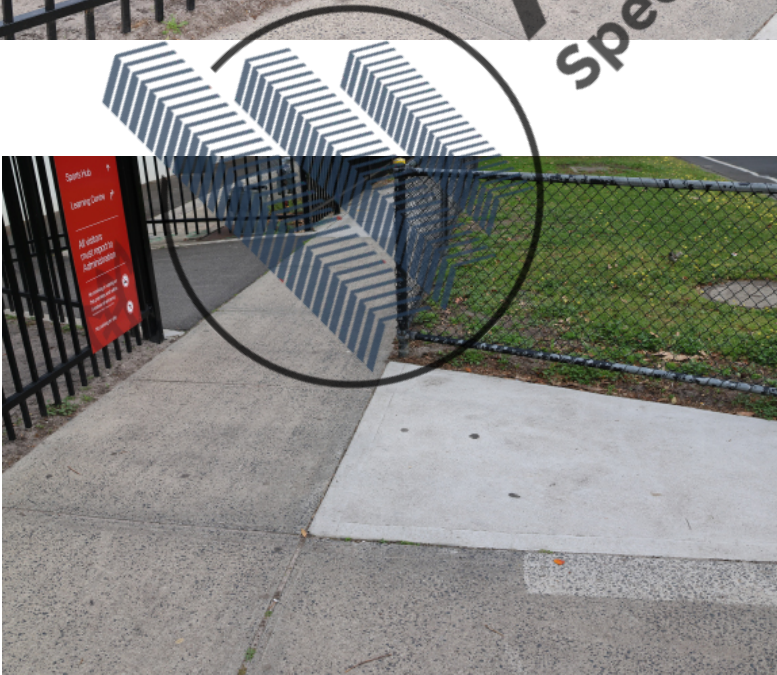
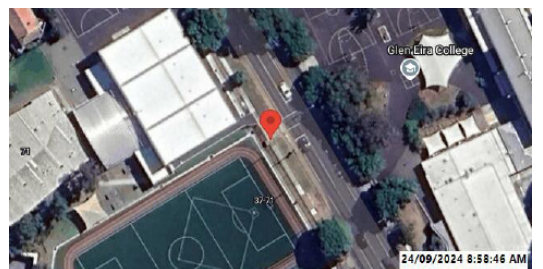
Figure: 0051
General view of the footpath on Booran Road.

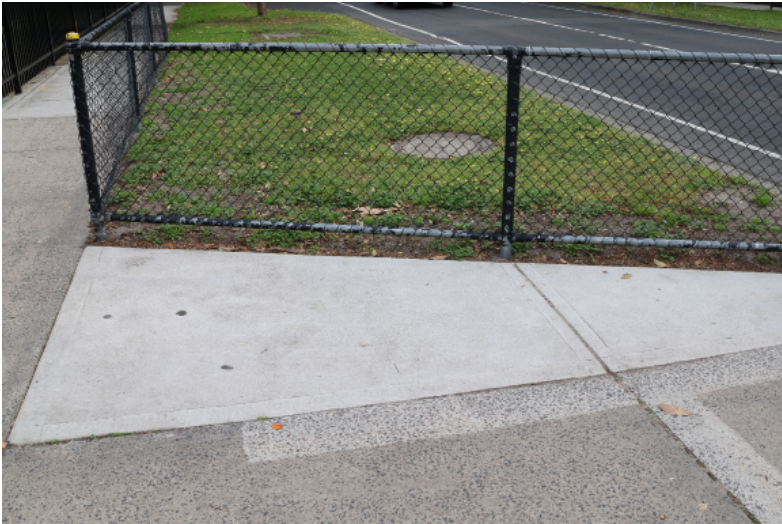
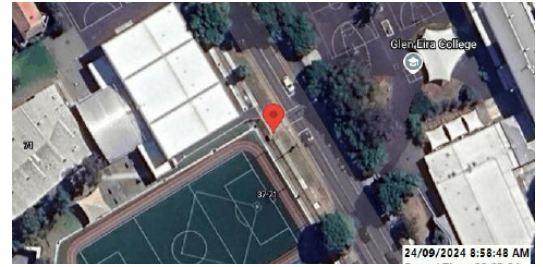
Figure: 0052
General view of the footpath and fence on Booran Road.

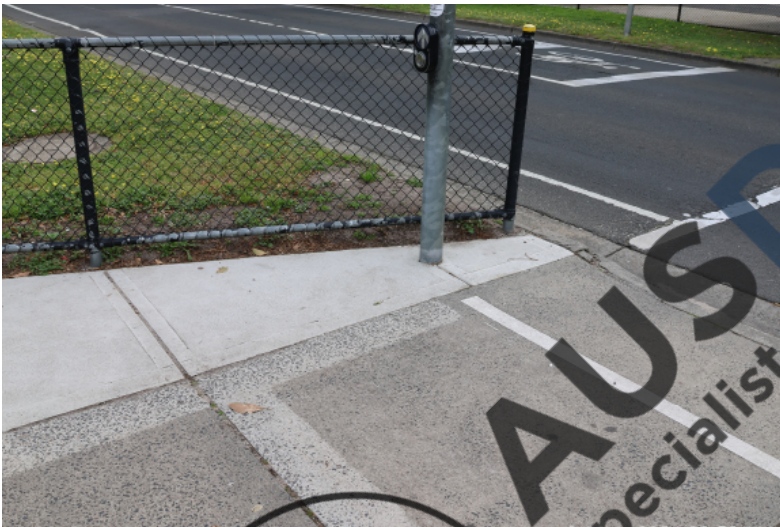
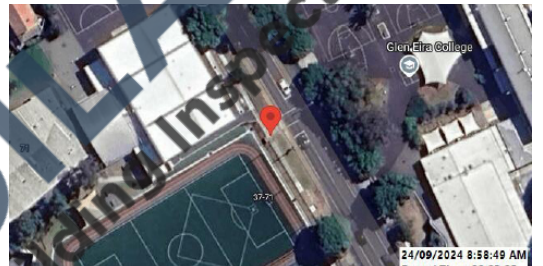
Figure: 0053
General view of the footpath and fence on Booran Road.

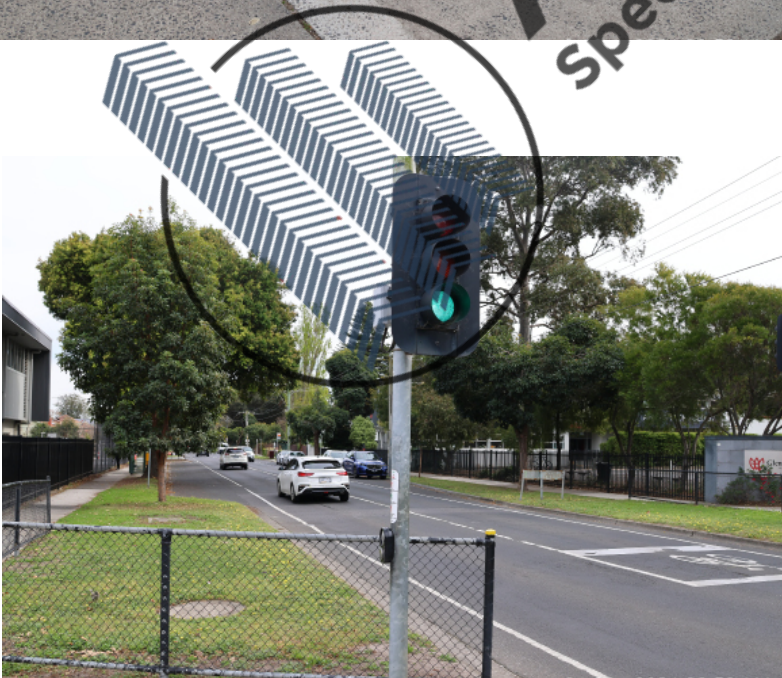
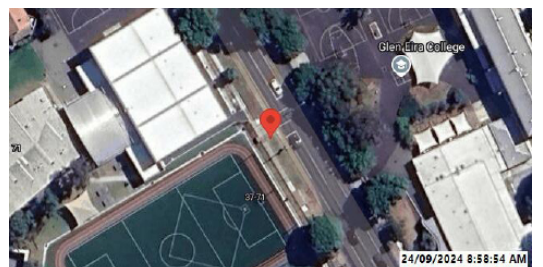
Figure: 0054
General view of the traffic light on Booran Road.

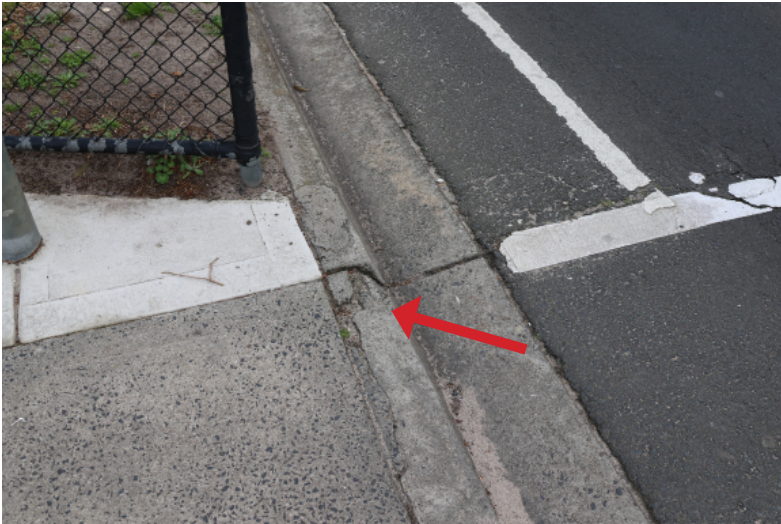
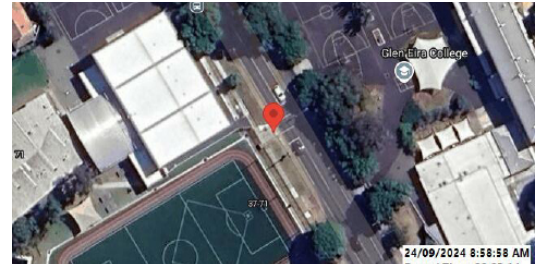
Figure: 0055
Chipping in the kerb on Booran Road.

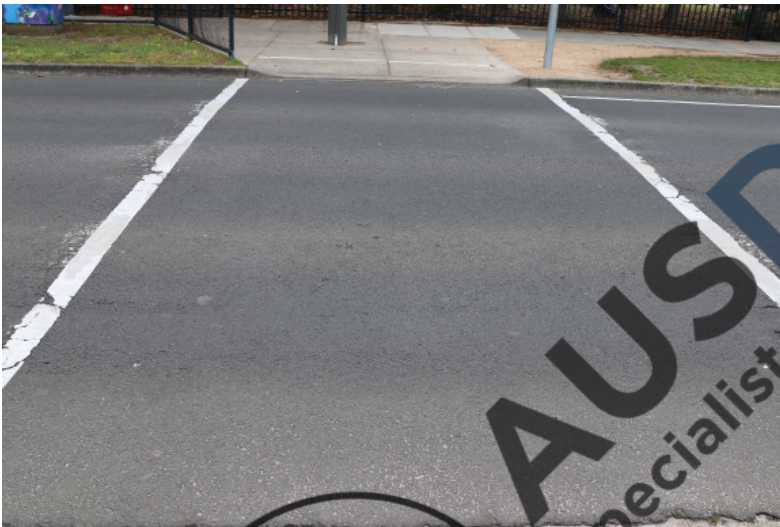
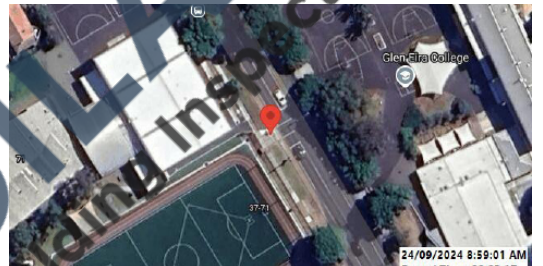
Figure: 0056
General view of the roadway on Booran Road.

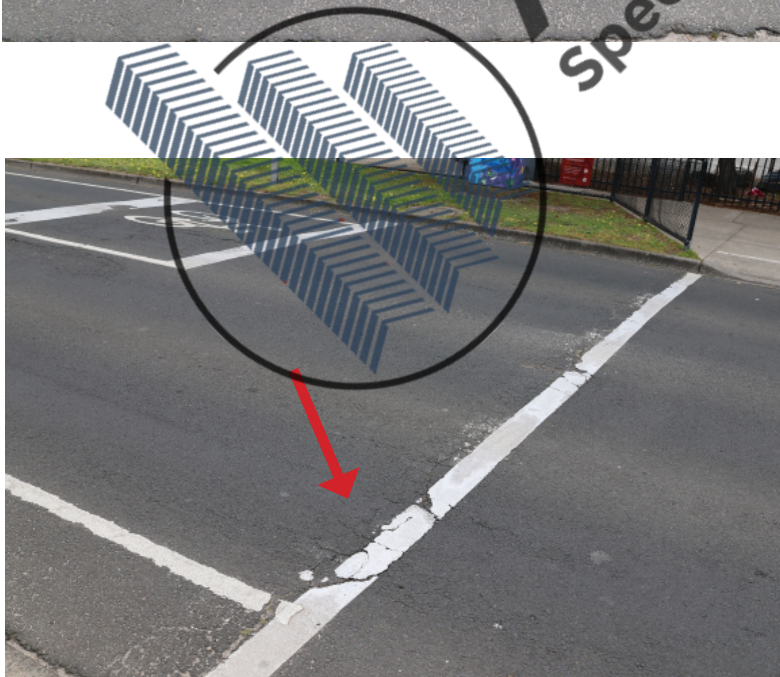
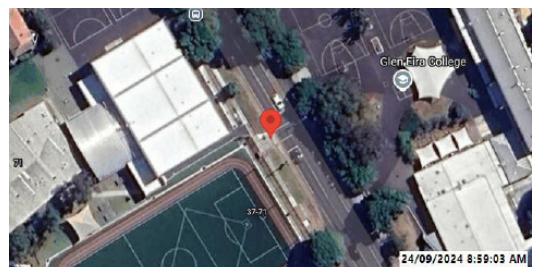
Figure: 0057
Fine cracking in the roadway on Booran Road.

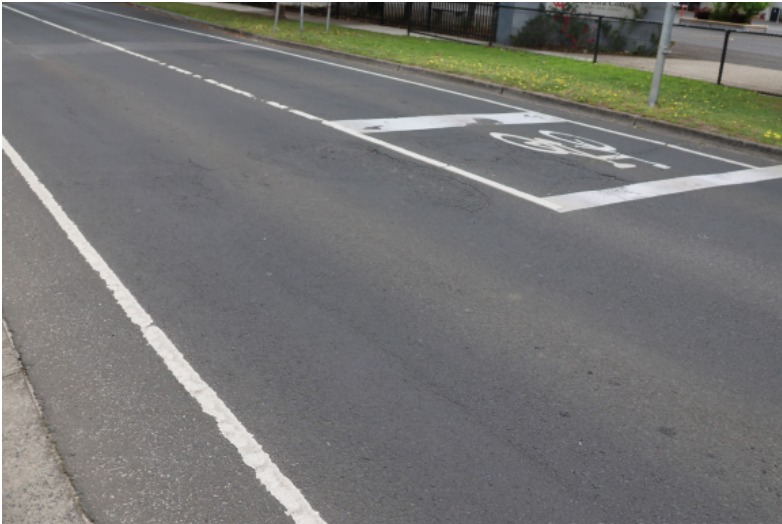
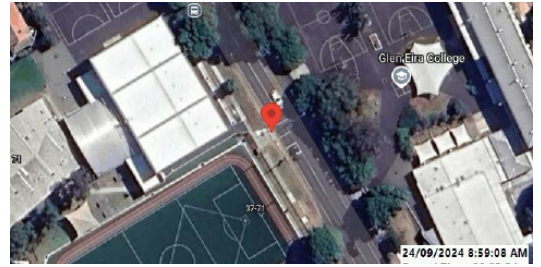
Figure: 0058
General view of the roadway on Booran Road.

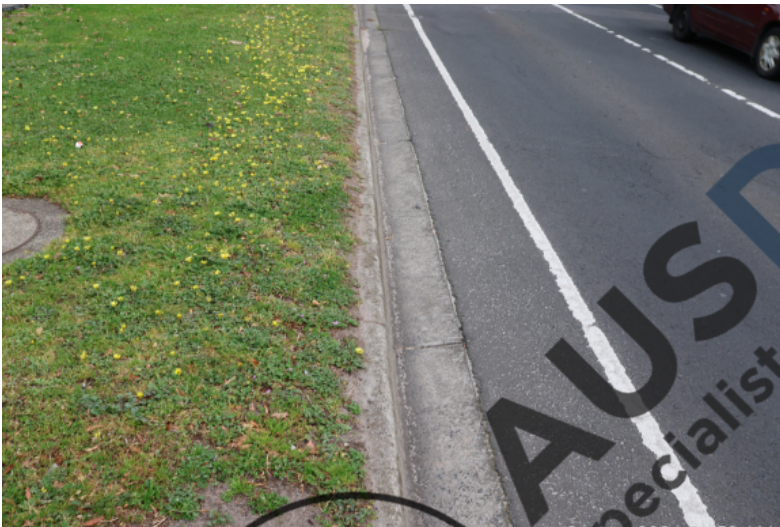
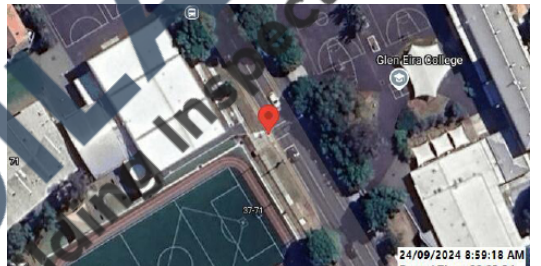
Figure: 0059
General view of the kerb and gutter on Booran Road.

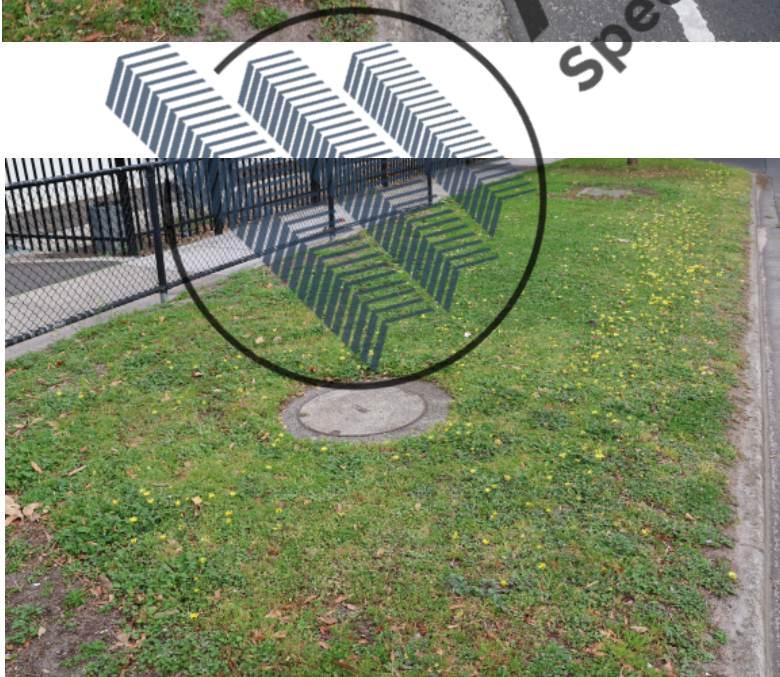
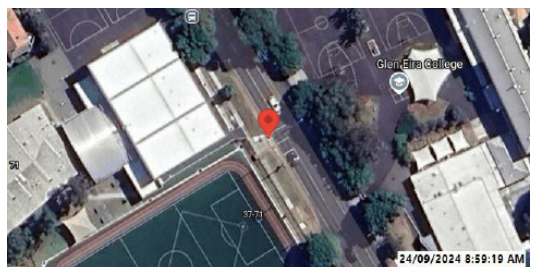
Figure: 0060
General view of the nature strip on Booran Road.
