**AUSDILAPS**  
Specialist Building Inspections

*POST-CONSTRUCTION CONDITION SURVEY*

**INSPECTION DATE:** February 18, 2025

**INSPECTOR:** George Agapiadis  
BEng (Civil)  
Structural & Civil Engineer

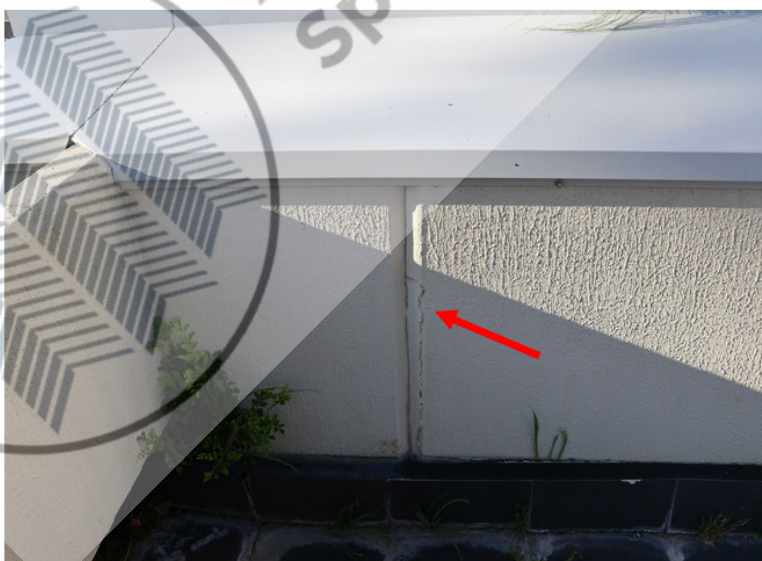
Figure 0006

Slight cracking in the south boundary wall on the level 3 balcony, east side.

Refer to figure 6 - No changes noted.

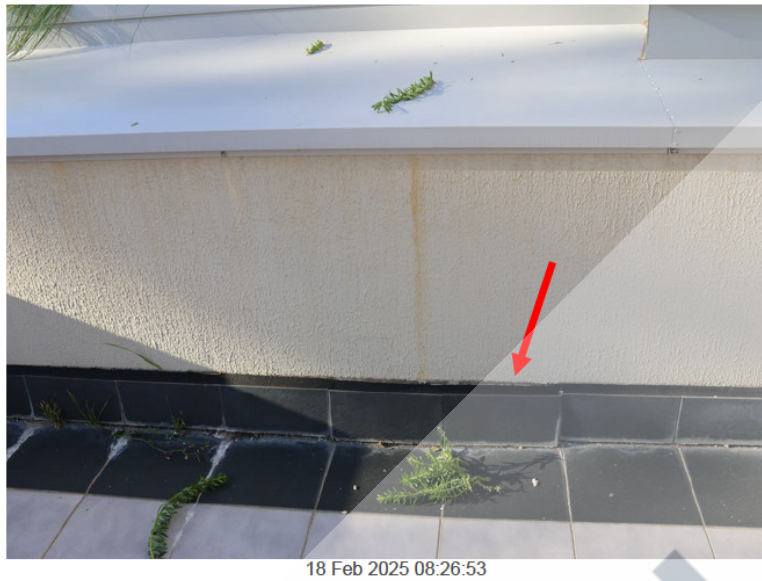
Figure 0007

Separation gap between the south boundary wall and the skirting on the level 3 balcony.

Refer to figure 7 - No changes noted.

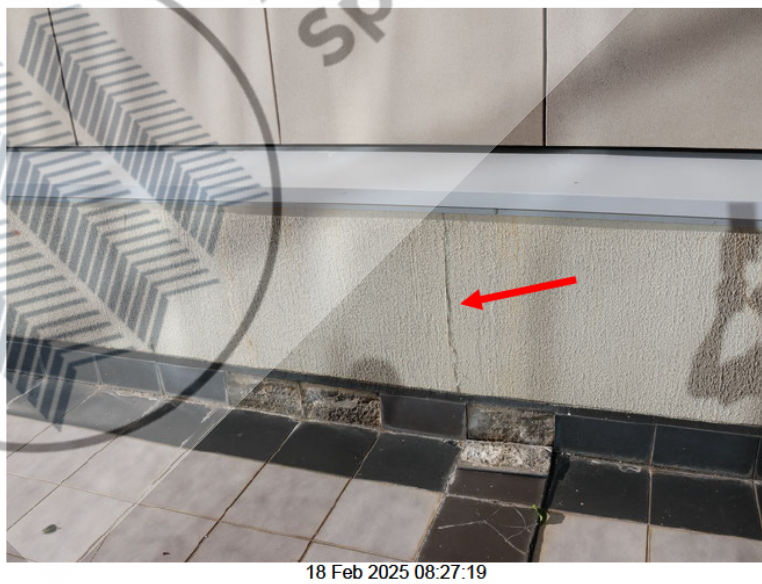
Figure 0009

Slight cracking in the south boundary wall on the level 3 balcony, east side.

Refer to figure 9 - No changes noted.

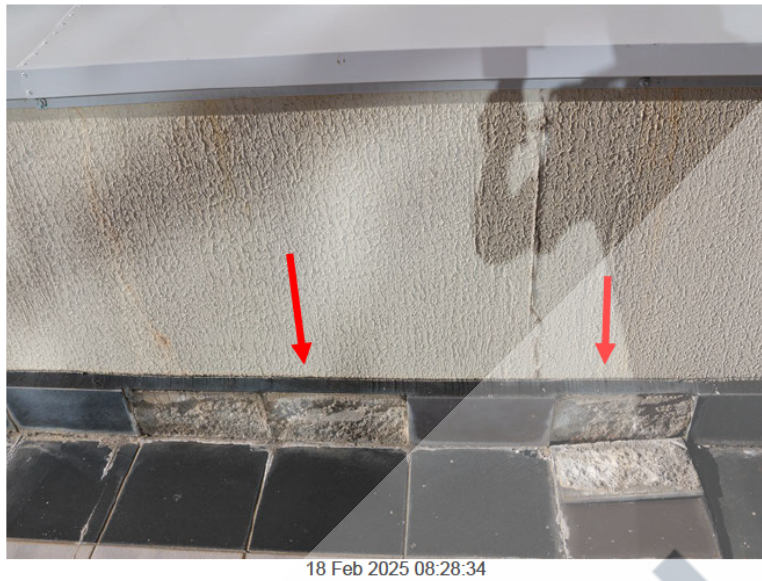
Figure 0010

Missing tiles in the skirting in the south wall on the level 3 balcony.

Refer to figure 10 - Showing exacerbated.

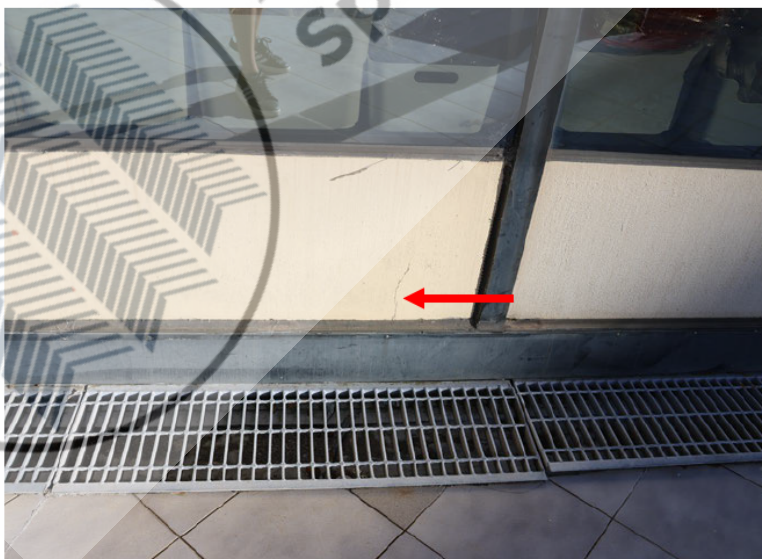
Figure 0021

Fine cracking in the north wall on the level 3 balcony, east side.

Refer to figure 27 - No changes noted.

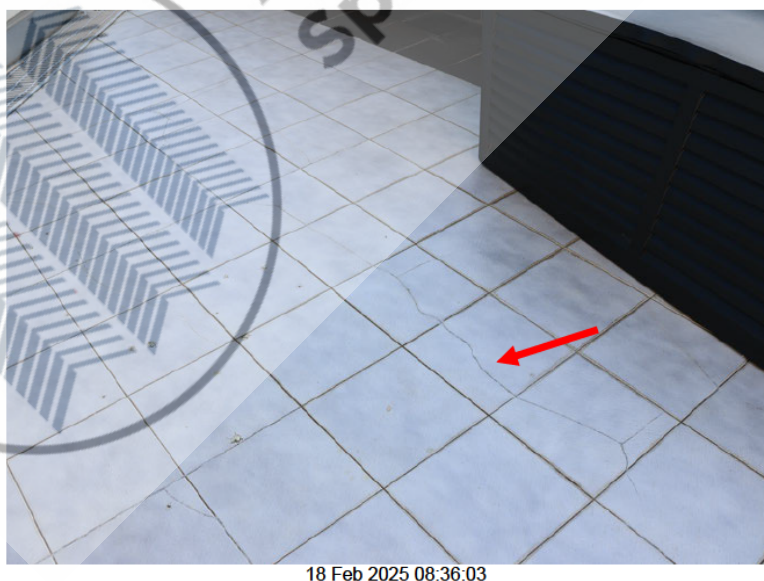
Figure 0024

Slight cracking in the tile paving on the level 3 balcony, northeast corner.

Refer to figure 30 - No changes noted.

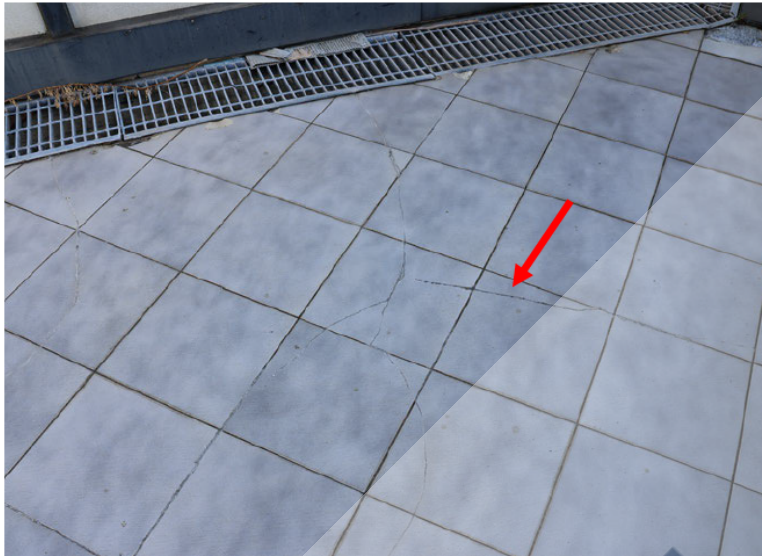
Figure 0025

Slight cracking in the tile paving on the level 3 balcony, northeast corner.

Refer to figure 31 - No changes noted.

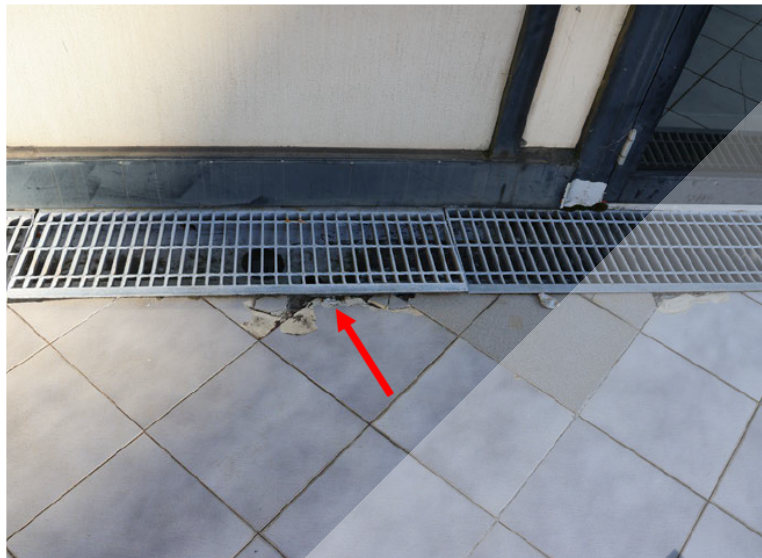
Figure 0027	Slight cracking in the tile paving on the level 3 balcony, northeast corner.	Refer to figure 33 - No changes noted.
Figure 0028	Damage in the tile paving on the level 3 balcony, northeast corner.	Refer to figure 34 - No changes noted.
Figure 0029	Slight cracking in the tile paving on the level 3 balcony, northeast corner.	Refer to figure 35 - No changes noted.
Figure 0031	Patched cracking in the tile paving on the level 3 balcony, northeast corner.	Refer to figure 37 - No changes noted.
Figure 0032	Slight cracking in the tile paving on the level 3 balcony, northeast corner.	Refer to figure 38 - No changes noted.
Figure 0033	Slight cracking in the tile paving on the level 3 balcony, northeast corner.	Refer to figure 39 - No changes noted.
Figure 0034	Patched cracking in the tile paving on the level 3 balcony, northeast corner.	Refer to figure 40 - No changes noted.
Figure 0036	Patched cracking in the tile paving on the level 3 balcony, near the northeast corner.	Refer to figure 42 - No changes noted.

Damage in the tile paving on the level 3 balcony, northeast corner.

Refer to figure 34 - No changes noted.

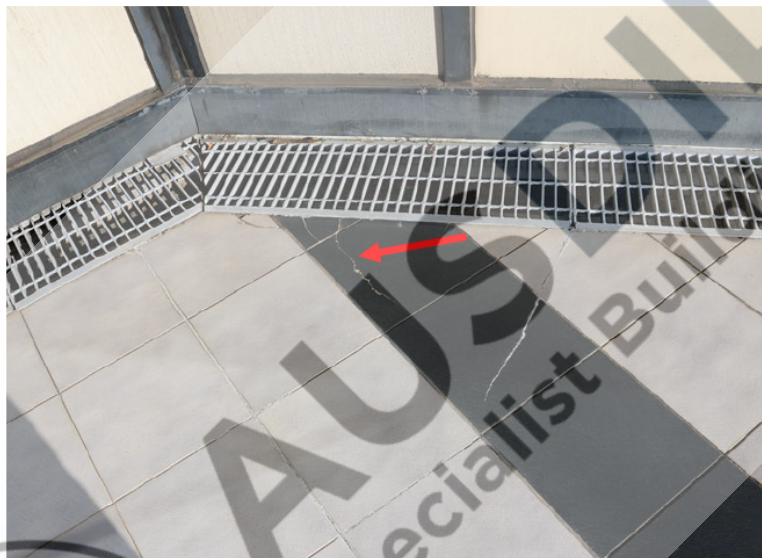
Figure 0029

Slight cracking in the tile paving on the level 3 balcony, northeast corner.

Refer to figure 35 - No changes noted.

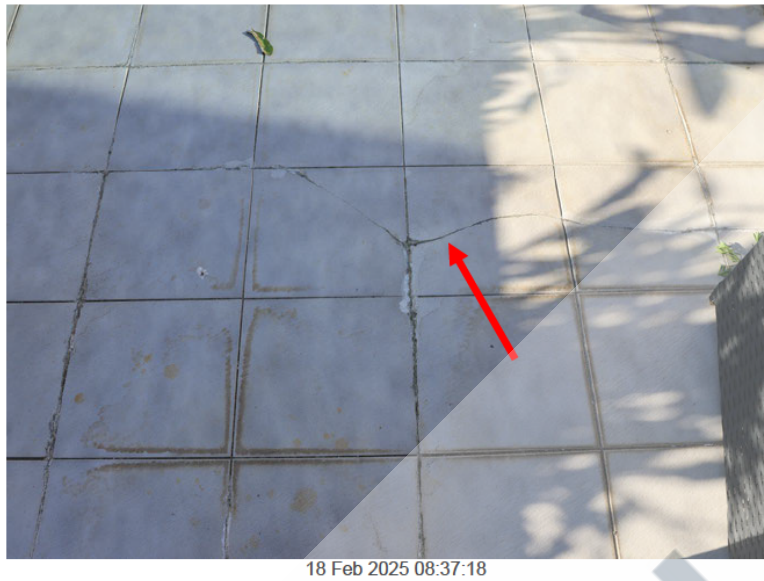
Figure 0031

Patched cracking in the tile paving on the level 3 balcony, northeast corner.

Refer to figure 37 - No changes noted.

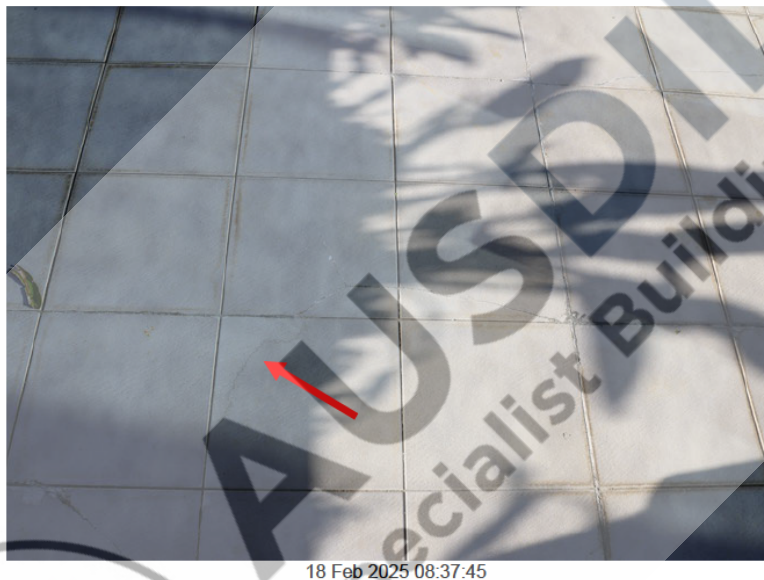
Figure 0032

Slight cracking in the tile paving on the level 3 balcony, northeast corner.

Refer to figure 38 - No changes noted.

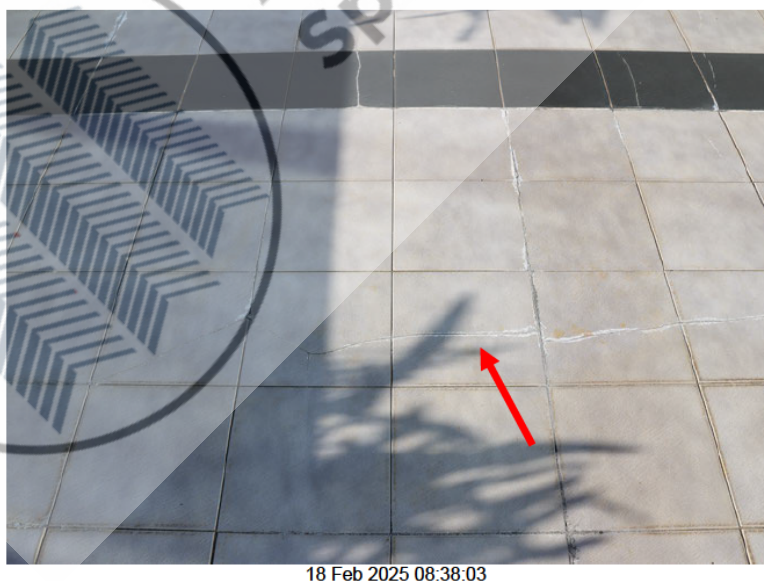
Figure 0033

Slight cracking in the tile paving on the level 3 balcony, northeast corner.

Refer to figure 39 - No changes noted.

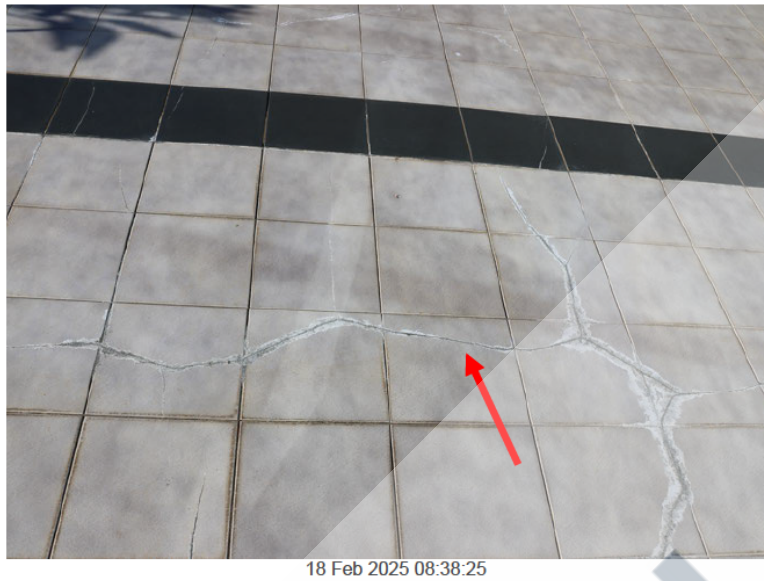
Figure 0034

Patched cracking in the tile paving on the level 3 balcony, northeast corner.

Refer to figure 40 - No changes noted.

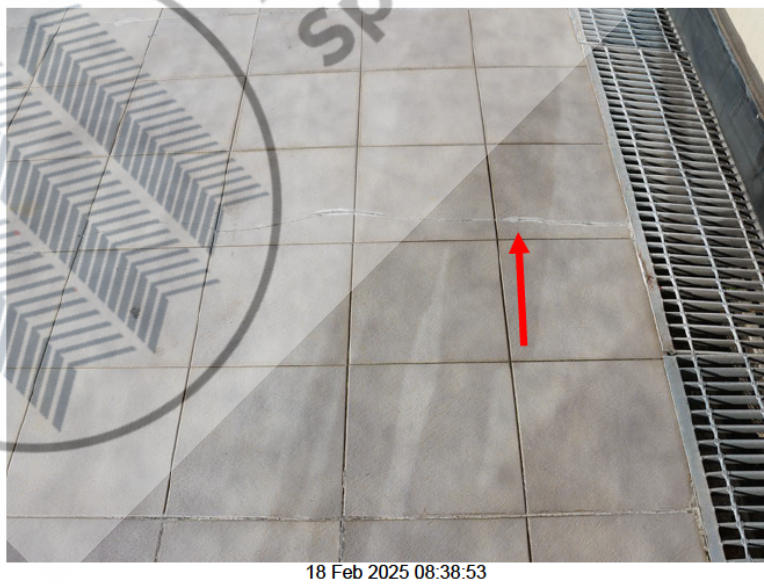
Figure 0036

Patched cracking in the tile paving on the level 3 balcony, near the northeast corner.

Refer to figure 42 - No changes noted.

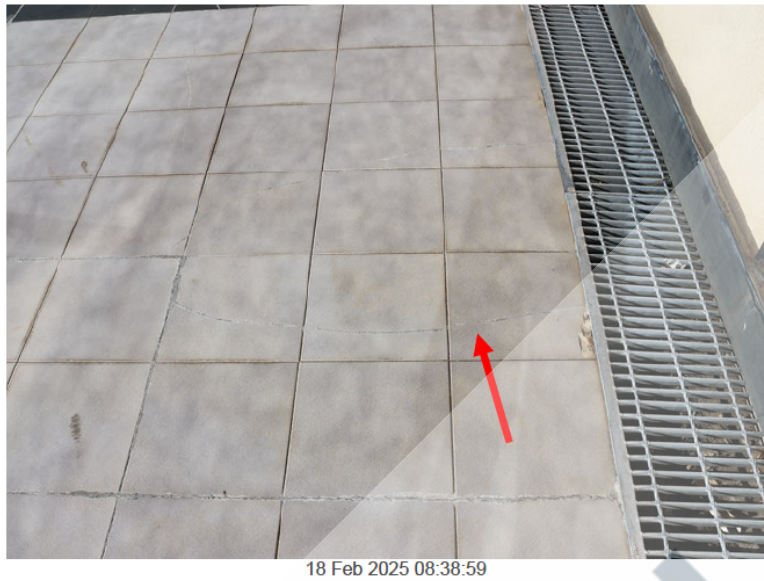
Figure 0037	Patched cracking in the tile paving on the level 3 balcony, near the northeast corner.	Refer to figure 43 - No changes noted.
Figure 0039	Patched cracking in the tile paving on the level 3 balcony.	Refer to figure 46 - No changes noted.
Figure 0040	Patched cracking in the tile paving on the level 3 balcony.	Refer to figure 47 - No changes noted.
Figure 0041	Patched cracking in the tile paving on the level 3 balcony, west side.	Refer to figure 49 - No changes noted.
Figure 0042	Patched cracking in the tile paving on the level 3 balcony, west side.	Refer to figure 50 - No changes noted.
Figure 0043	Patched cracking in the tile paving on the level 3 balcony.	Refer to figure 51 - No changes noted.
Figure 0044	Slight cracking in the tile paving on the level 3 balcony.	Refer to figure 52 - No changes noted.
Figure 0046	Fine cracking in the tile paving on the level 3 balcony, west side.	Refer to figure 54 - No changes noted.

Patched cracking in the tile paving on the level 3 balcony, near the northeast corner.

Refer to figure 43 - No changes noted.

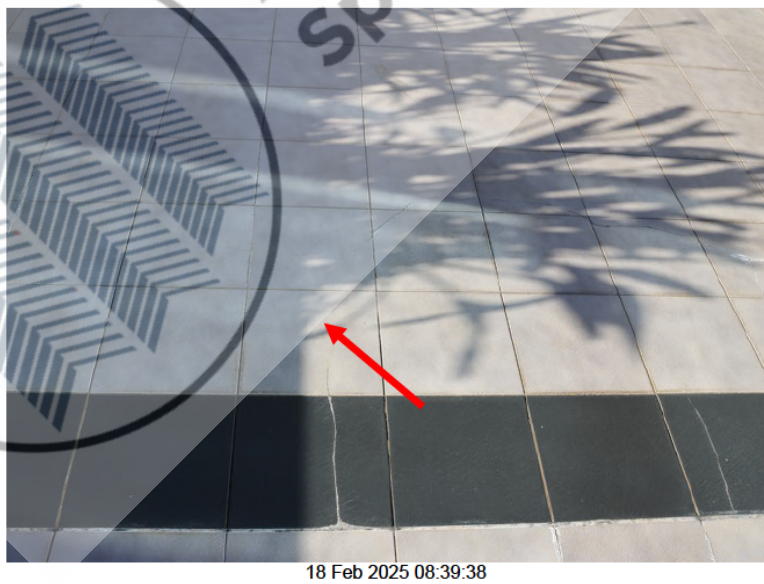
Figure 0039

Patched cracking in the tile paving on the level 3 balcony.

Refer to figure 46 - No changes noted.

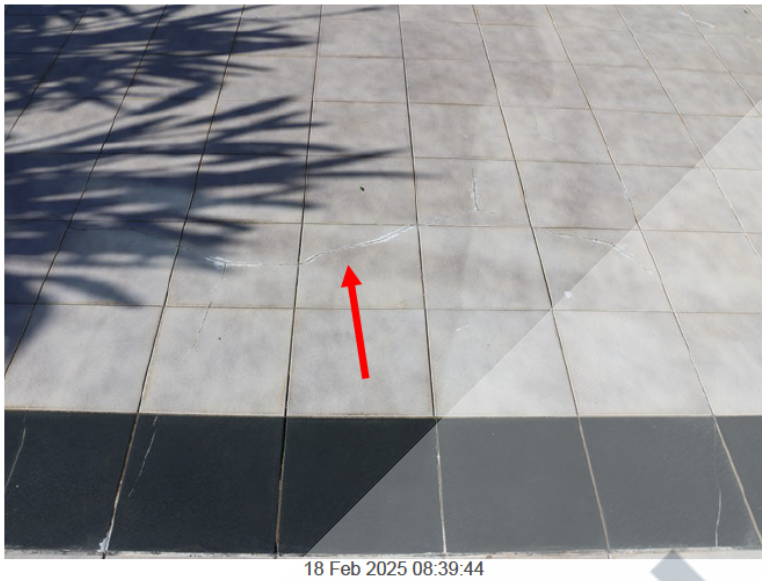
Figure 0040

Patched cracking in the tile paving on the level 3 balcony.

Refer to figure 47 - No changes noted.

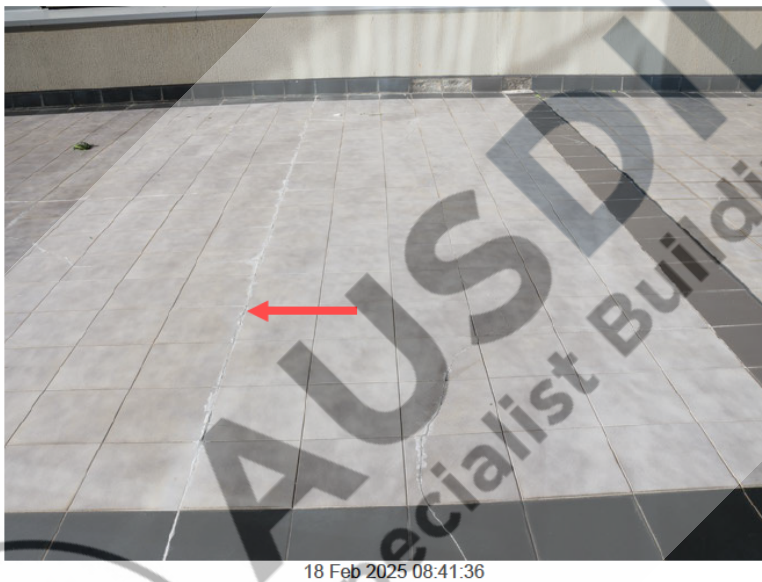
Figure 0041

Patched cracking in the tile paving on the level 3 balcony, west side.

Refer to figure 49 - No changes noted.

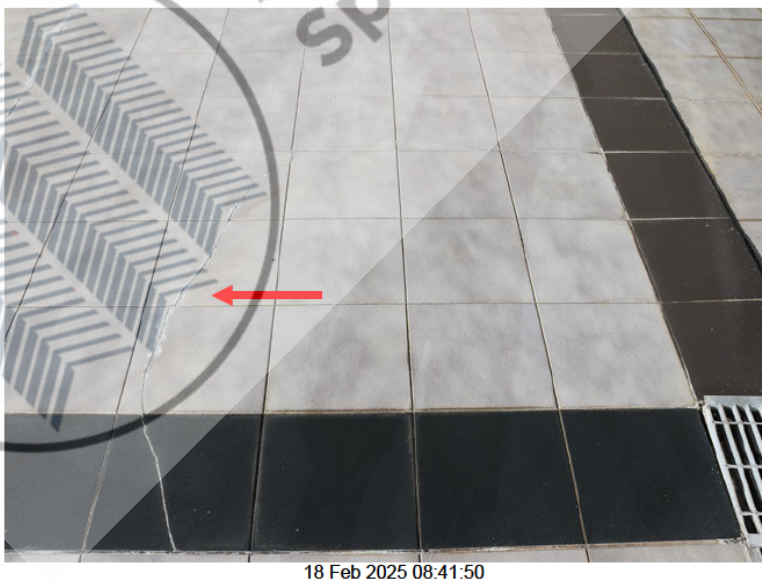
Figure 0042

Patched cracking in the tile paving on the level 3 balcony, west side.

Refer to figure 50 - No changes noted.

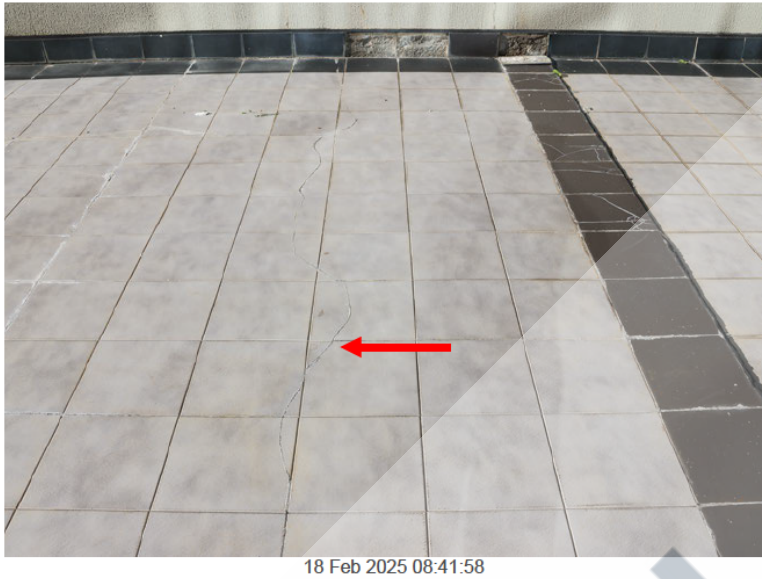
Figure 0043

Patched cracking in the tile paving on the level 3 balcony.

Refer to figure 51 - No changes noted.

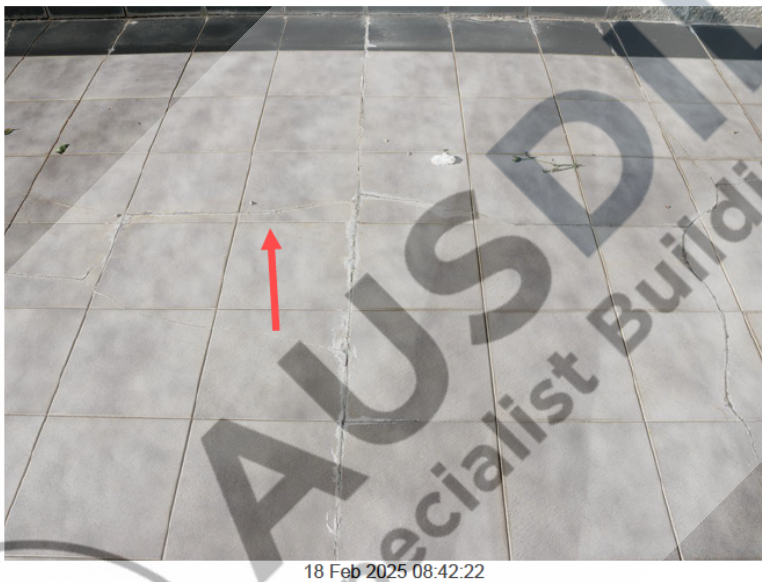
Figure 0044

Slight cracking in the tile paving on the level 3 balcony.

Refer to figure 52 - No changes noted.

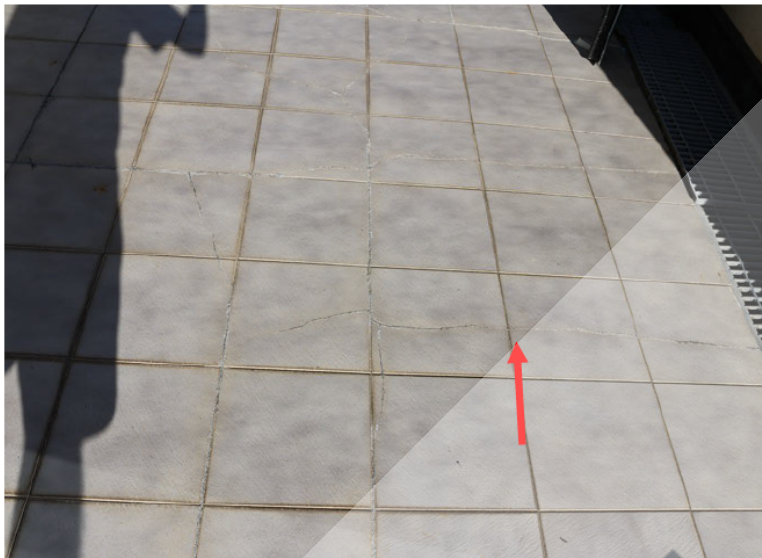
Figure 0046

Fine cracking in the tile paving on the level 3 balcony, west side.

Refer to figure 54 - No changes noted.

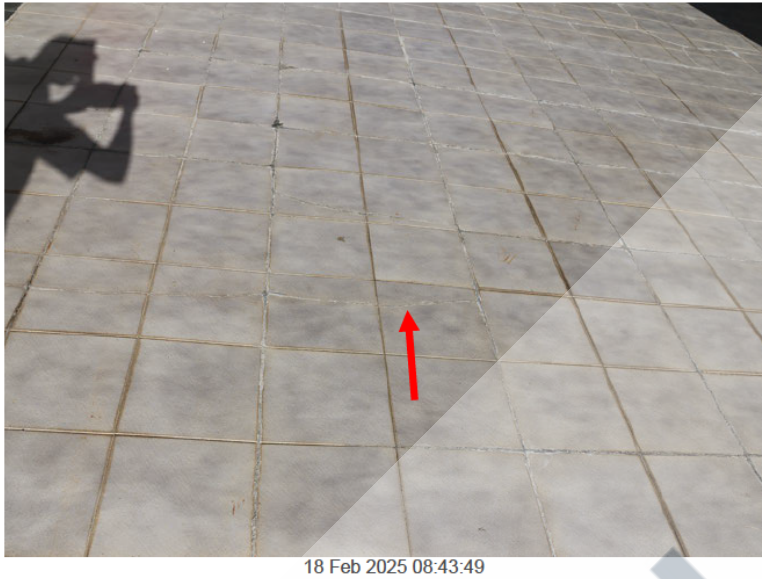
Figure 0049

Patched cracking in the tile paving on the level 3 balcony, east side.

Refer to figure 57 - No changes noted.

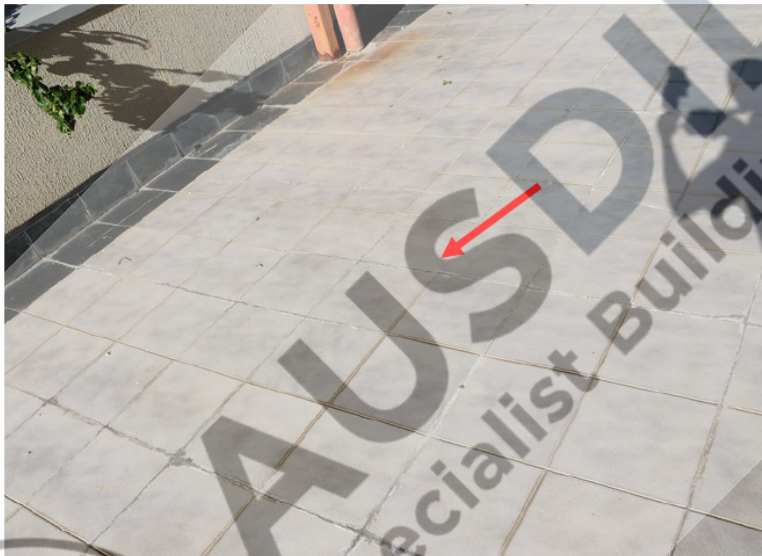
Figure 0050

Patched cracking in the tile paving on the level 3 balcony, east side.

Refer to figure 58 - No changes noted.

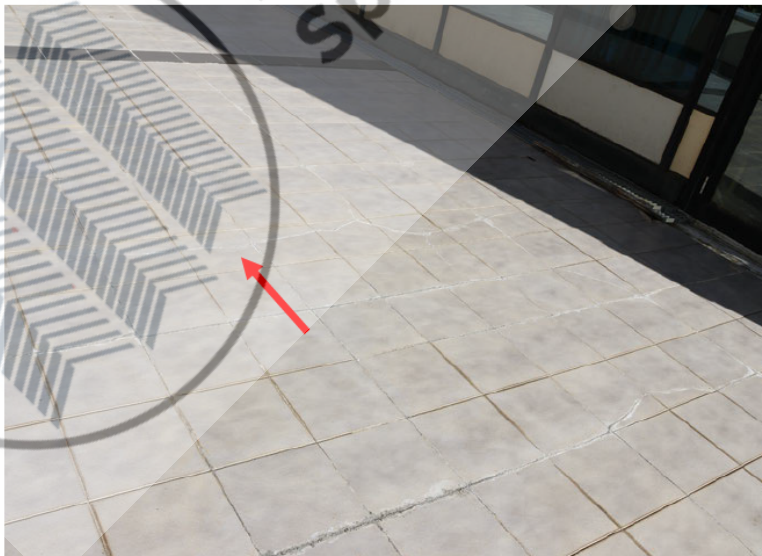
Figure 0051

Patched cracking in the tile paving on the level 3 balcony.

Refer to figure 59 - No changes noted.

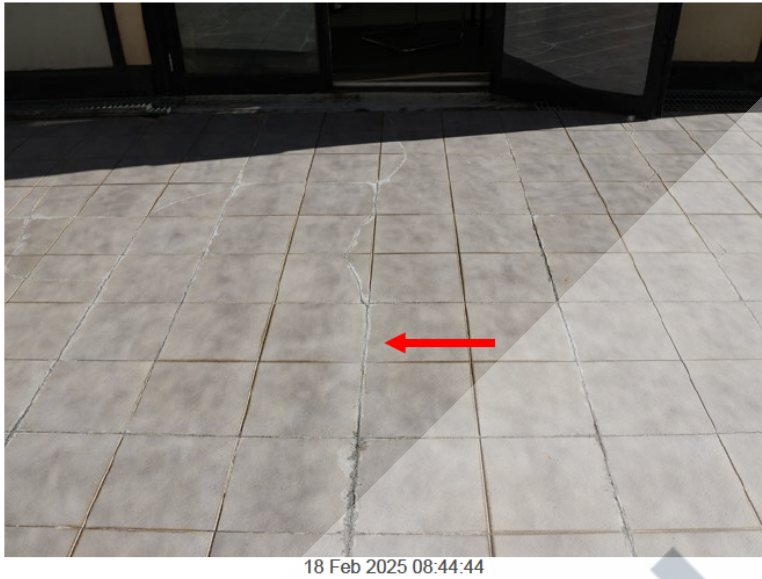
Figure 0052

Patched cracking in the tile paving on the level 3 balcony, west side.

Refer to figure 60 - No changes noted.

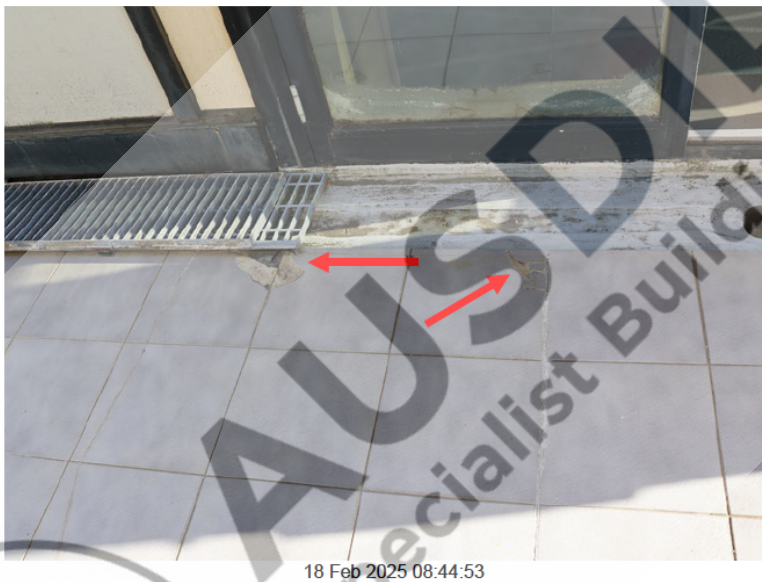
Figure 0053

Damage and missing tiles in the paving on the level 3 balcony, west side.

Refer to figure 61 - No changes noted.
