AUSDILAPS
Specialist Building Inspections

PRE-CONSTRUCTION CONDITION SURVEY

INSPECTION DATE: November 28, 2024

INSPECTOR: Niroshan Rudrakumar
B.Eng, MIEAust | Civil
Civil Engineer

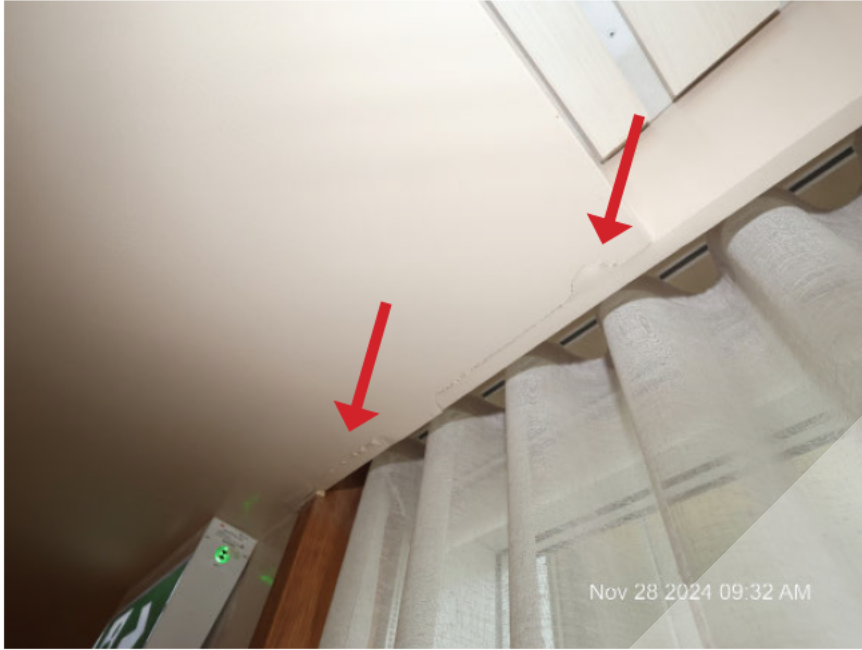
Figure: 0094

Pg#	Description
41	Cracking in the ceiling in the shop1 hallway, east side. Also showing bubbling paint.

Cracking in the ceiling in the shop hallway, east side. Also showing bubbling paint.
