PRE-CONSTRUCTION CONDITION SURVEY

INSPECTION DATE: February 13, 2025

INSPECTOR: Linda Win
ME (Civil), MEM
Civil Engineer

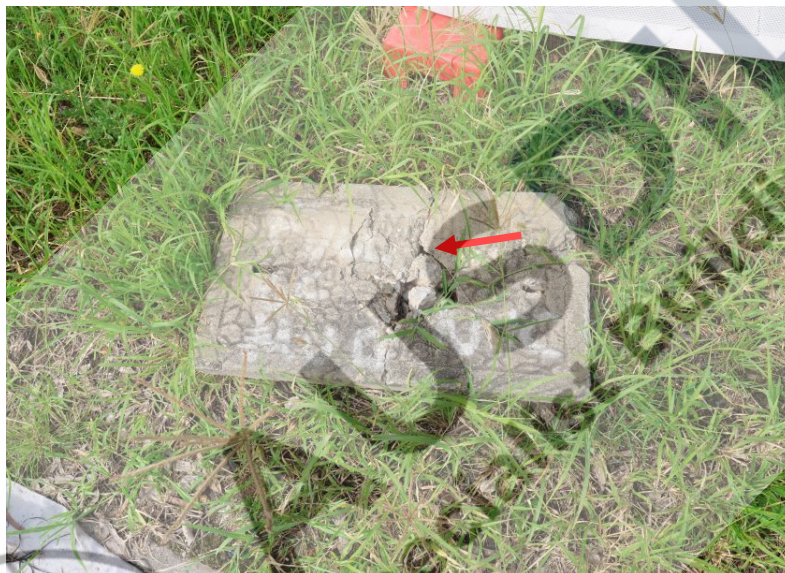
Figure 0005

General view of the pit lid in the grass area on Main Road. Showing damage.

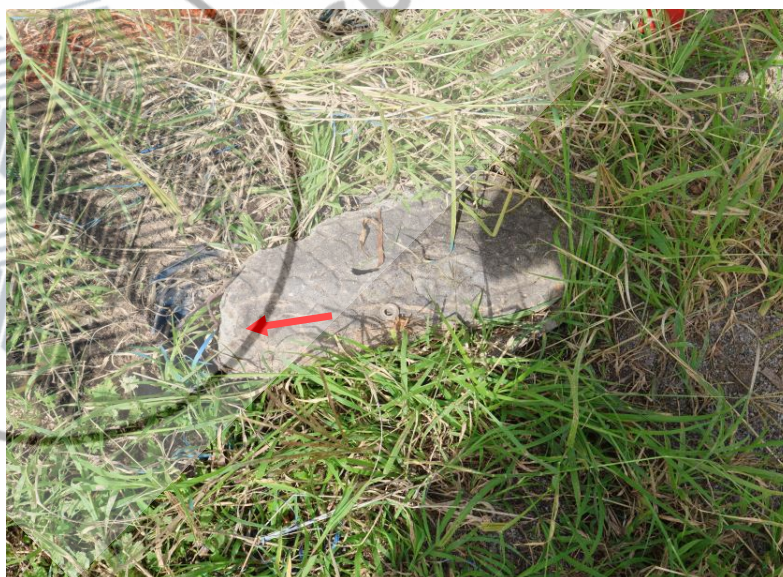
Figure 0009

Damage in the pit lid on Main Road.

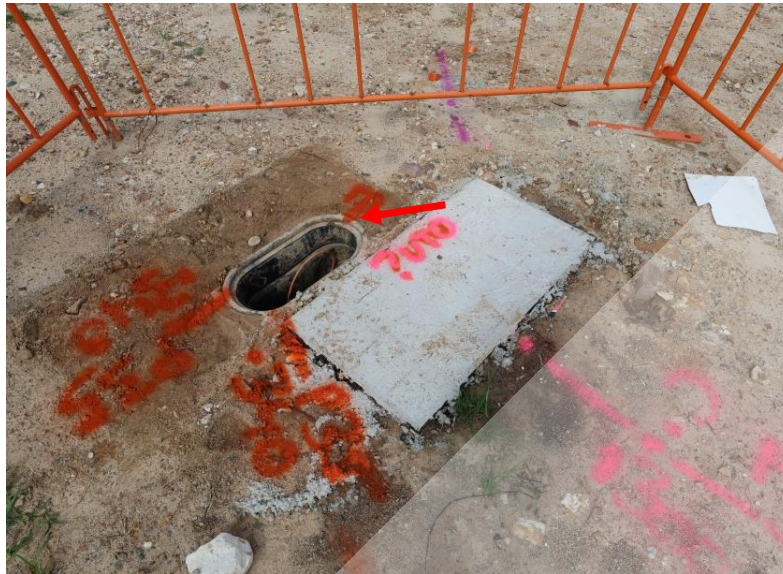
Figure 0028

General view of the pit lid in the grass area on Main Road. Showing missing cover.

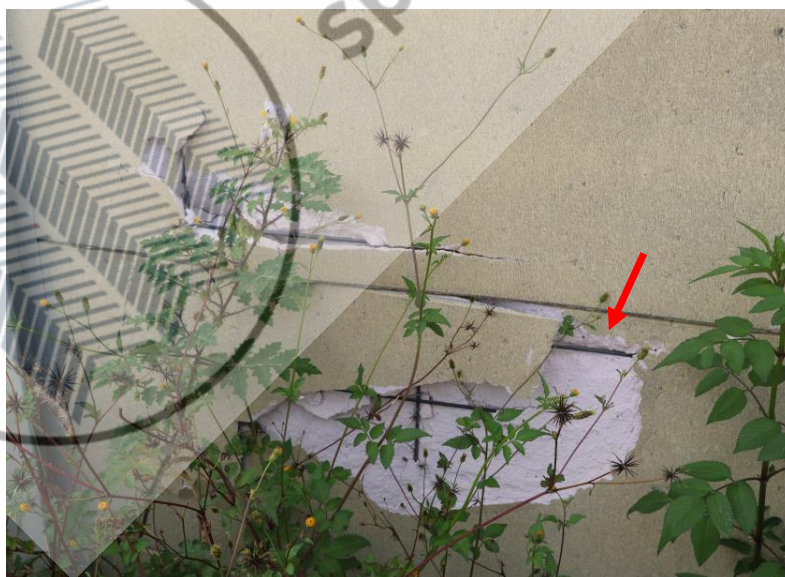
Figure 0042

Damage in the boundary wall on Main Road. Showing exposed reinforcement.

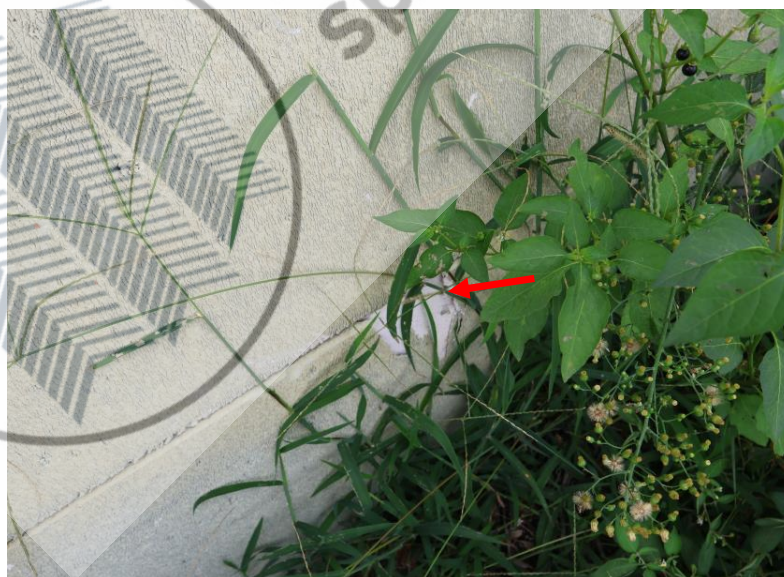
Figure 0045

Chipping in the boundary wall on Main Road.

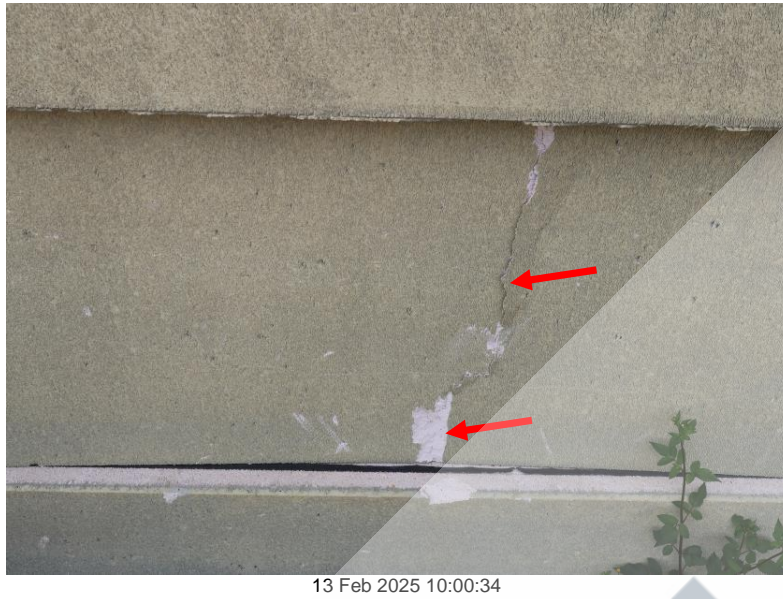
Figure 0046

Chipping and fine cracking in the boundary wall on Main Road.

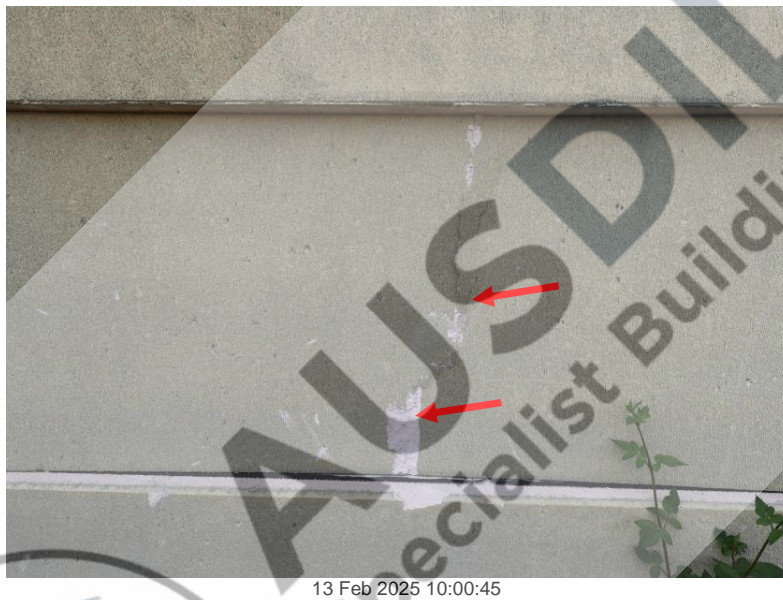
Figure 0047

Chipping and fine cracking in the boundary wall on Main Road.

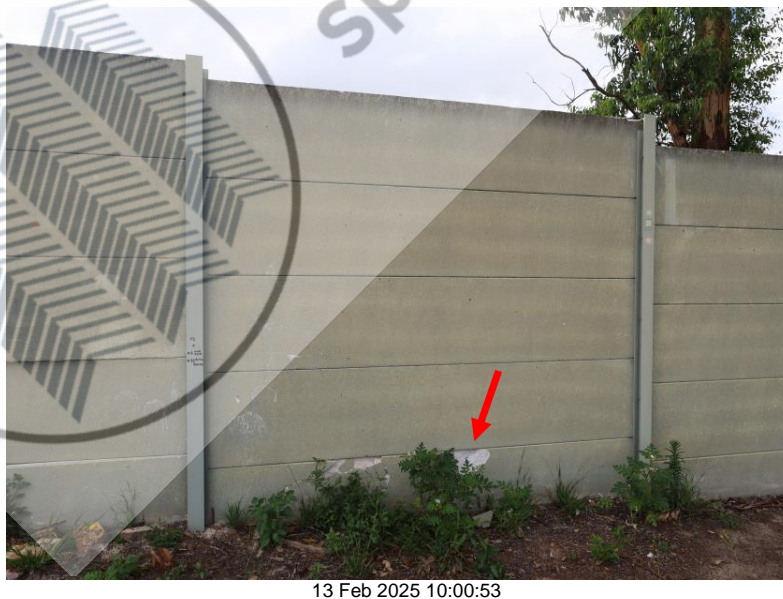
Figure 0048

General view of the boundary wall on Main Road. Showing chipping.

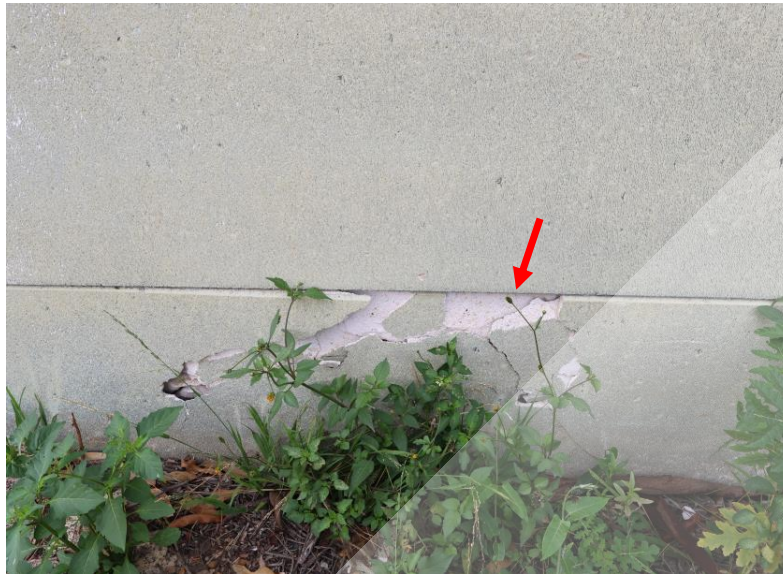
Figure 0049

Chipping in the boundary wall on Main Road.

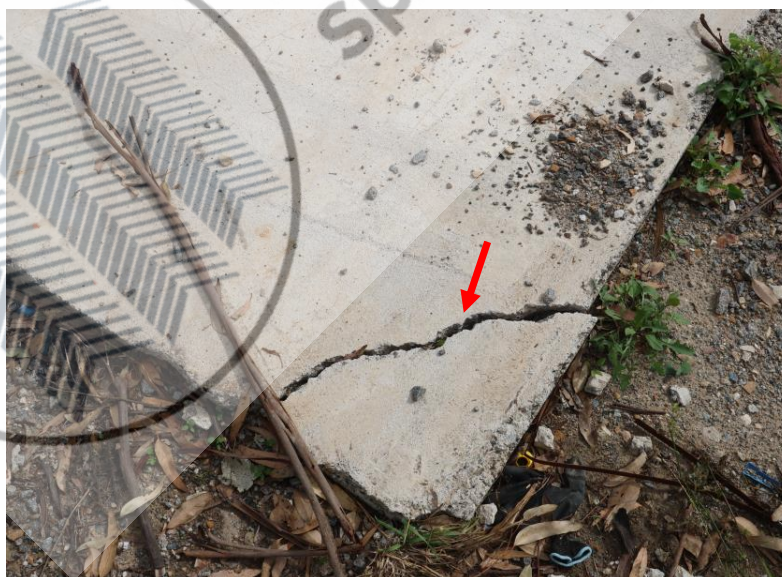
Figure 0069

Moderate cracking in the paving in the site area.

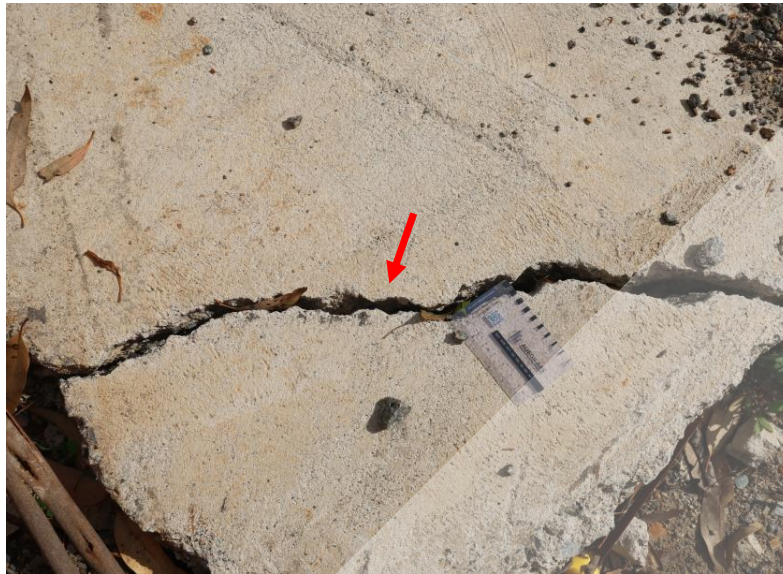
Figure 0070

Moderate cracking in the paving in the site area.
