PRE-CONSTRUCTION CONDITION SURVEY

INSPECTION DATE: February 14, 2025

INSPECTOR: Linda Win
ME (Civil), MEM
Civil Engineer

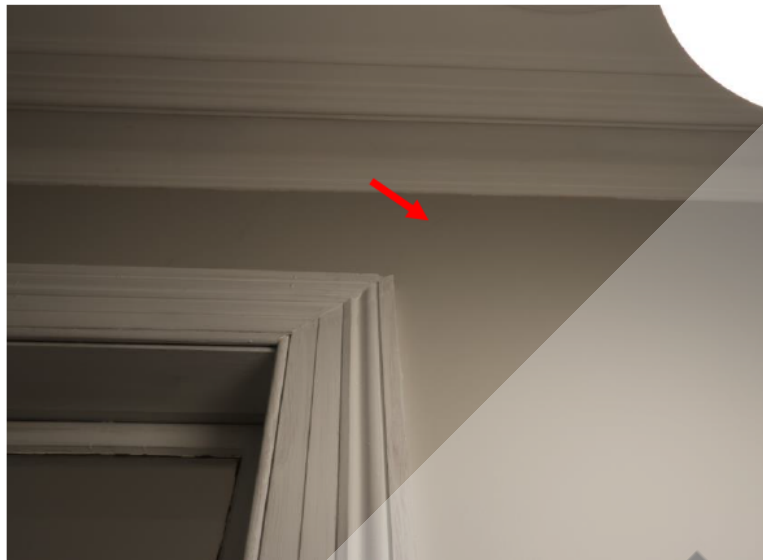
Figure 0022

Hairline cracking in the east wall in the entrance.

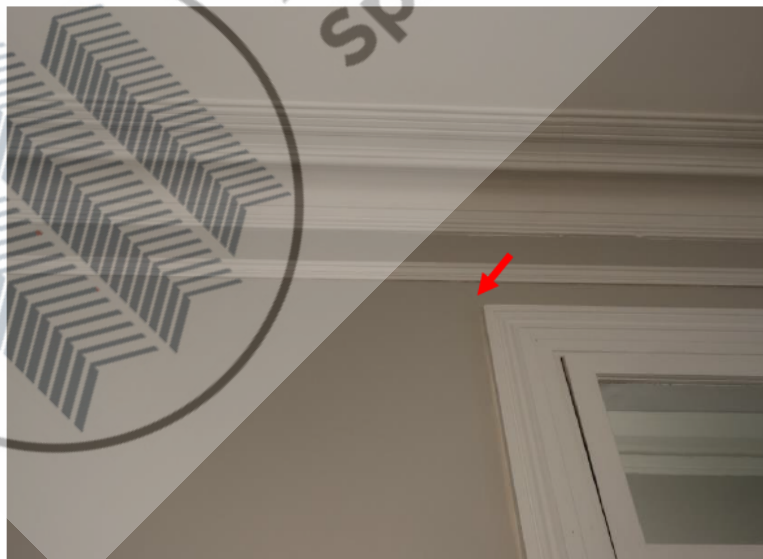
Figure 0036

Hairline cracking in the west wall in lounge.

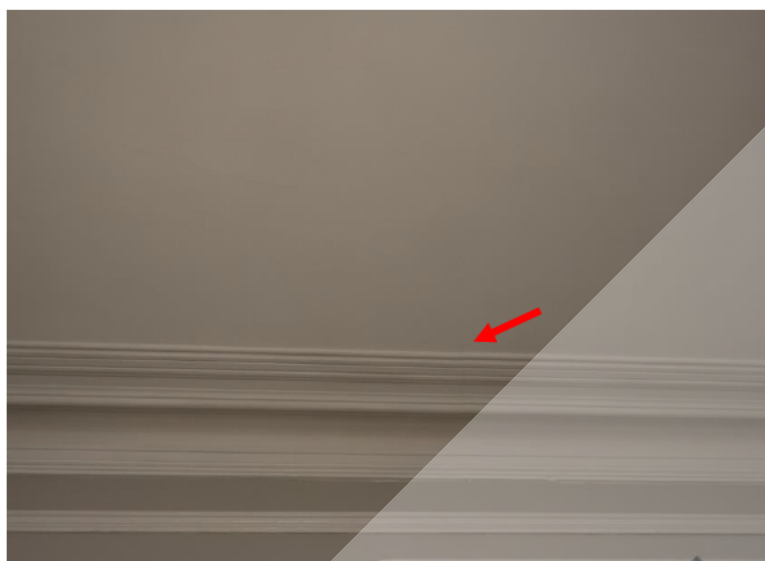
Figure 0037

Hairline cracking in the ceiling in the lounge.

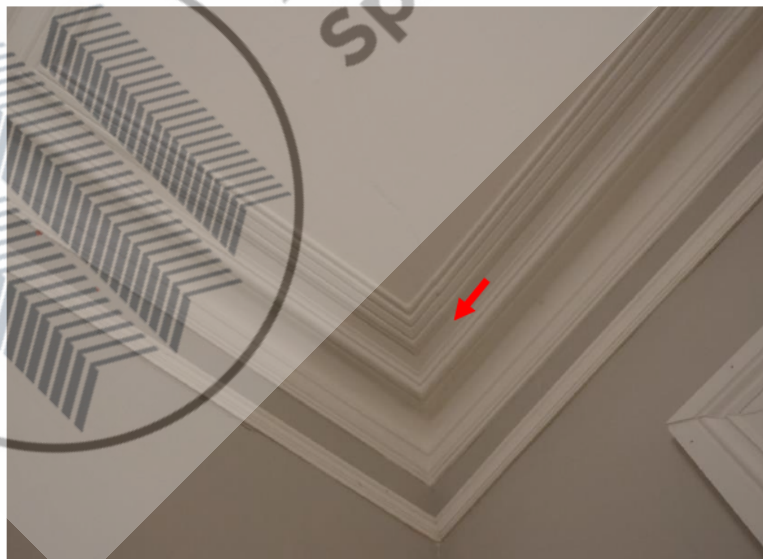
Figure 0051

Hairline cracking in the ceiling cornice in the southeast corner in the meals area.

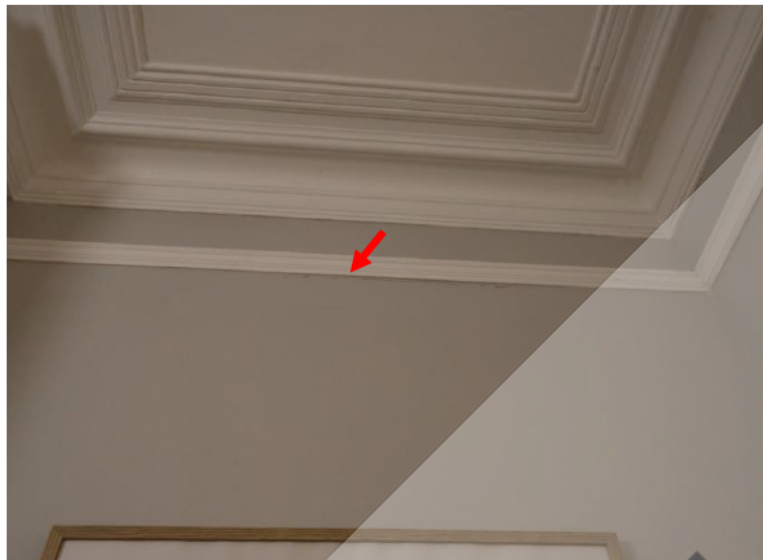
Figure 0052

Hairline cracking in the east wall in the meals area.

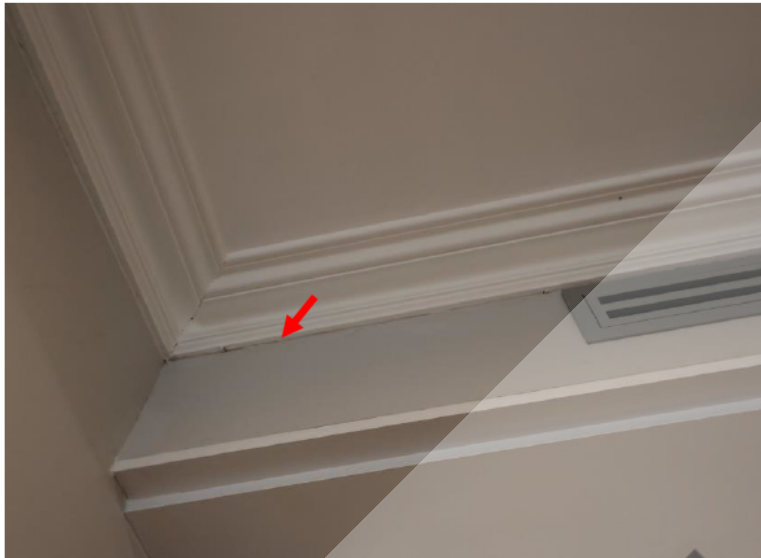
Figure 0064

Separation gap between the ceiling cornice and the north wall in the laundry, west side.
