POST-CONSTRUCTION CONDITION SURVEY

INSPECTION DATE: October 30, 2024

AusDilaps was commissioned by [REDACTED] to carry out a visual condition inspection and report in accordance with AS.4349.0 for the [REDACTED] project.

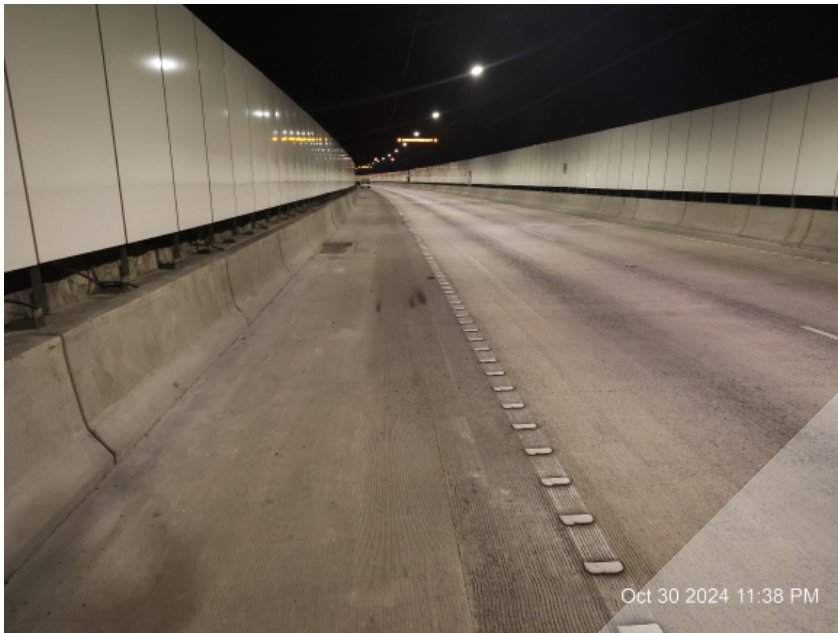
Figure: 0001

General View, EB, XP335-334, Ch 6994, NS.
Refer to figure 1 - No changes noted.

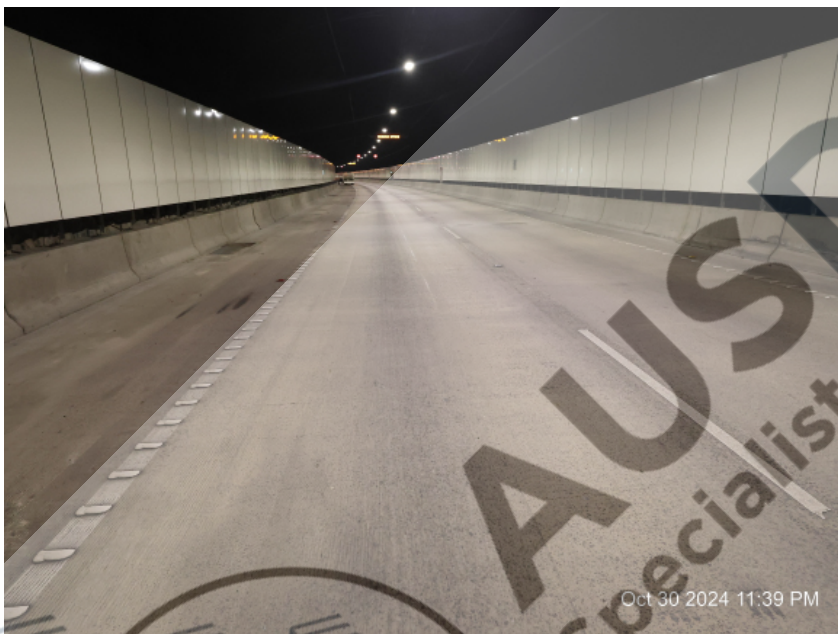
Figure: 0002

General View, EB, XP335-334, Ch 6994, L1.
Refer to figure 2 - No changes noted.

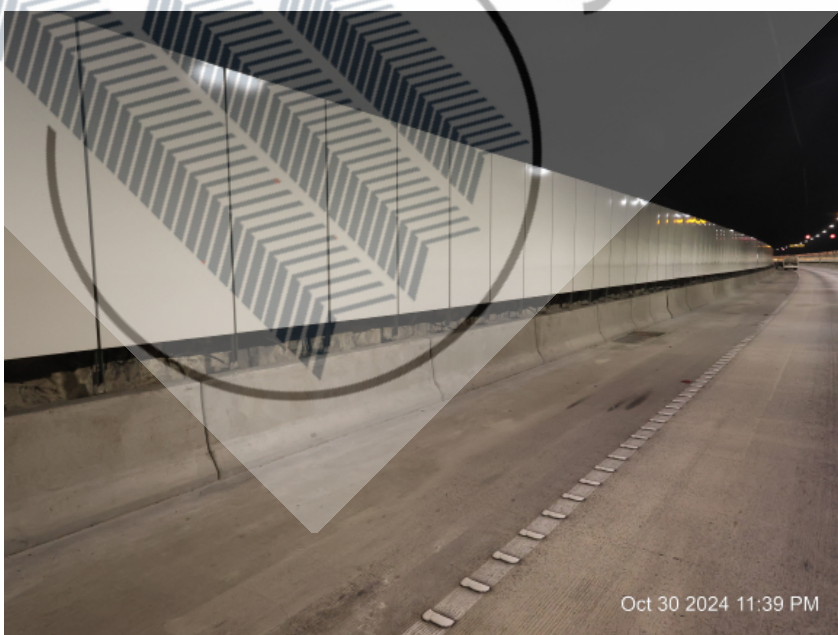
Figure: 0003

General View, EB, XP335-334, Ch 6994, NS. Architectural panels.
Refer to figure 3 - No changes noted.

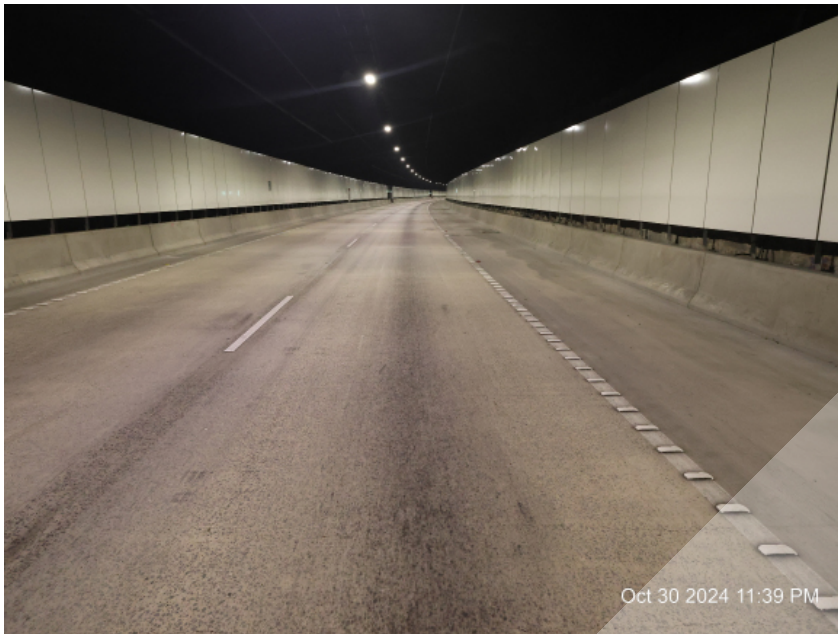
Figure: 0004

General View, EB, XP335-334, Ch 6994, NS. Architectural panels.
Refer to figure 4 - No changes noted.

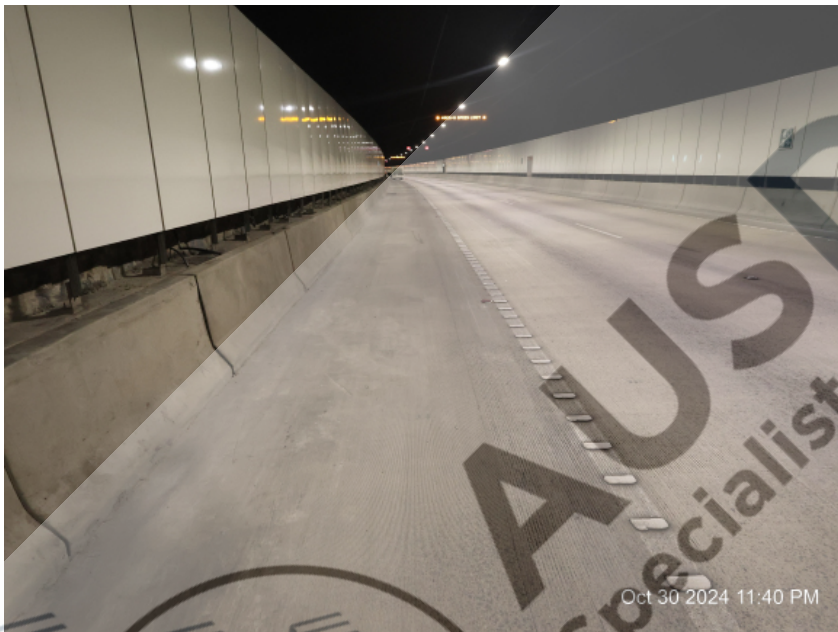
Figure: 0005

General View, EB, XP335-334, Ch 7014, NS.
Refer to figure 5 - No changes noted.

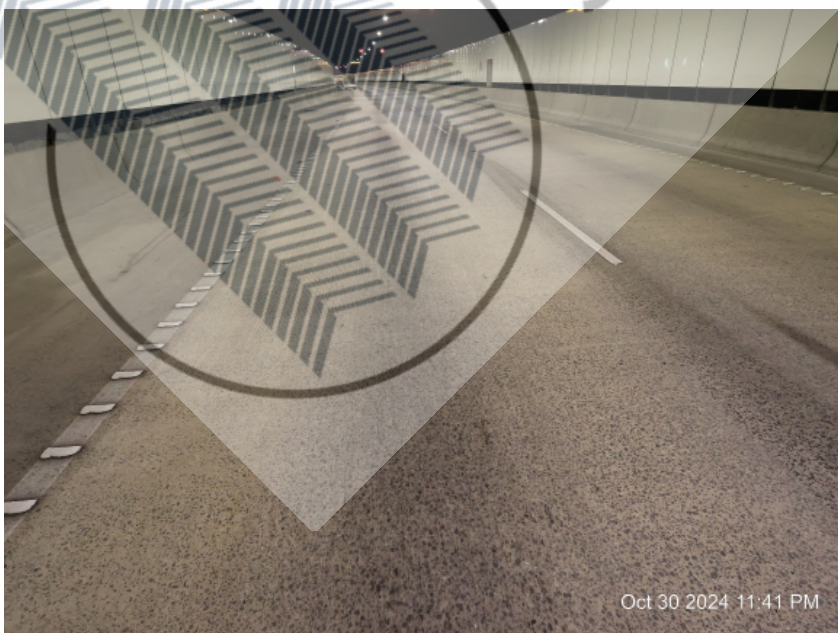
Figure: 0006

General View, EB, XP335-334, Ch 7014, L1.
Refer to figure 6 - No changes noted.

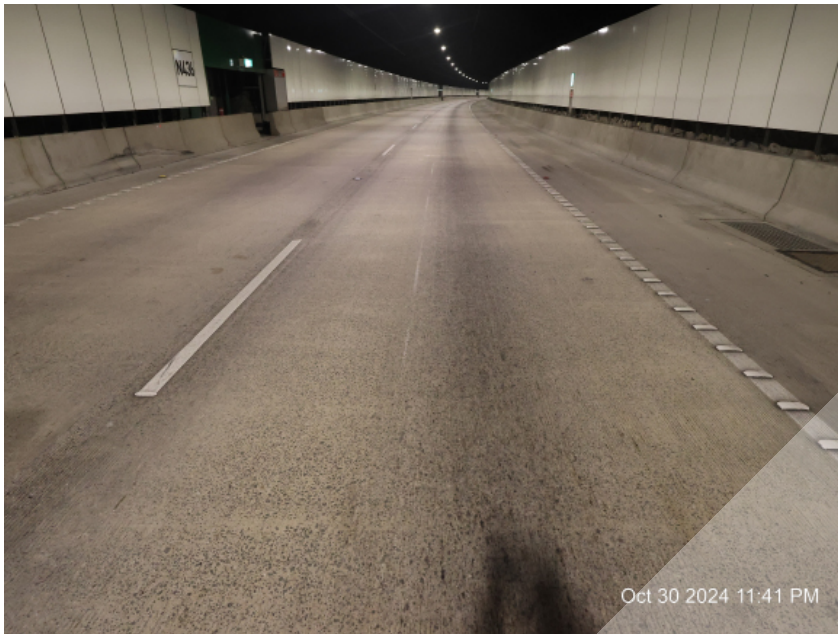
Figure: 0007

General View, EB, XP335-334, Ch 7014, L1.
Refer to figure 7 - No changes noted.

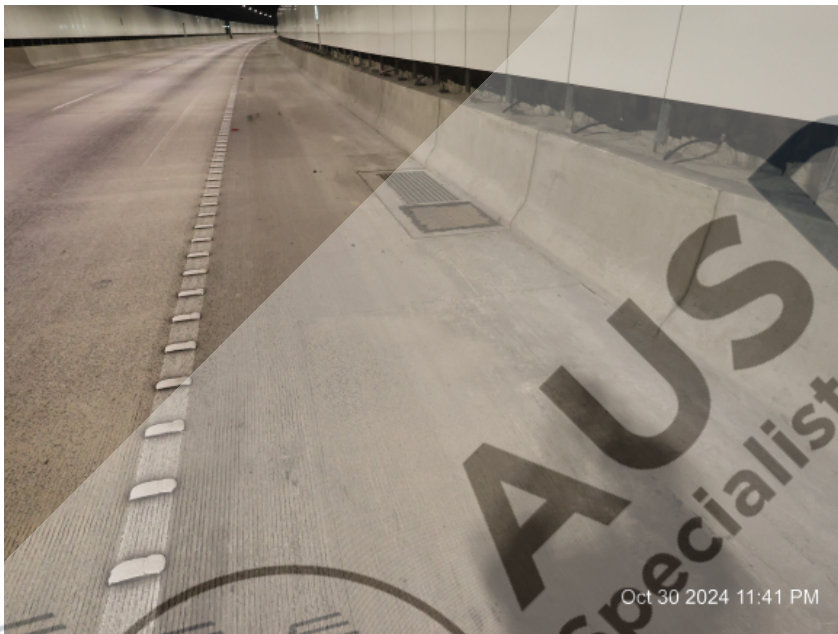
Figure: 0008

General View, EB, XP335-334, Ch 7014, NS.
Refer to figure 8 - No changes noted.

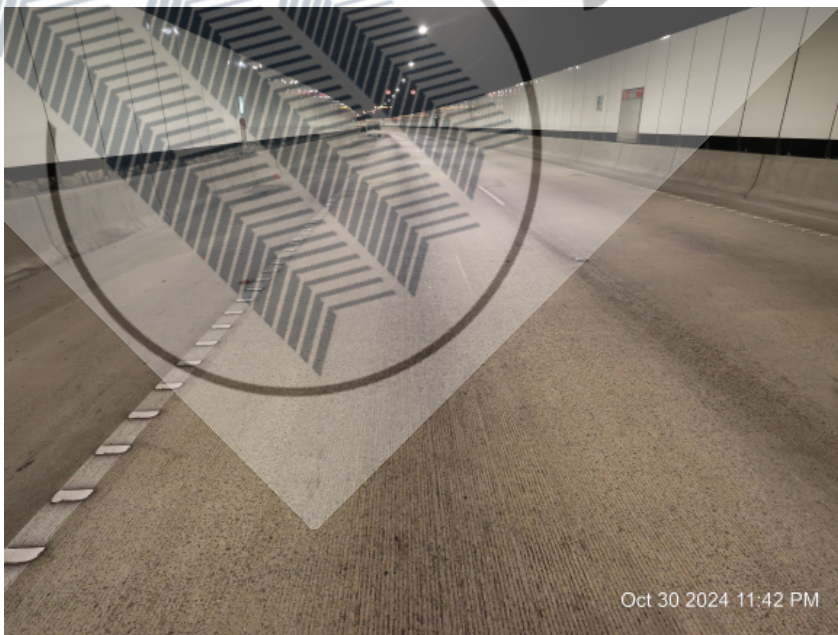
Figure: 0009

General View, EB, XP335-334, Ch 7034, L1.
Refer to figure 9 - No changes noted.

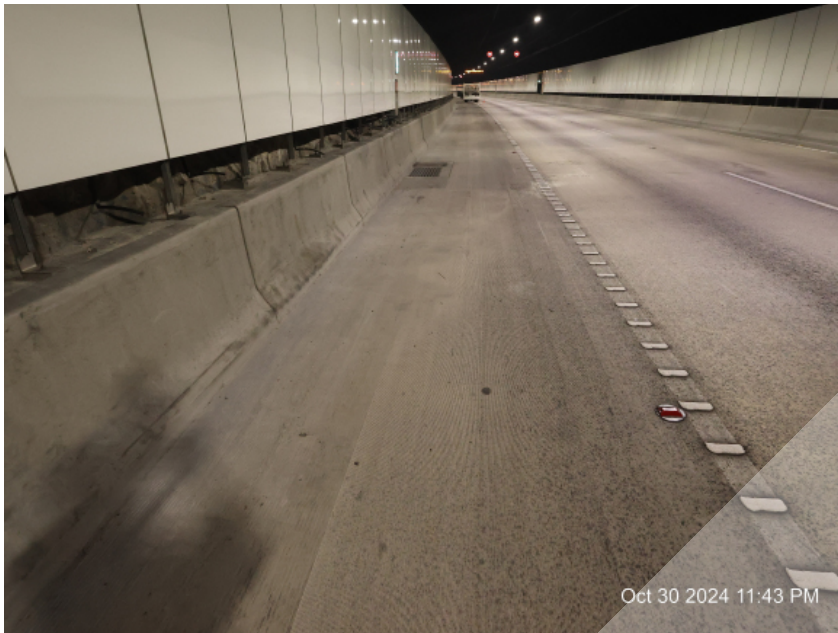
Figure: 0010

General View, EB, XP335-334, Ch 7034, NS.
Refer to figure 10 - No changes noted.

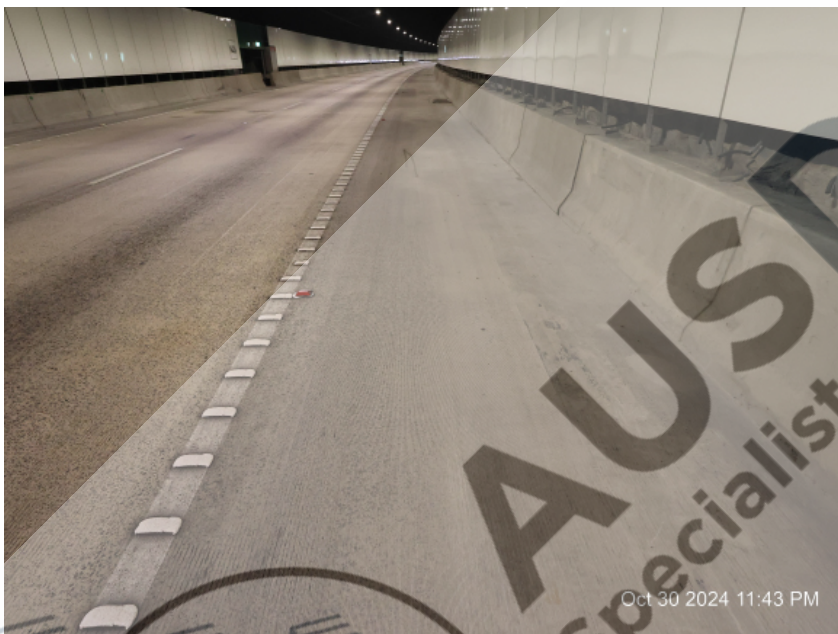
Figure: 0011

General View, EB, XP335-334, Ch 7034, NS.
Refer to figure 11 - No changes noted.

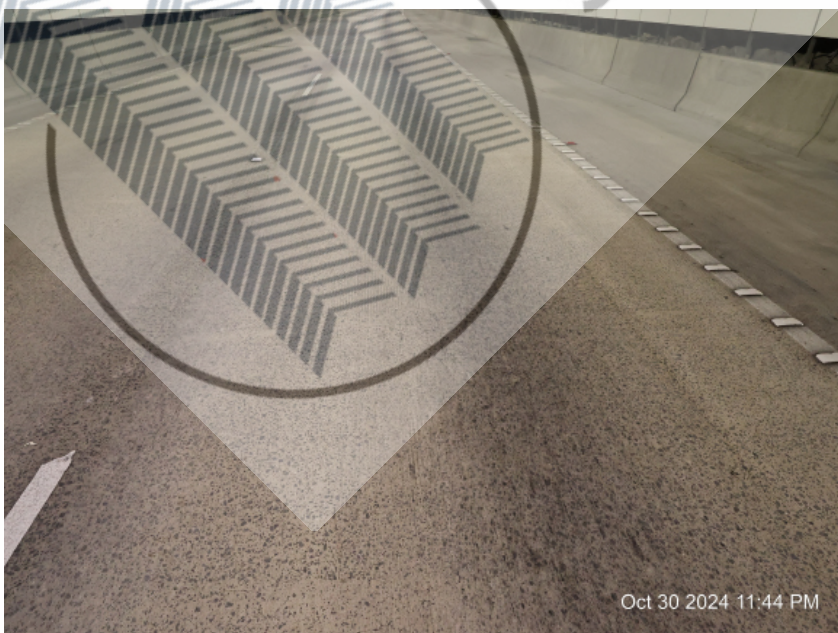
Figure: 0012

General View, EB, XP335-334, Ch 7034, L1.
Refer to figure 12 - No changes noted.

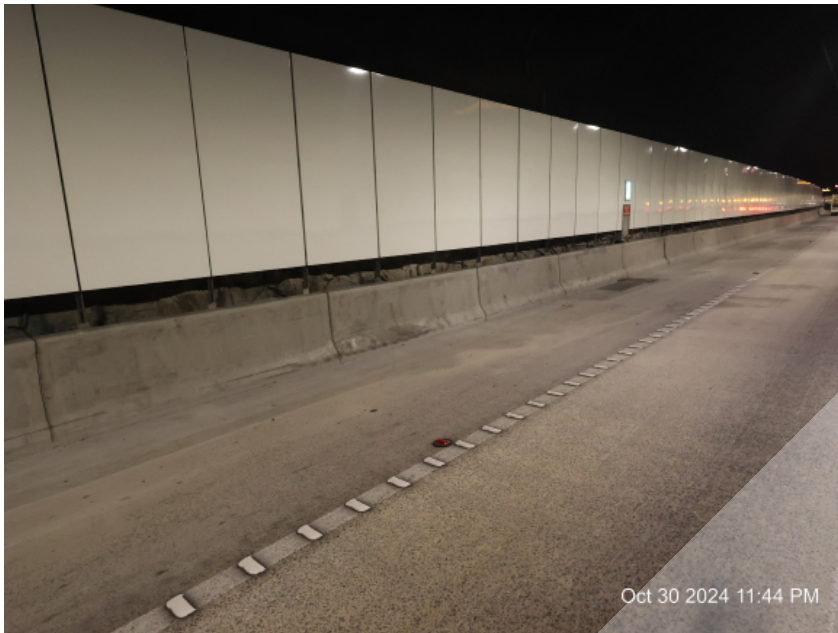
Figure: 0013

General View, EB, XP335-334, Ch 7034, NS. Architectural panels.
Refer to figure 13 - No changes noted.

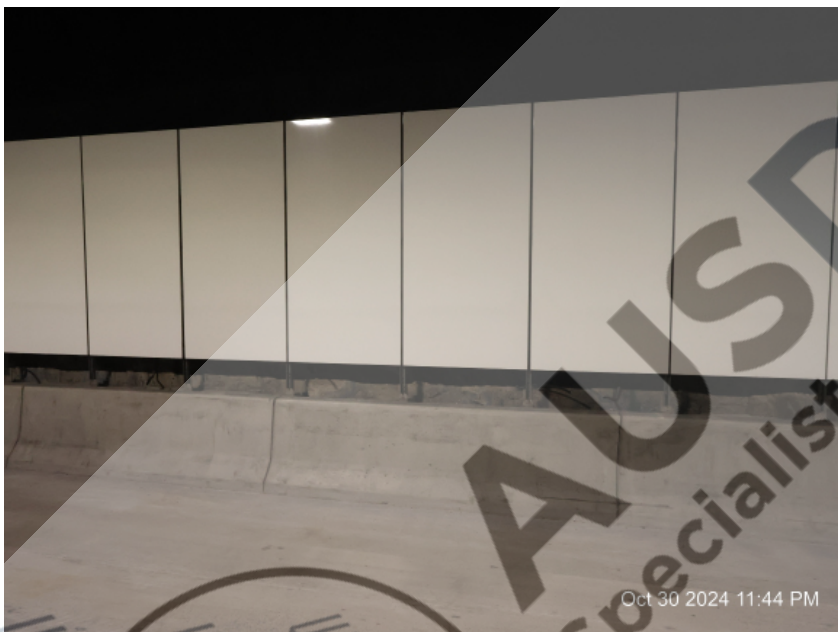
Figure: 0014

General View, EB, XP335-334, Ch 7034, NS. Architectural panels.
Refer to figure 14 - No changes noted.

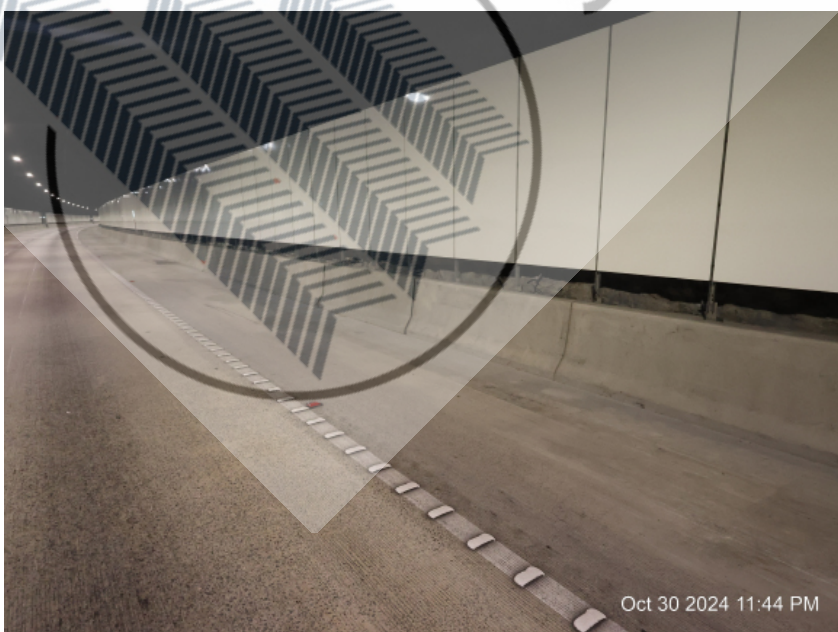
Figure: 0015

General View, EB, XP335-334, Ch 7034, NS. Architectural panels.
Refer to figure 15 - No changes noted.

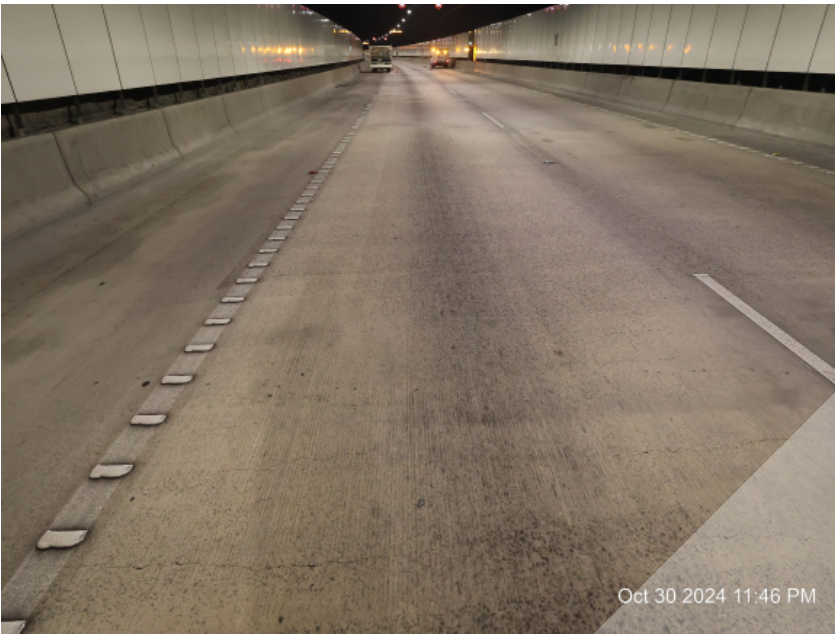
Figure: 0016

General View, EB, XP335-334, Ch 7054, L1.

Refer to figure 16 - No changes noted.

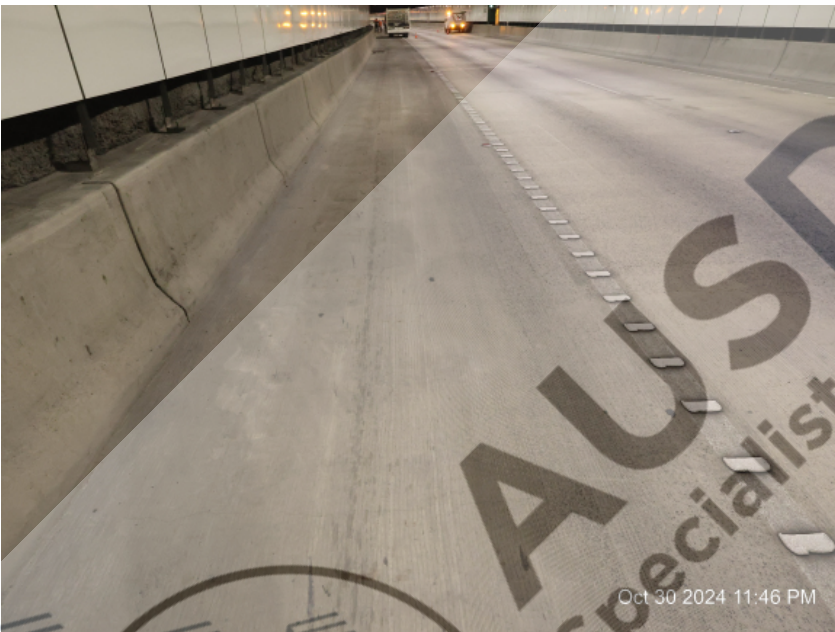
Figure: 0017

General View, EB, XP335-334, Ch 7054, NS.

Refer to figure 17 - No changes noted.

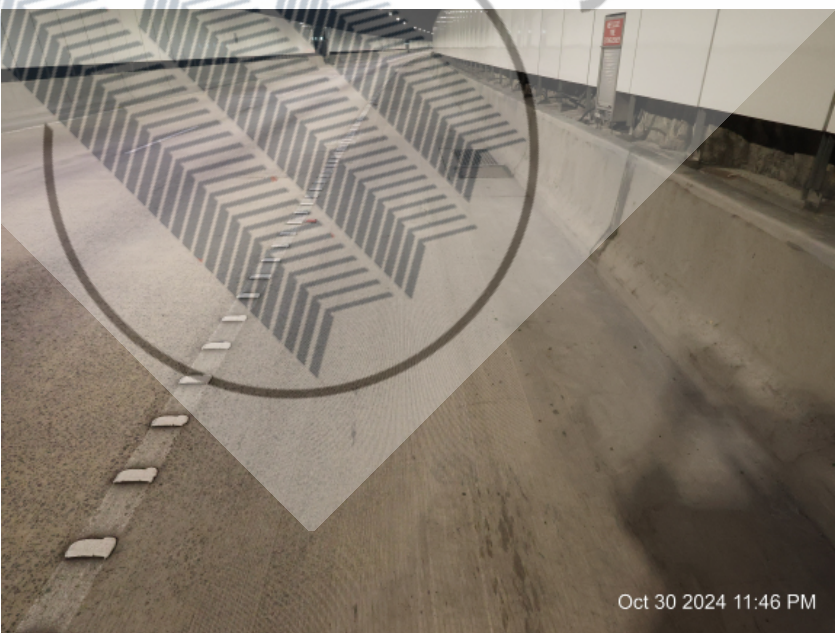
Figure: 0018

General View, EB, XP335-334, Ch 7054, NS.

Refer to figure 18 - No changes noted.

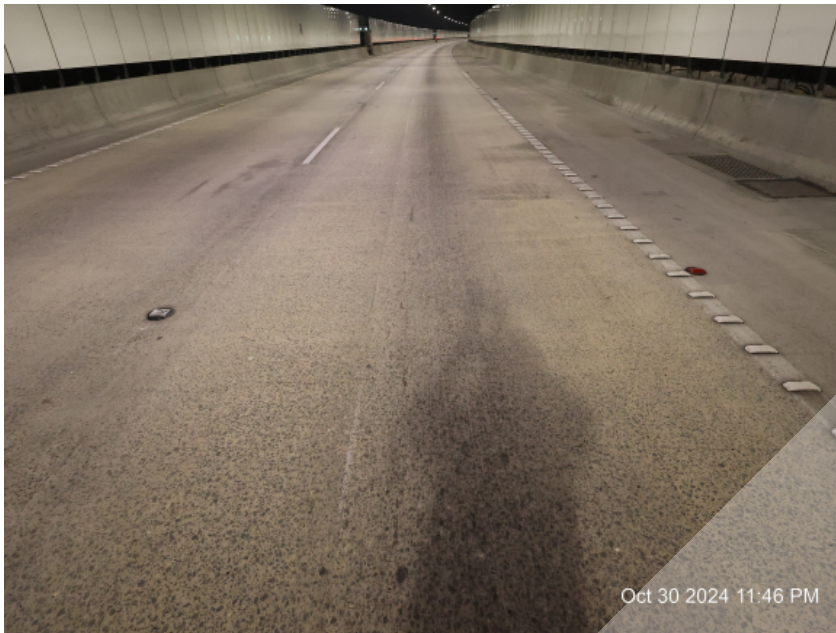
Figure: 0019

General View, EB, XP335-334, Ch 7054, L1.

Refer to figure 19 - No changes noted.

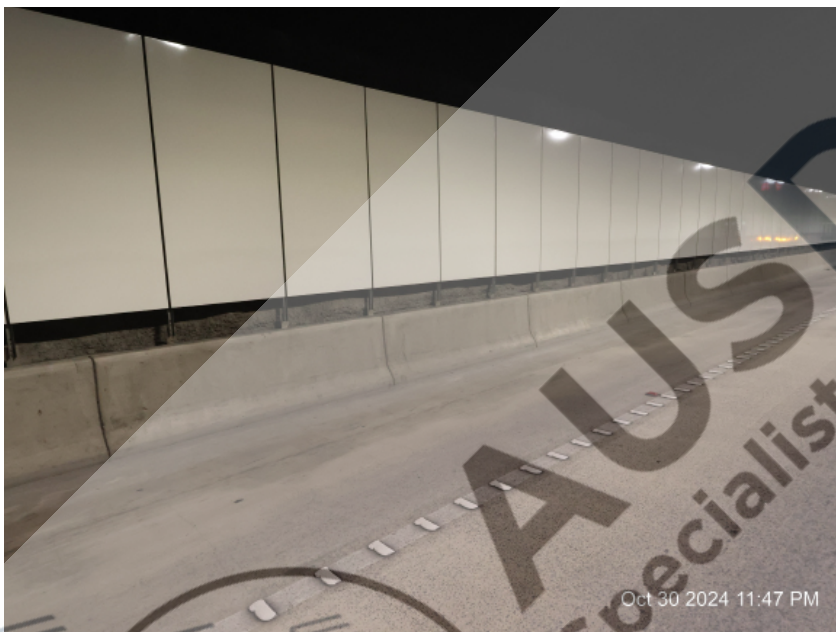
Figure: 0020

General View, EB, XP335-334, Ch 7054, NS. Architectural panels.

Refer to figure 20 - No changes noted.

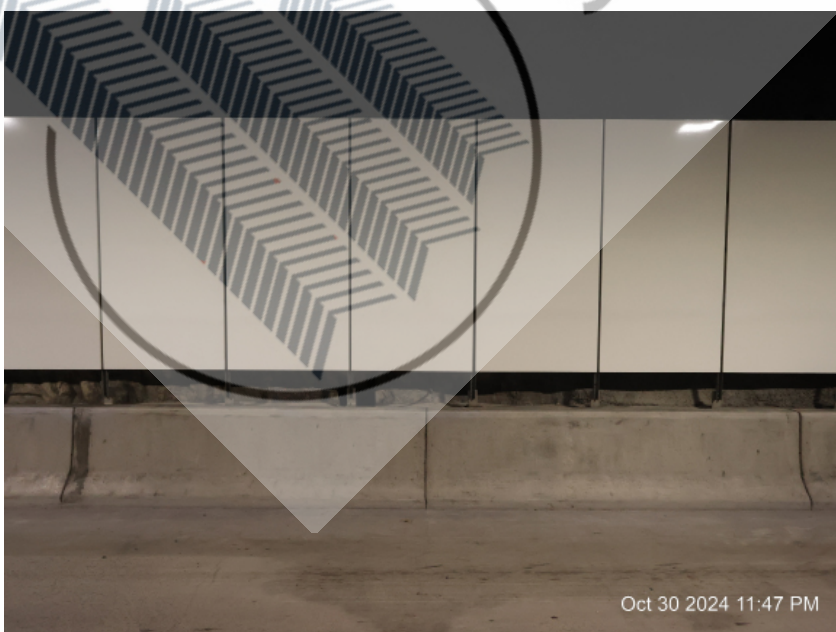
Figure: 0021

General View, EB, XP335-334, Ch 7054, NS. Architectural panels.

Refer to figure 21 - No changes noted.

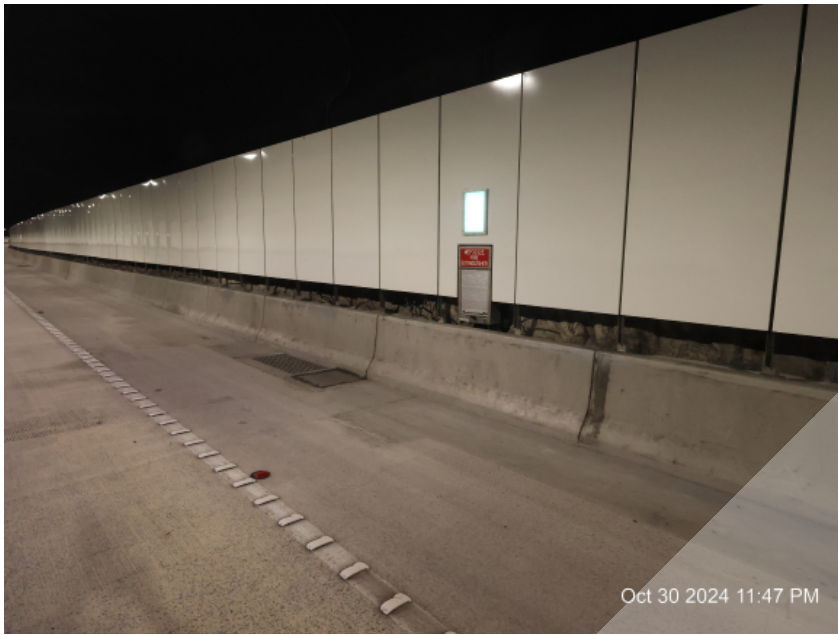
Figure: 0022

General View, EB, XP335-334, Ch 7054, NS. Architectural panels.
Refer to figure 22 - No changes noted.

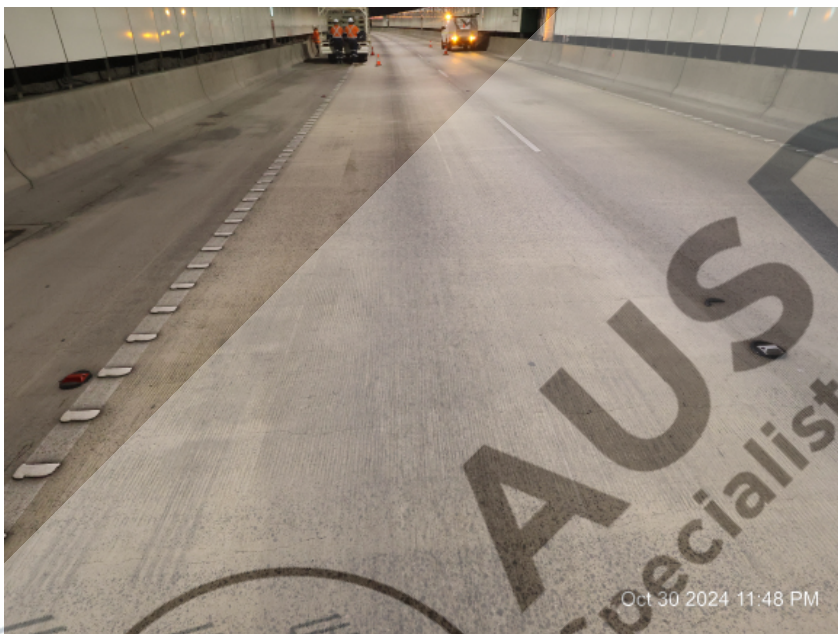
Figure: 0023

General View, EB, XP335-334, Ch 7084, L1.
Refer to figure 23 - No changes noted.

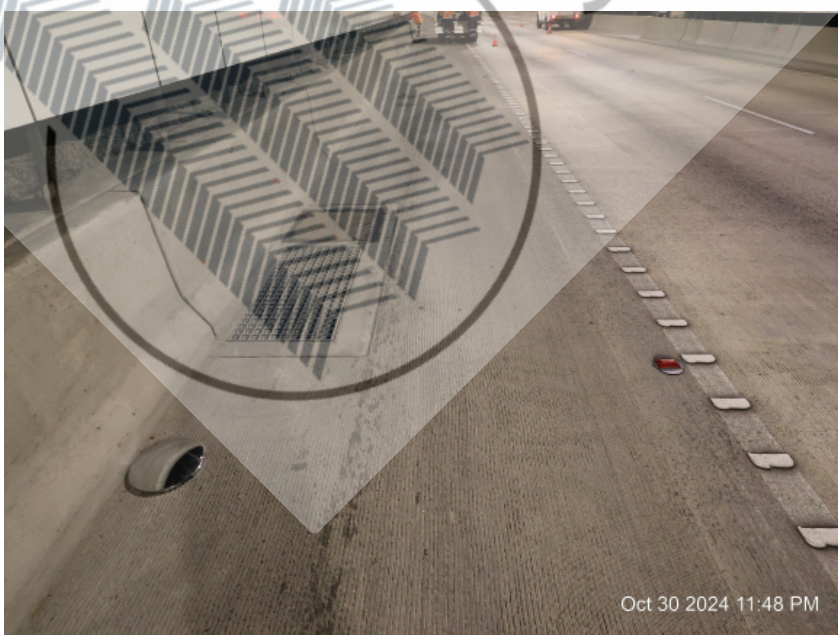
Figure: 0024

General View, EB, XP335-334, Ch 7084, NS.
Refer to figure 24 - No changes noted.

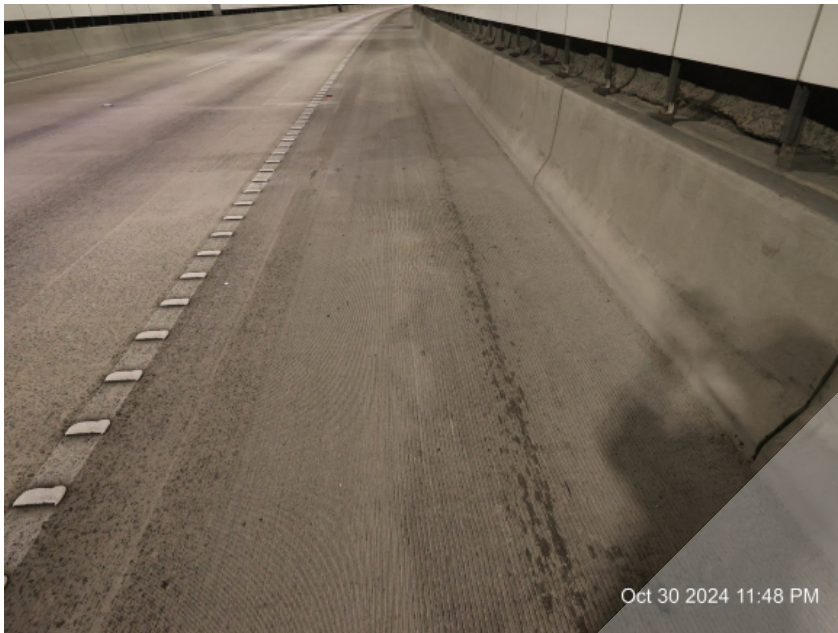
Figure: 0025

General View, EB, XP335-334, Ch 7084, NS.

Refer to figure 25 - No changes noted.

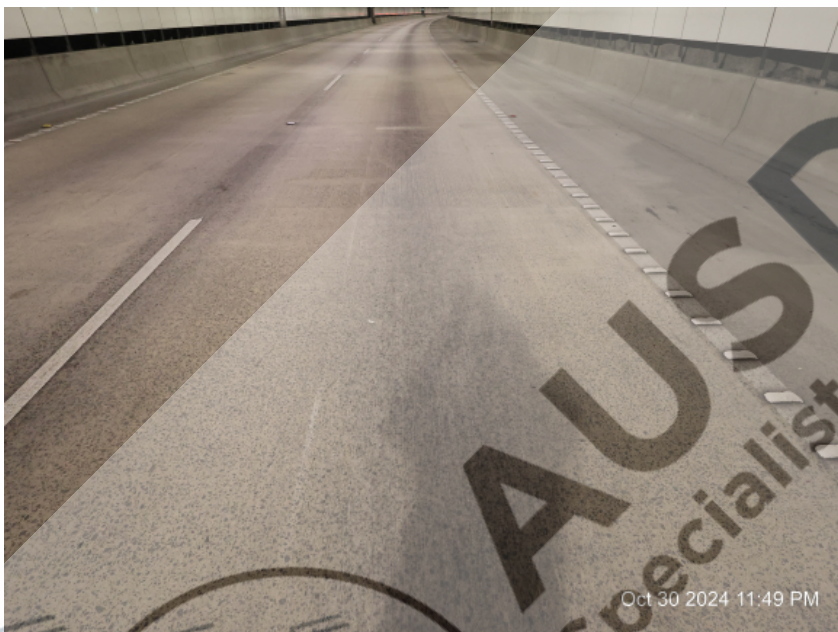
Figure: 0026

General View, EB, XP335-334, Ch 7084, L1.

Refer to figure 26 - No changes noted.

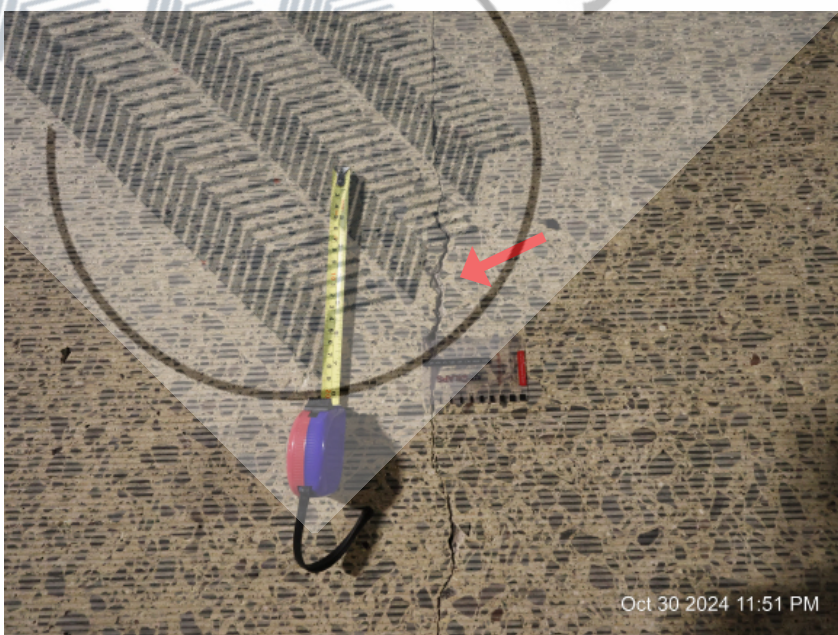
Figure: 0027

S1, EB, XP335-334, Ch 7094, L1,
Spalling at joints, Length: 140 mm

Width: 5-10 mm Depth: 5-10 mm

Refer to figure 27 - No changes noted.

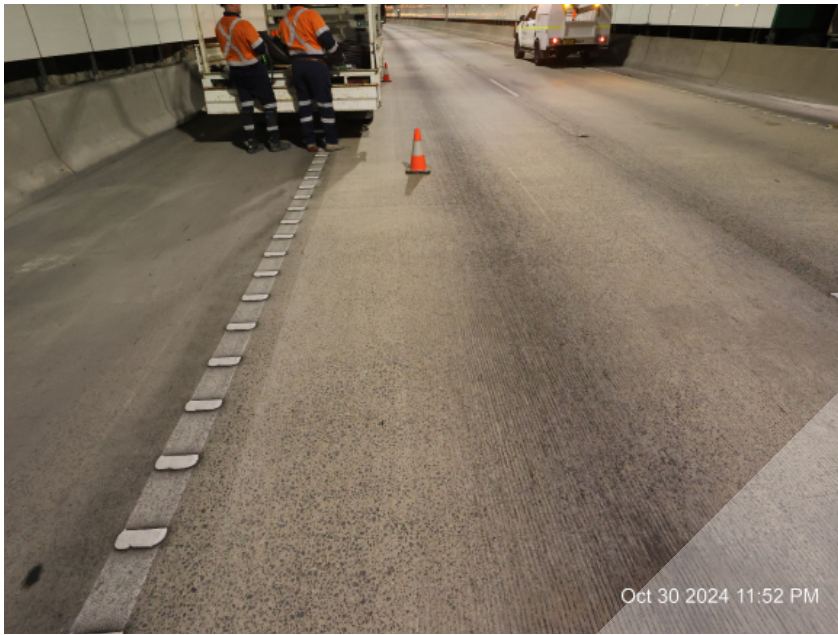
Figure: 0028

General View, EB, XP335-334, Ch 7104, L1.
Refer to figure 28 - No changes noted.

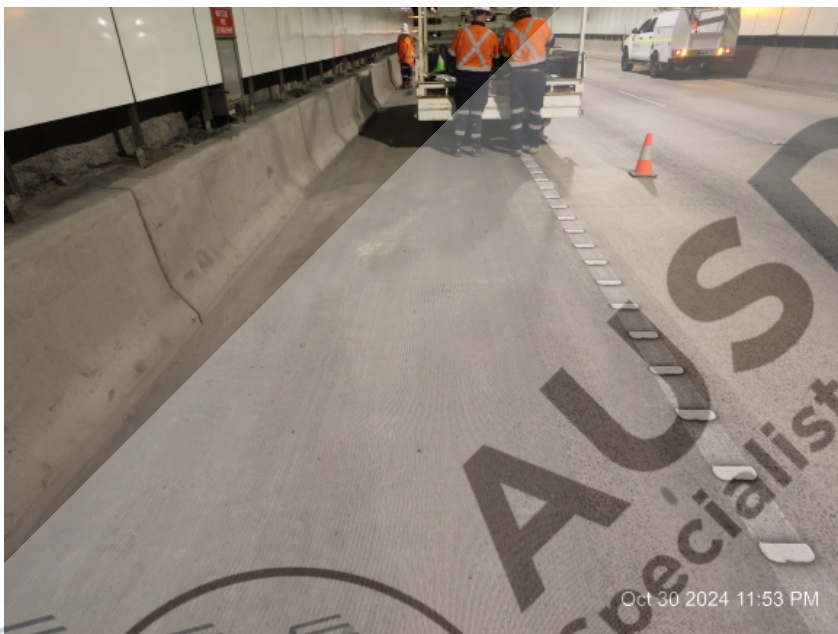
Figure: 0029

General View, EB, XP335-334, Ch 7104, NS.
Refer to figure 29 - No changes noted.

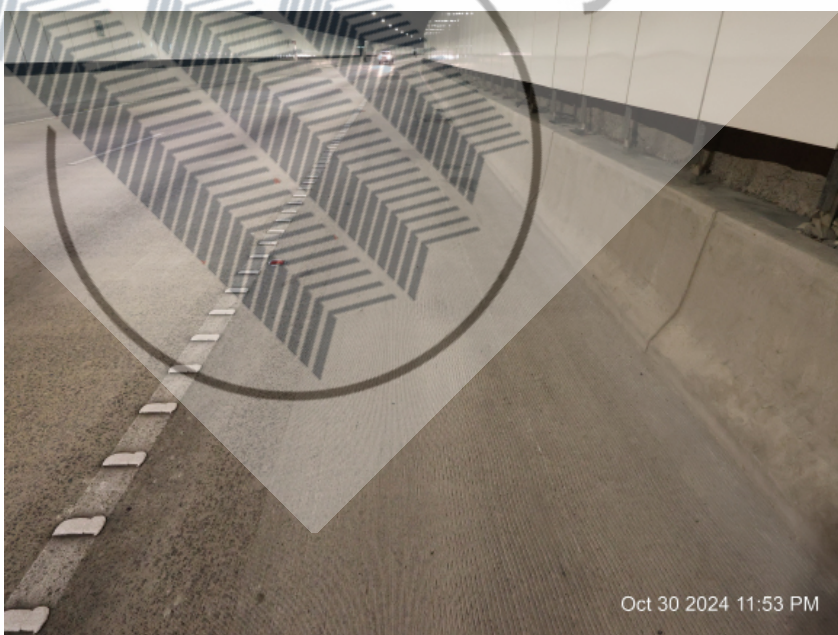
Figure: 0030

General View, EB, XP335-334, Ch 7104, NS.
Refer to figure 30 - No changes noted.

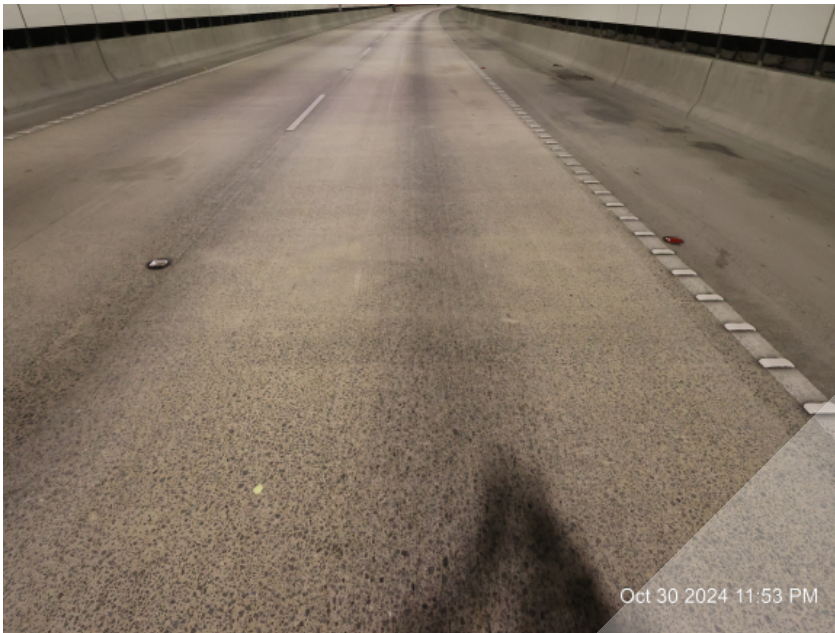
Figure: 0031

General View, EB, XP335-334, Ch 7104, L1.

Refer to figure 31 - No changes noted.

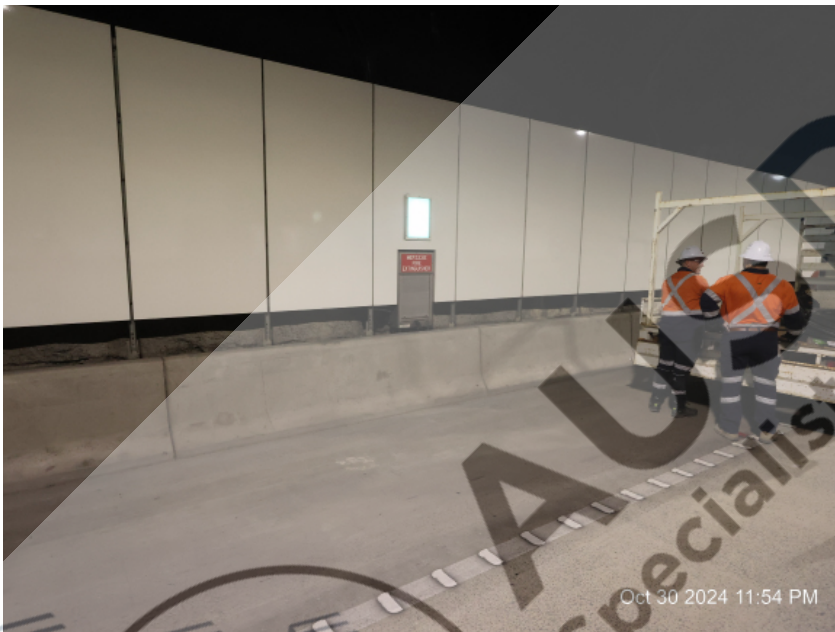
Figure: 0032

General View, EB, XP335-334, Ch 7104, NS. Architectural panels.

Refer to figure 32 - No changes noted.

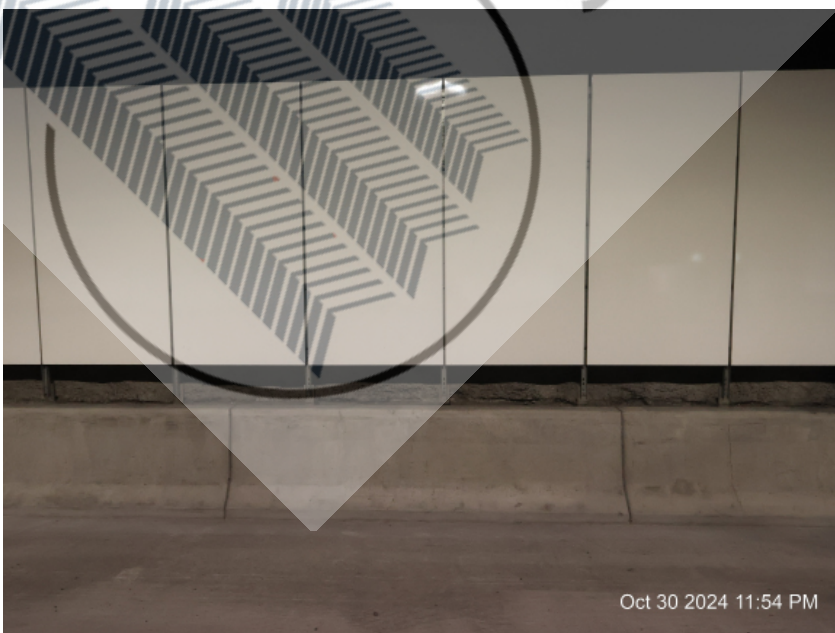
Figure: 0033

General View, EB, XP335-334, Ch 7104, NS. Architectural panels.

Refer to figure 33 - No changes noted.

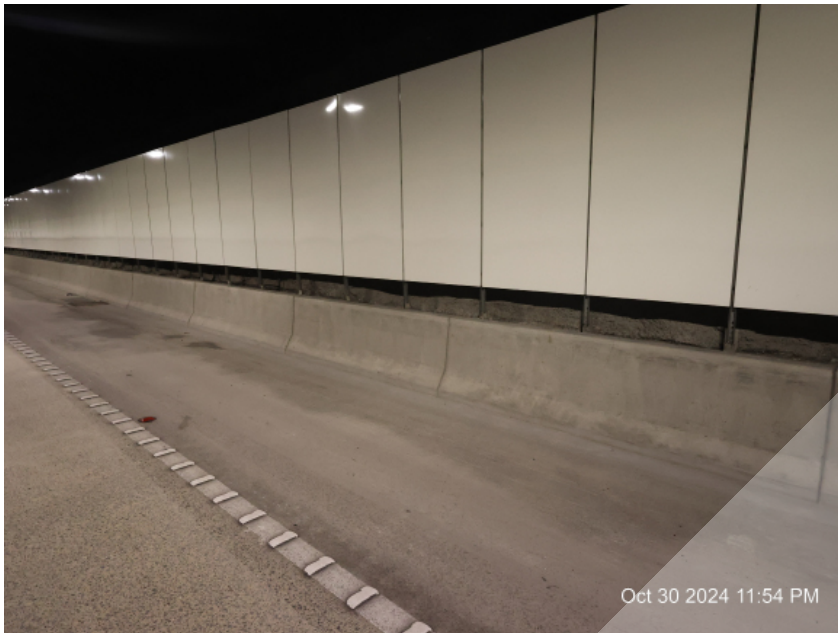
Figure: 0034

General View, EB, XP335-334, Ch 7104, NS. Architectural panels.
Refer to figure 34 - No changes noted.

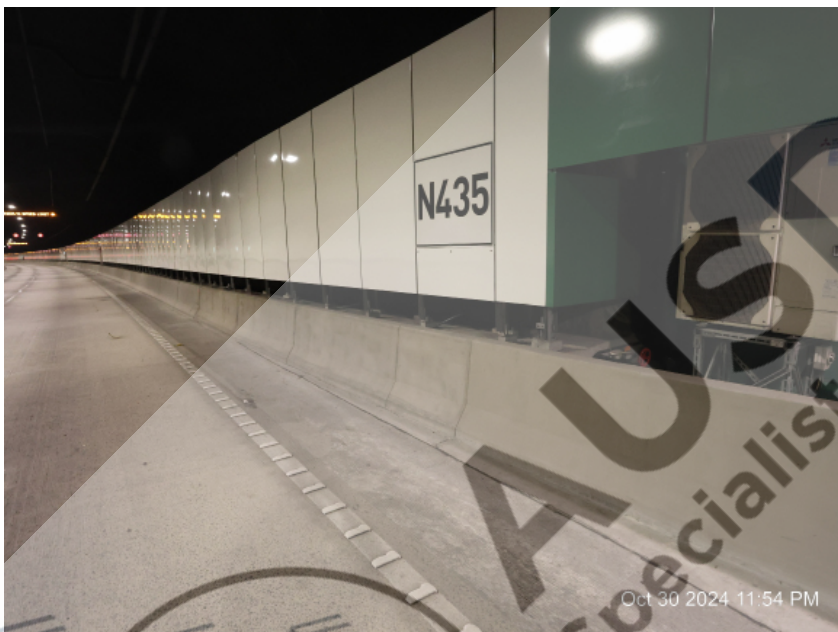
Figure: 0035

General View, EB, XP334-333, Ch 7112, L2.
Refer to figure 35 - No changes noted.

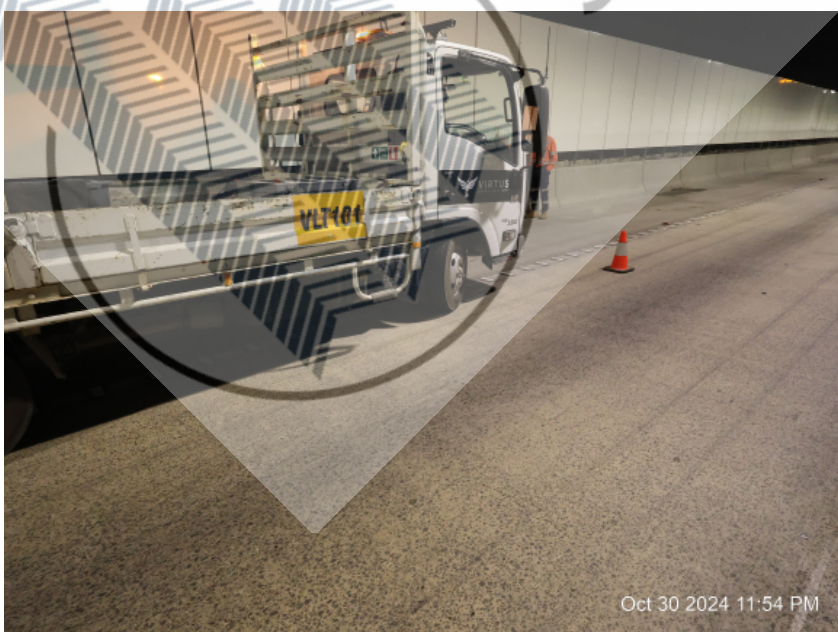
Figure: 0036

General View, EB, XP334-333, Ch 7112, L1.
Refer to figure 36 - Showing compromised visibility.
