**POST-CONSTRUCTION VIDEO CONDITION SURVEY
DEFECT ANALYSIS**

INSPECTION DATE: January 8, 2025

INSPECTOR: Brandon Wang
B.Eng Civil
Structural & Civil Engineer

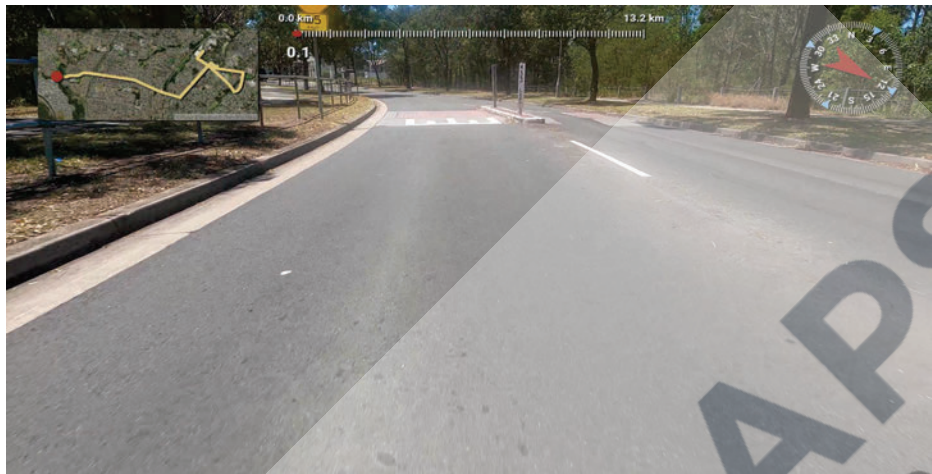
Figure 0014

Figure	Road Name	Direction	Defect	Classification
0014	Brine Pipeline P1.4 Elizabeth Drive Kemps Creek	East	Edge Cracking	Minor
0031	Brine Pipeline P1.4 Elizabeth Drive Kemps Creek	East	Transverse Cracking	Minor
0040	Brine Pipeline P1.4 Elizabeth Drive Kemps Creek	East	Longitudinal Cracking	Minor
0045	Brine Pipeline P1.4 Elizabeth Drive Kemps Creek	East	Longitudinal Cracking	Minor
0049	Brine Pipeline P1.4 Elizabeth Drive Kemps Creek	East	Transverse Cracking	Minor
0061	Brine Pipeline P1.4 Elizabeth Drive Kemps Creek	East	Longitudinal Cracking	Minor
0065	Brine Pipeline P1.4 Elizabeth Drive Kemps Creek	East	Longitudinal Cracking	Minor
0076	Brine Pipeline P1.4 Elizabeth Drive Kemps Creek	East	Longitudinal Cracking	Minor
0090	Brine Pipeline P1.4 Elizabeth Drive Kemps Creek	East	Alligator cracking	Minor
0121	Brine Pipeline P1.4 Elizabeth Drive Kemps Creek	East	Transverse Cracking	Minor
0122	Brine Pipeline P1.4 Elizabeth Drive Kemps Creek	East	Transverse Cracking	Minor
