AUSDILAPS
Specialist Building Inspections

PRE-CONSTRUCTION CONDITION SURVEY

- Property Type: Council Assets
- Asset Type: Culvert
- Traveling Direction: East to West

CULVERT 190 : PIPE 1 - LEFT PIPE (FACING SOUTH)

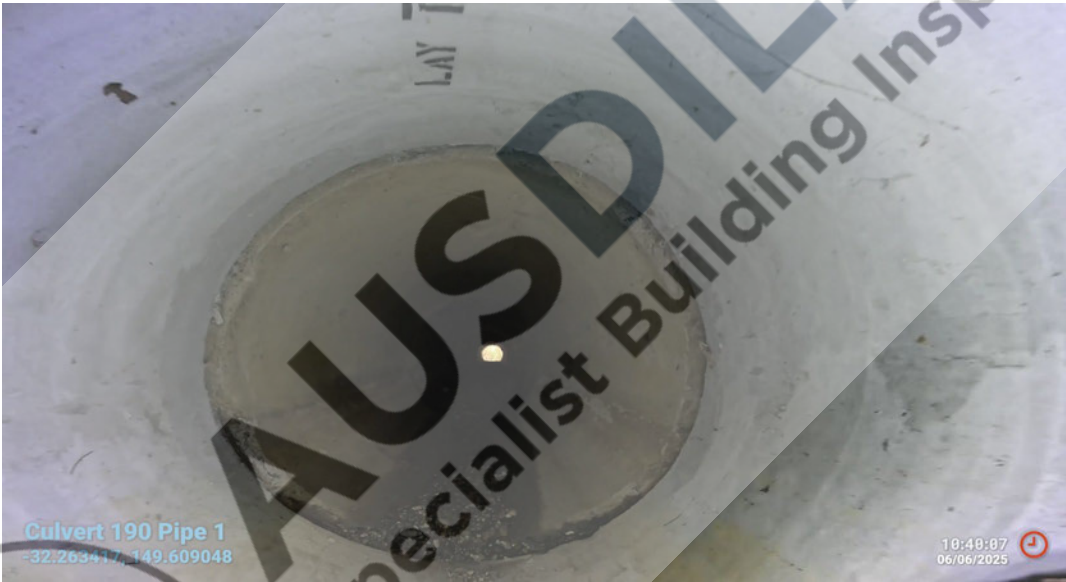
Figure 0008

Figure	Culvert Name	Latitude	Longitude	Defect	Classification
0008	Culvert 190 - Pipe 1	32°15'48.3"S	149°36'32.6"E	Spalling / Delamination	Minor
0012-0035	Culvert 190 - Pipe 1	32°15'48.3"S	149°36'32.6"E	Sediment Build-up	Minor
0017-0023	Culvert 190 - Pipe 1	32°15'48.3"S	149°36'32.6"E	Longitudinal Cracking	Minor
0028	Culvert 190 - Pipe 1	32°15'48.3"S	149°36'32.6"E	Spalling / Delamination	Minor
0030-0031	Culvert 190 - Pipe 1	32°15'48.3"S	149°36'32.6"E	Spalling / Delamination	Minor
0040	Culvert 190 - Pipe 2	32°15'48.3"S	149°36'32.6"E	Spalling / Delamination	Minor
0042-0043	Culvert 190 - Pipe 2	32°15'48.3"S	149°36'32.6"E	Spalling / Delamination	Minor
0053	Culvert 190 - Pipe 2	32°15'48.3"S	149°36'32.6"E	Spalling / Delamination	Minor
0055	Culvert 190 - Pipe 2	32°15'48.3"S	149°36'32.6"E	Spalling / Delamination	Minor
0058	Culvert 190 - Pipe 2	32°15'48.3"S	149°36'32.6"E	Spalling / Delamination	Minor
0064	Culvert 186	32°16'53.1"S	149°36'29.5"E	Debris Accumulation	Minor
