AUSDILAPS
Specialist Building Inspections

DEFECT ORIGIN ASSESSMENT (DOA)

DEFECT ORIGIN ASSESSMENT DATE: August 26, 2025

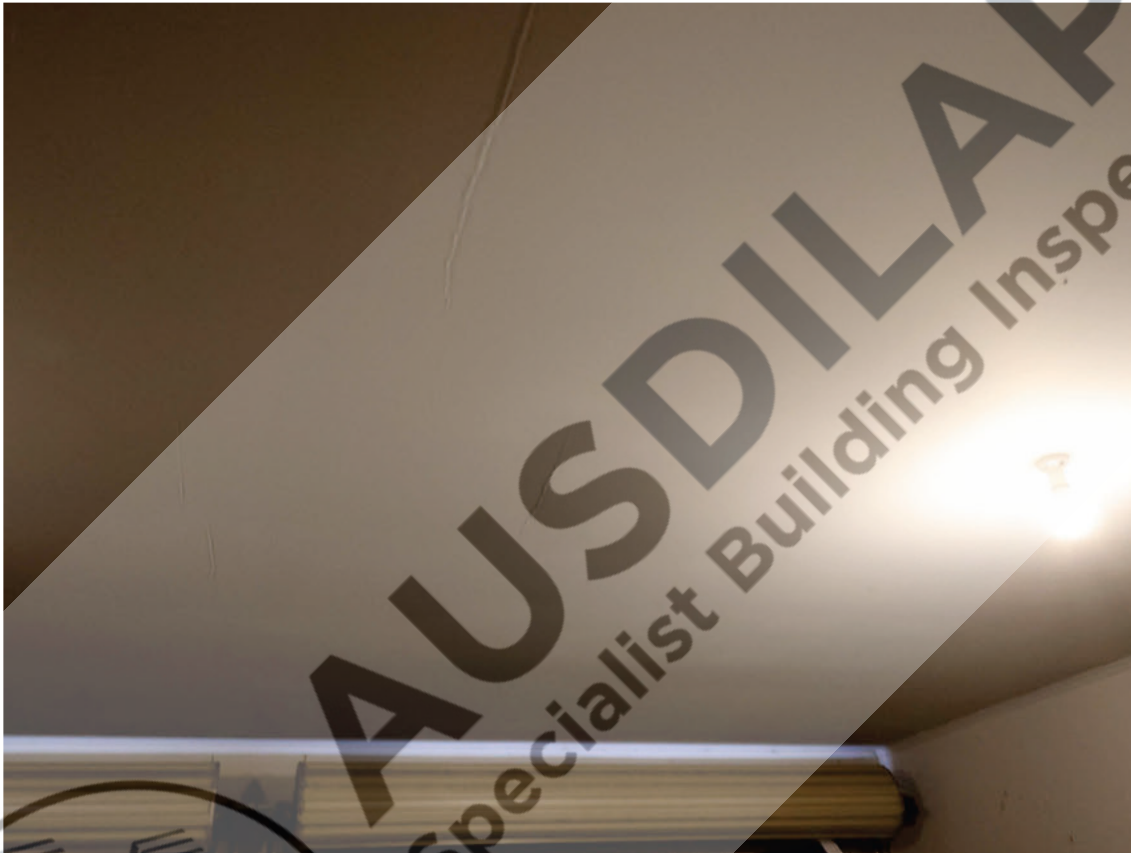
Findings in Building Dilapidations Report	PHOTO NUMBER in Pre-report	PHOTO NUMBER in Post-report	Notes from Post-report	Change that could be linked to the Construction Activities	Potential Cause	Expert Opinion – Structural Engineer of AusDilaps
Defect Description	No.	No.	Comment of defect changes	Likelihood 1 - Yes 2 - Likely 3 - Unlikely 4 - No	Potential causes that leads to the defect	Reasoning of the likelihood
Bubbling paint in the ceiling in the garage.	113, 115	113, 115	Defect not previously visible.	No	<ul style="list-style-type: none"> The bubbling paint is due to moisture ingress, and surface adhesion failure typically caused by moisture or vapor pressure beneath the paint film. The location (garage ceiling) is vulnerable to roof drainage issues, Plumbing above, or condensation due to limited ventilation. 	There is no evidence of cracking, displacement, or vibration-related damage, making the defect is not associated with construction activity or structural movement.

Picture 1 - Bubbling paint in the ceiling in the garage- Figure 113

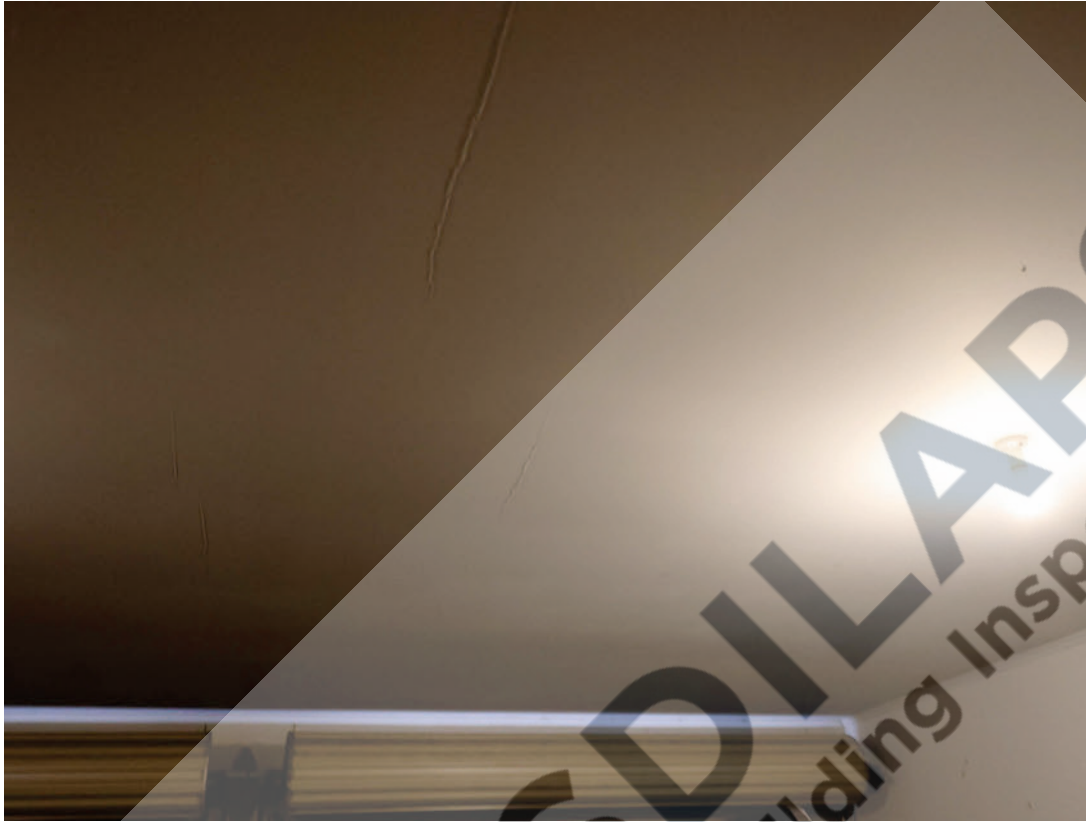
Picture 2 - Bubbling paint in the ceiling in the garage- Figure 115

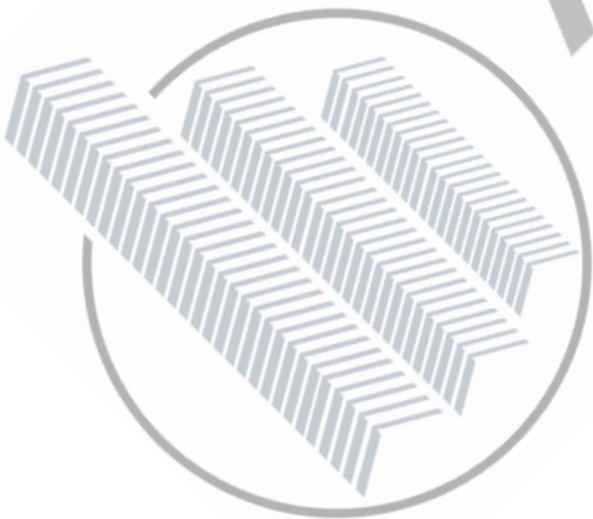
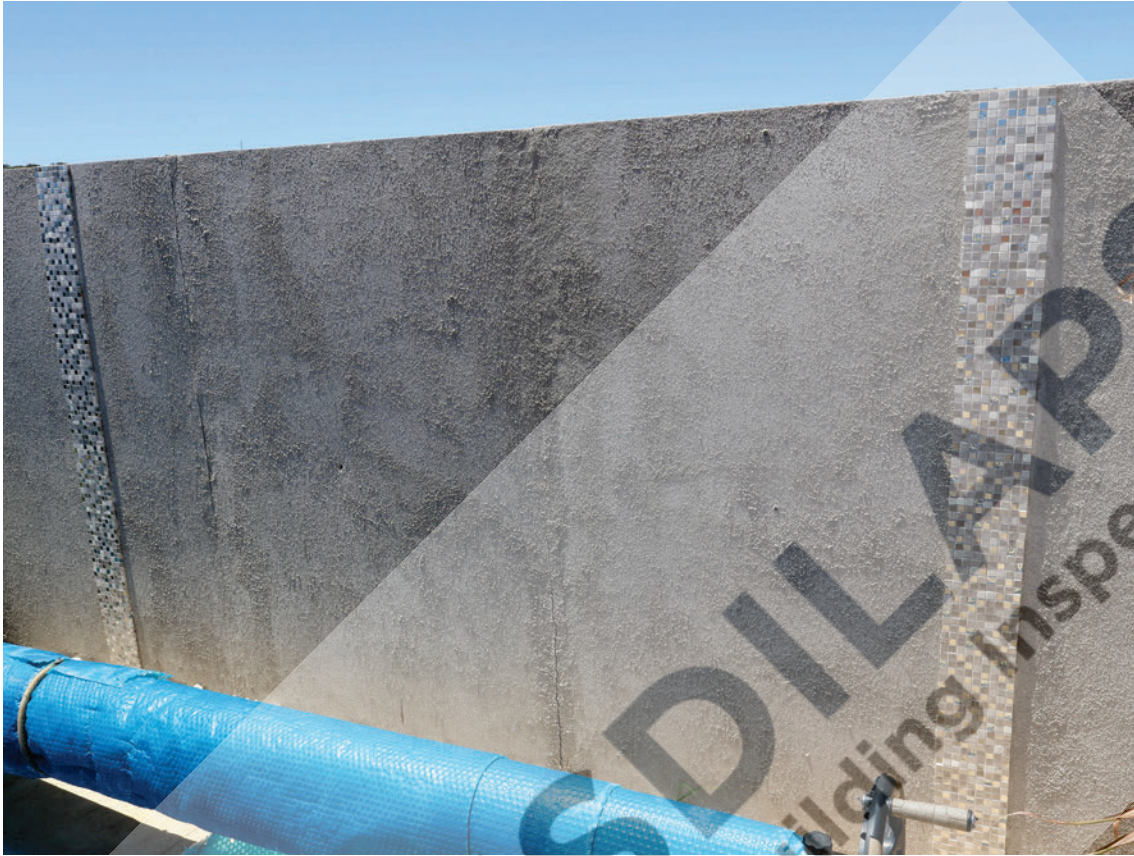
Cracks in the rear wall on the pool area.	256-259	256-259	Not Previously Photographed	Unlikely	Vertical alignment of cracks usually points to foundation settlement, shrinkage, or expansion stress rather than impact or vibration.	<ul style="list-style-type: none"> The location near a pool makes soil moisture variation and drainage issues a highly probable factor. Cracks from vibration or displacement due to construction are usually diagonal or stepped, not clean vertical lines — making construction activity an unlikely cause.
Cracking in the front wall of the house.	262-264	262-264	Not Previously Photographed	Unlikely	<ul style="list-style-type: none"> Structural stress and movement concentrated at weak points. building movement (thermal or settlement) the most probable cause. 	<ul style="list-style-type: none"> Horizontal cracks typically indicate tensile stress across a continuous line, often linked to thermal movement or structural settlement. The fact that the cracks are between window openings suggests that stresses are concentrated at these weaker wall sections, rather than being caused by vibration or construction activity.

Picture 3 – Vertical alignment of crack- Figure No 256 from the Post report

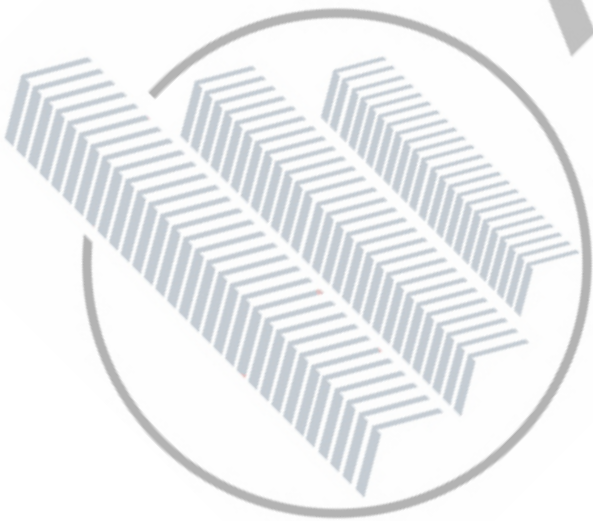
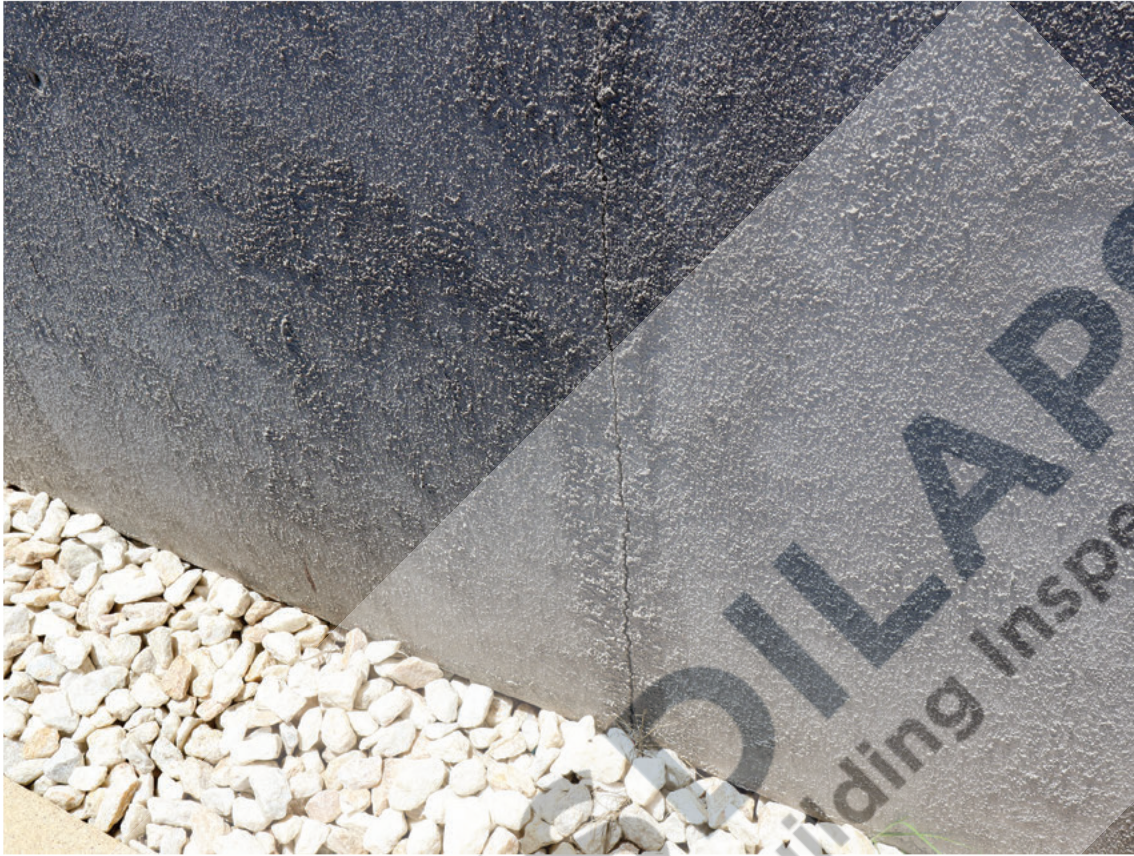
Picture 4 – Vertical alignment of crack- Figure No 257 from the Post report

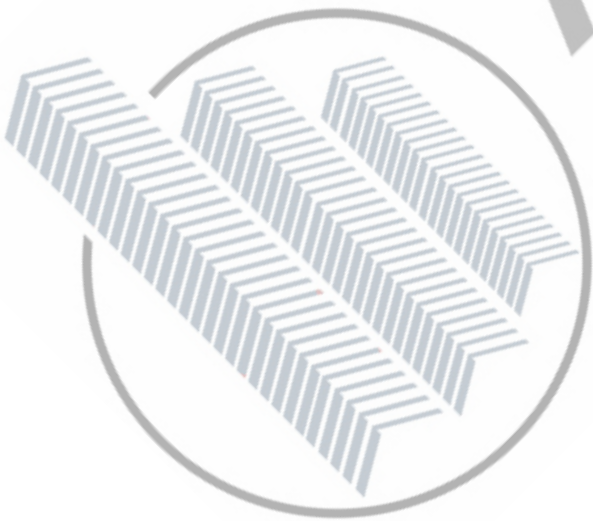
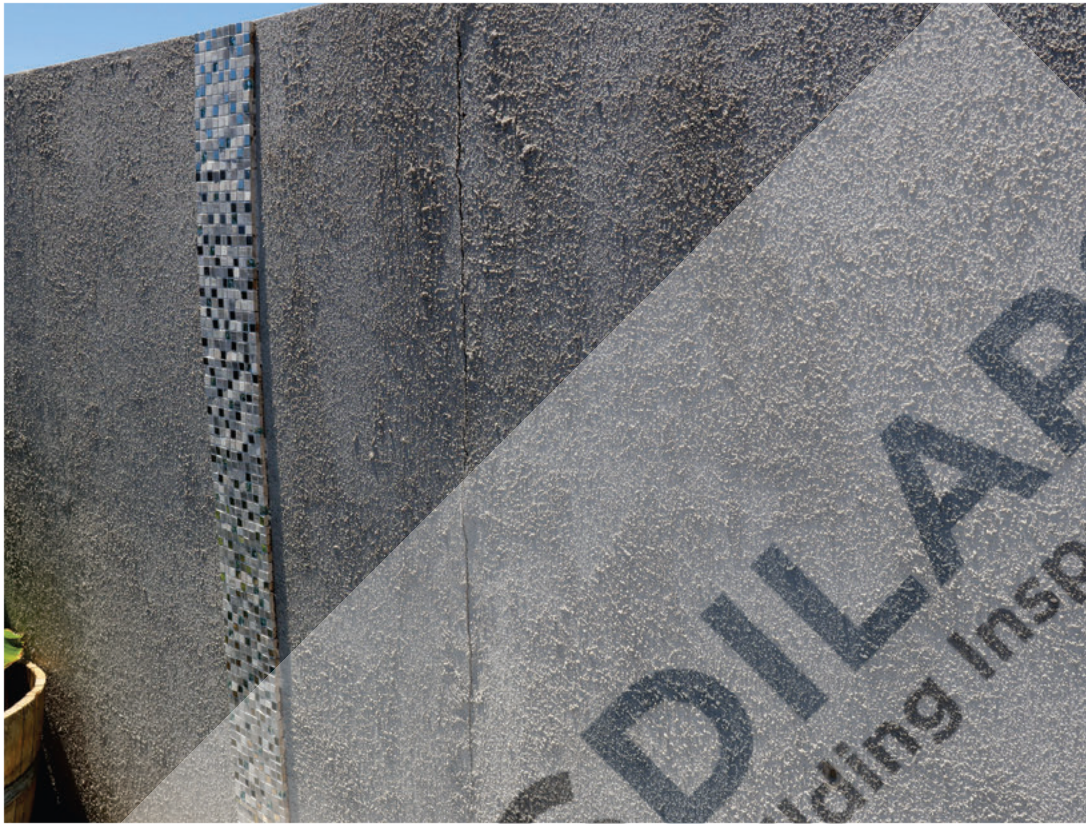
Picture 5 – Vertical alignment of crack- Figure No 258 from the Post report

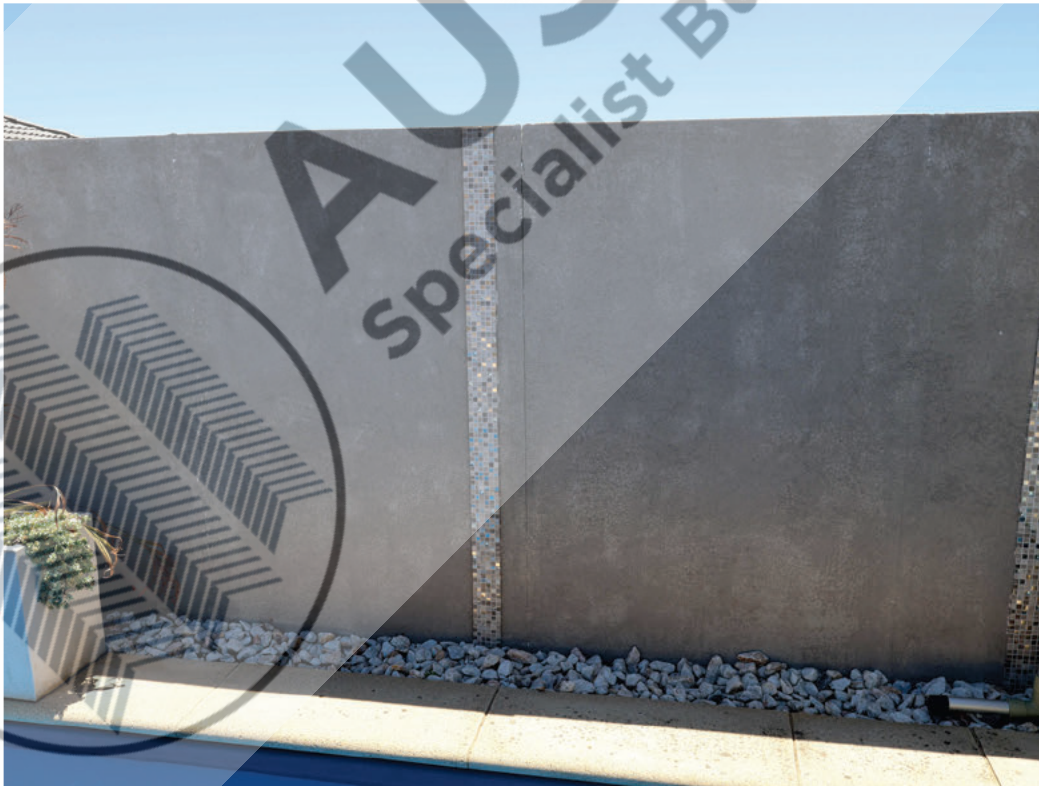
Picture 6 – Vertical alignment of crack- Figure No 259 from the Post report

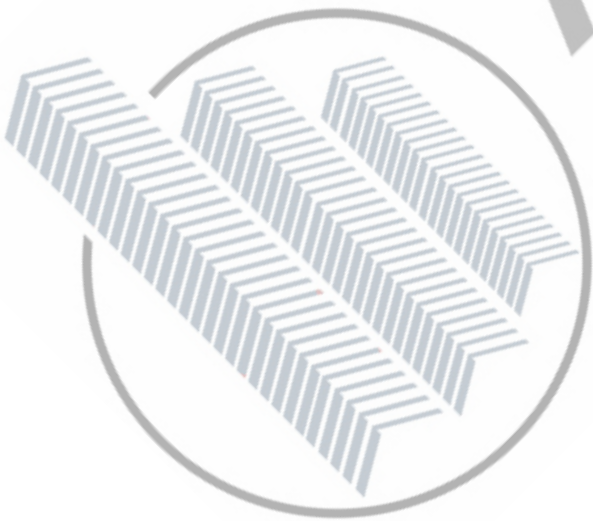
Picture 9 – Figure 264 in the post-report

Cracking in the front wall of the house.	265	265	Not Previously Photographed	Unlikely	<ul style="list-style-type: none"> The horizontal crack in the timber column beside the garage door opening is most likely caused by shrinkage, which is common in timber exposed to fluctuating moisture and temperature conditions. The crack may also be related to stress concentration at the fixing points, where the timber is restrained and tensile forces developed. 	<ul style="list-style-type: none"> The location beside a garage door opening is critical: garage openings reduce lateral support, and columns at these edges are highly stressed. A horizontal crack here is more likely due to structural stress, shrinkage, rather than vibration or external displacement.
