[REDACTED]  
*STRUCTURAL INTEGRITY ASSESSMENT (SIA)*

**INSPECTION DATE:** September 23, 2025

**SITE ASSESSED:** [REDACTED]

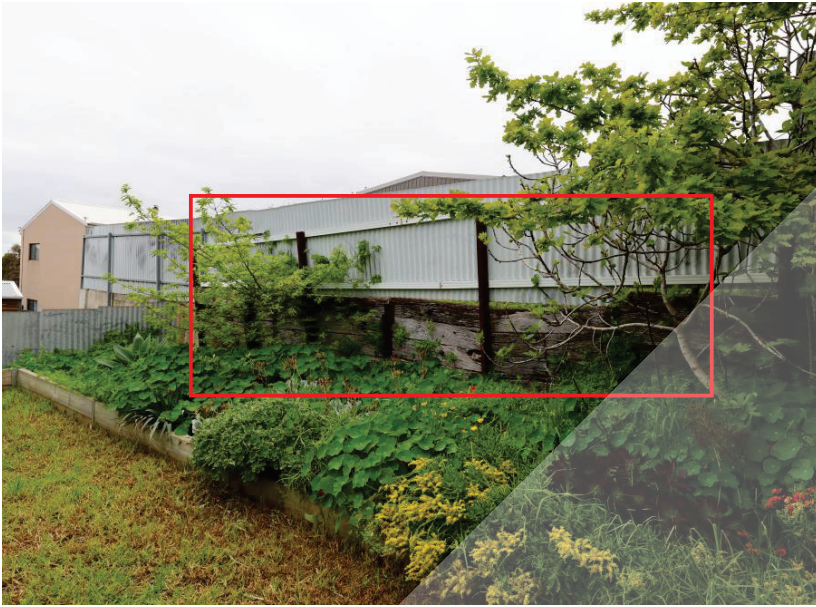
Figure 0001

Leaning in the east boundary fence.

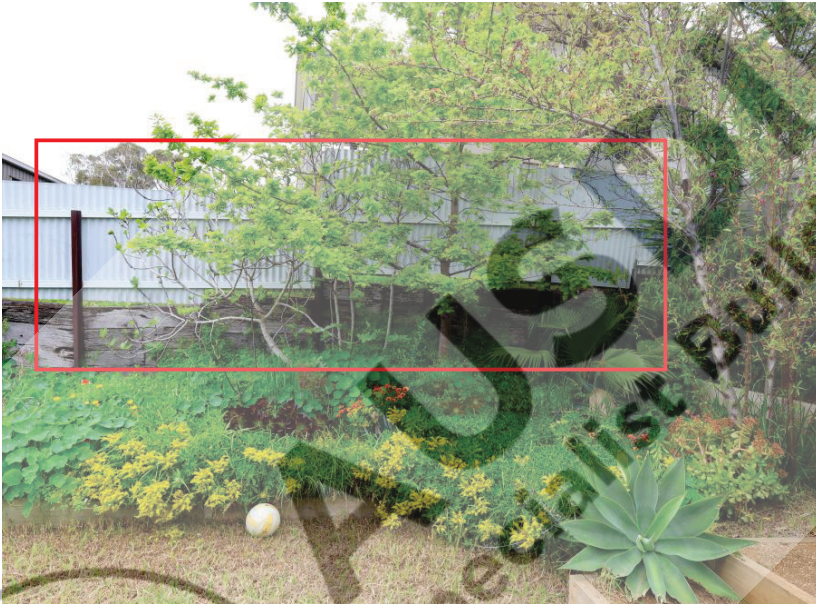
Figure 0002

Leaning in the east boundary fence.

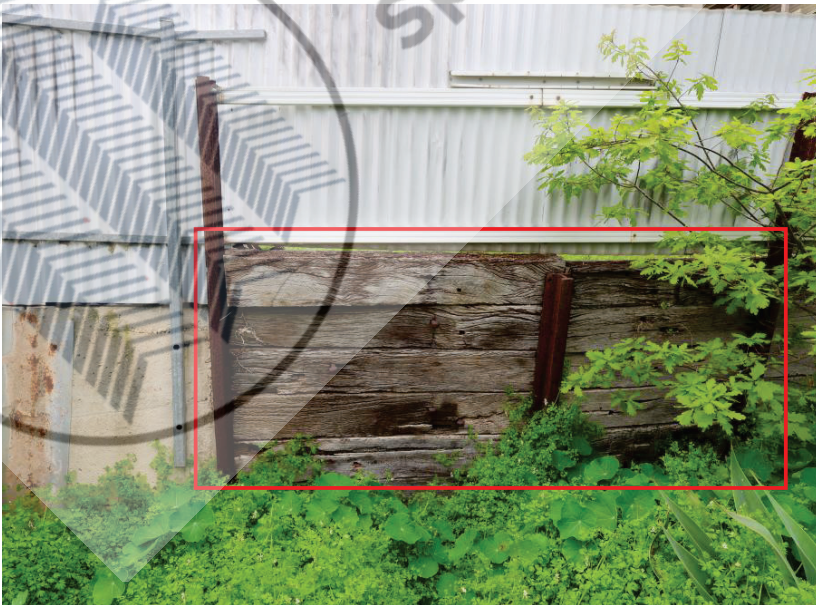
Figure 0003

Leaning in the east boundary fence. Showing movement in the paling.

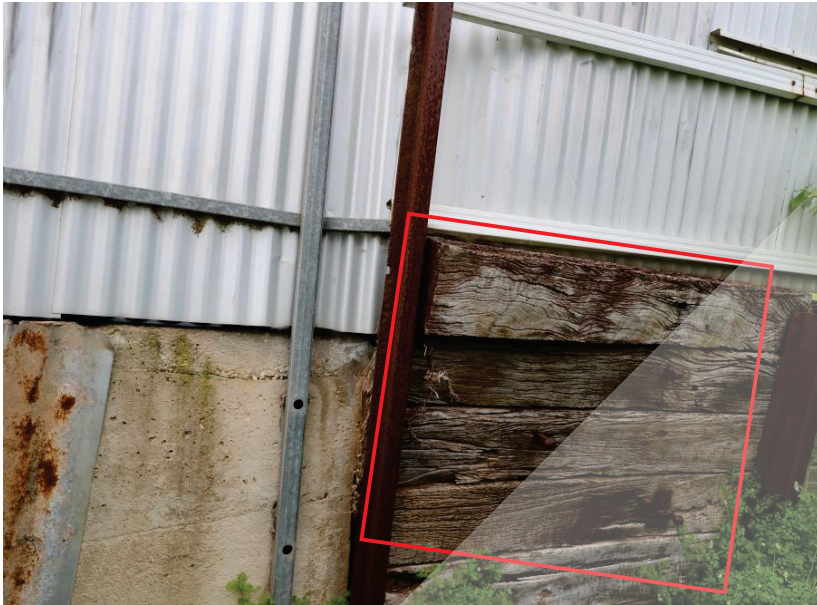
Figure 0004

Findings from the inspection	Photo number in the report (captured on 23 Sep 2025)	Photo number in the Pre-report	Potential Causes	Change that could be linked to the flooding event	Structural engineer's opinion
Bulging and movement of the timber paling	Fig.0004	Fig. 0074 in [REDACTED] (captured on 31 July 2023)	Aging timber materials	Unlikely	Timber aging results from prolonged exposure to environmental factors such as moisture variations, UV radiation, and biological decay (fungi, termites, rot), which weaken the timber's structural capacity over time. This process occurs independently of a specific flooding event, as it reflects cumulative weathering and material fatigue rather than damage induced by a single or recent water discharge incident.
Visible leaning and bulging in parts of the wall	Fig.0008	Fig. 0069 and Fig. 0074 in [REDACTED] (captured on 31 July 2023)	<p>a. The retained soil and potential accumulation of moisture behind the wall are likely exerting continuous lateral pressure. If subsurface drainage (e.g. agi pipe or weep holes) is inadequate or blocked, water buildup can increase pressure and cause gradual wall displacement.</p> <p>b. Variations in soil moisture—particularly after heavy rainfall or flooding—may have softened the foundation soil, leading to rotation or settlement of the post footings.</p>	Unlikely	<p>The leaning of the retaining wall was already documented in the 31 July 2023 inspection, and no noticeable change has been observed since then. The drainage system appears to be functioning properly, with no evidence of water pooling, soil scour, or recent movement. Therefore, the leaning is assessed as a pre-existing condition likely related to long-term material deterioration rather than the recent flooding event.</p>

Leaning in the east boundary fence. Showing movement in the paling.

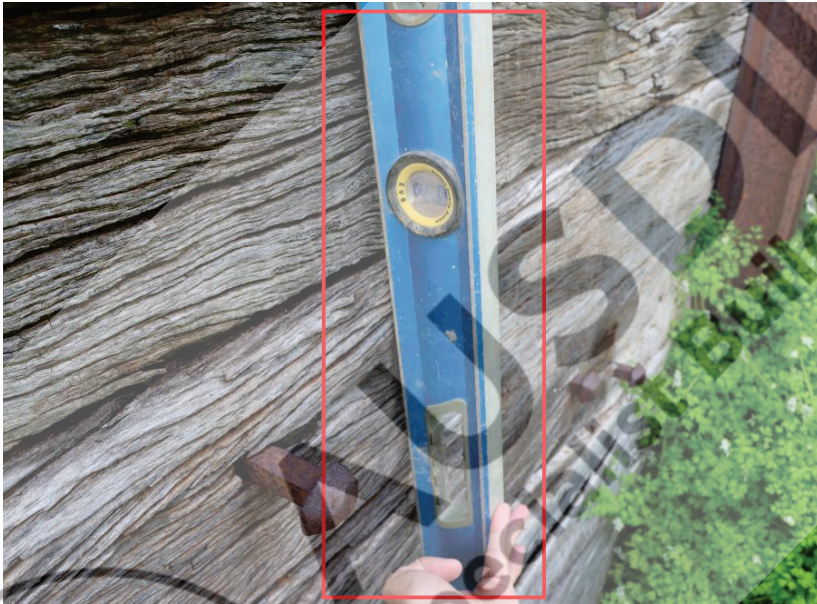
Figure 0005

Leaning in the east boundary fence.

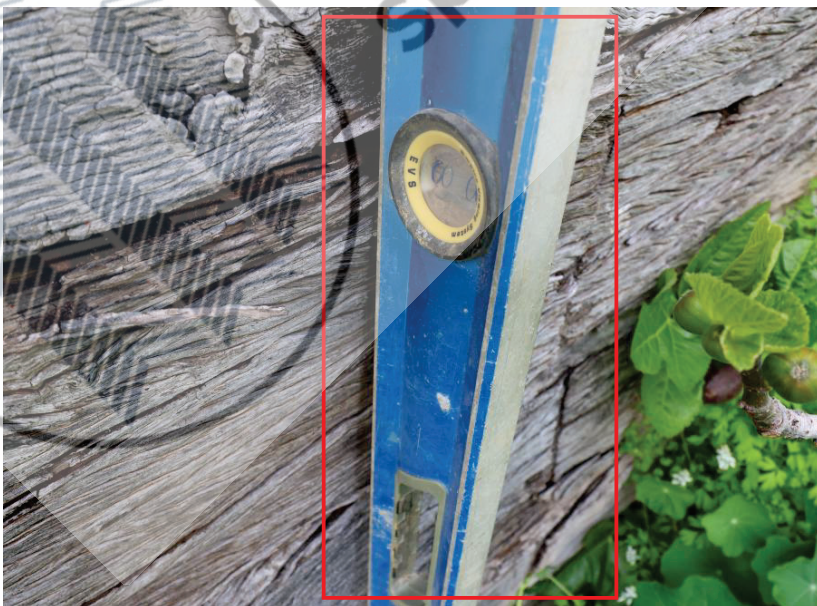
Figure 0006

Leaning in the east boundary fence.
