[REDACTED]
PRE-CONSTRUCTION GEOTAGGED CONDITION SURVEY

INSPECTION DATE: April 26, 2025
WEATHER: Clear, 17°C
DOCUMENT ID: [REDACTED]
INSPECTOR: Lawrence Ferrer
B.Sc (Eng) Civil Engineer
Civil Engineer
SITE SURVEYED: [REDACTED]
COMMISSIONED BY: [REDACTED]

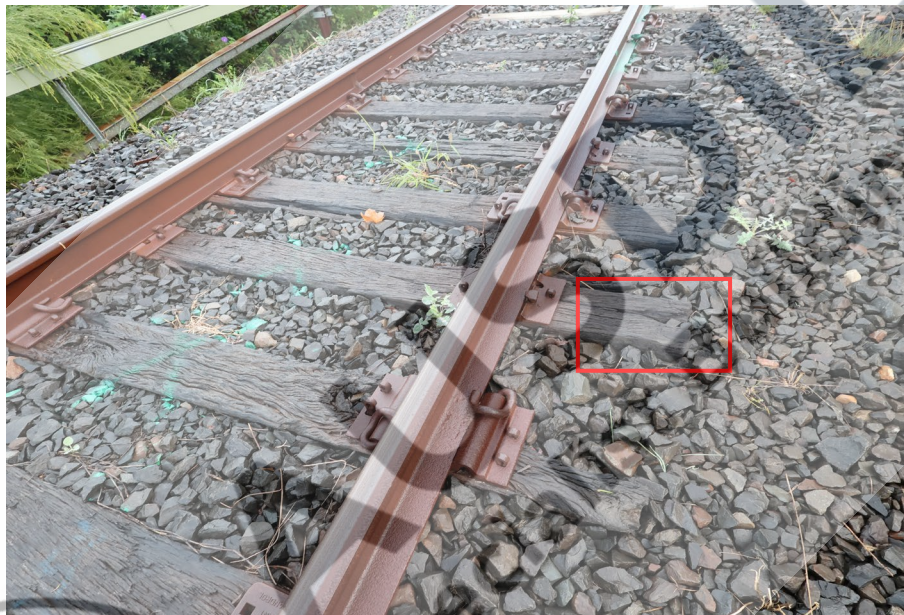
Figure No.	Description
Figure 0011	Chipping in the timber plank on the south side of the railway.
Figure 0013	Chipping in the timber plank on the south side of the railway.
Figure 0022	General view of the overhead structure NS 6+019 on the south side of the railway. Showing slight chipping on concrete footing.
Figure 0028	Chipping in the concrete plank on the south side of the railway.

Chipping in the timber plank on the south side of the railway.

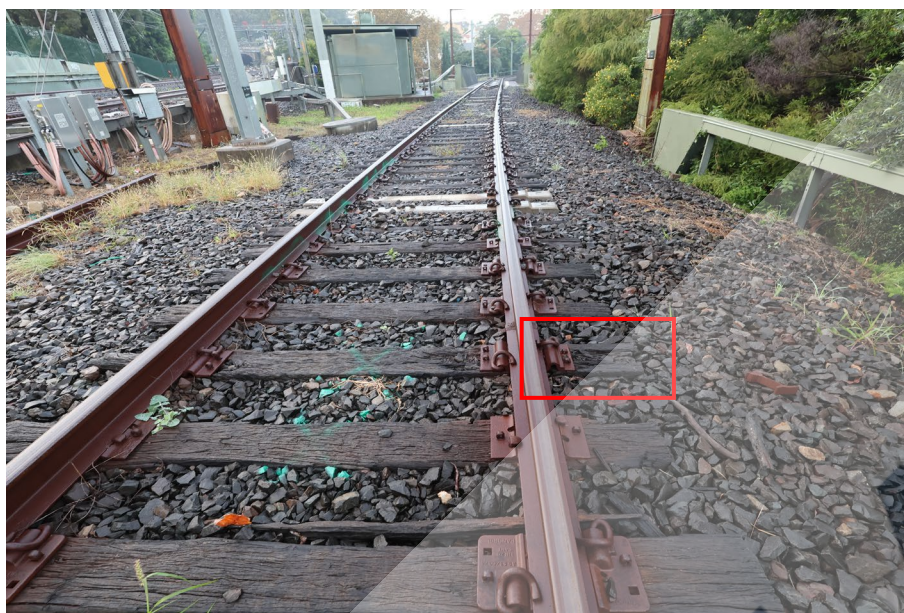
Figure 0013

Chipping in the timber plank on the south side of the railway.

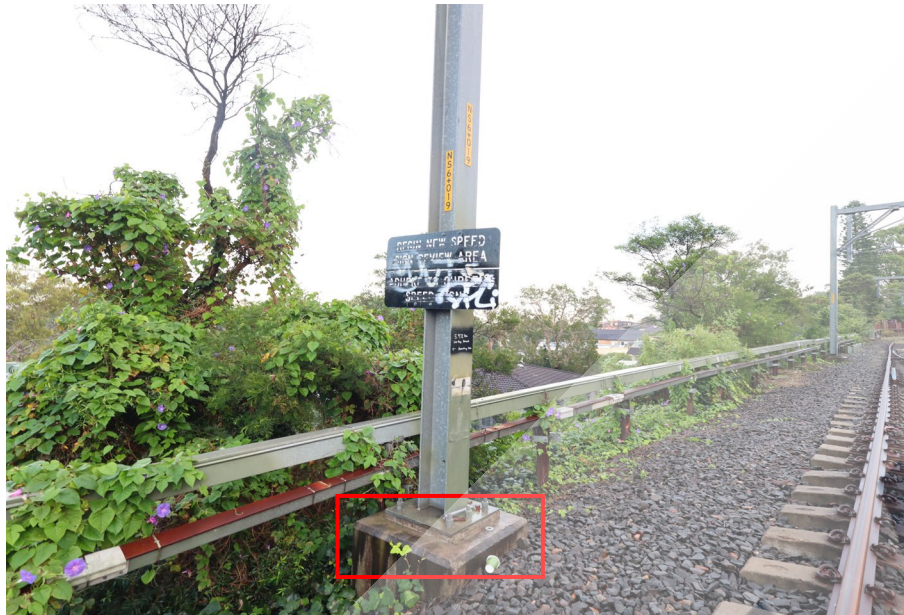
Figure 0022

General view of the overhead structure NS 6+019 on the south side of the railway. Showing slight chipping on concrete footing.

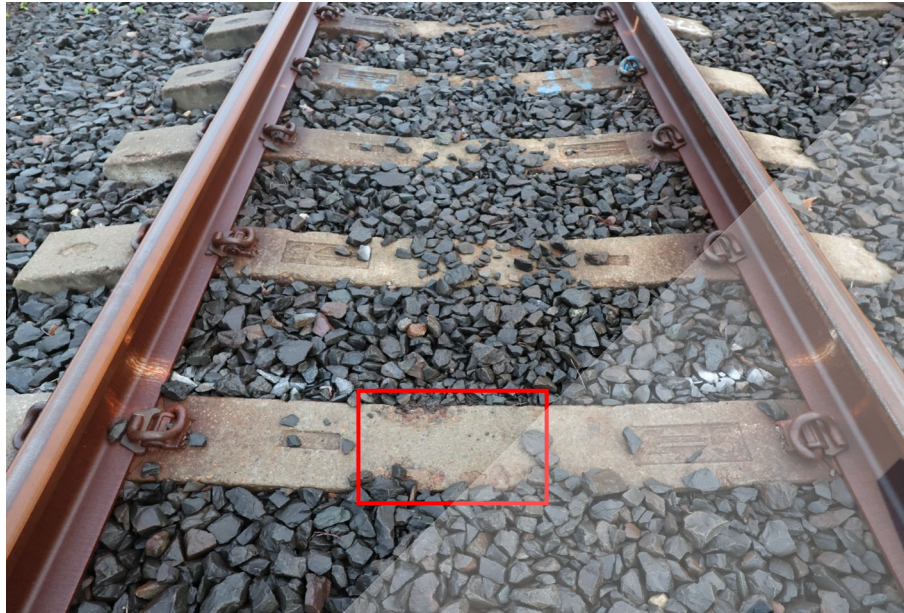
Figure 0028

Chipping in the concrete plank on the south side of the railway.
