AUSDILAPS

POST-CONSTRUCTION VIDEO CONDITION SURVEY DEFECT ANALYSIS

INSPECTION DATE: 25 March 2026

- Property Type: Council Assets
- Asset Type: Road

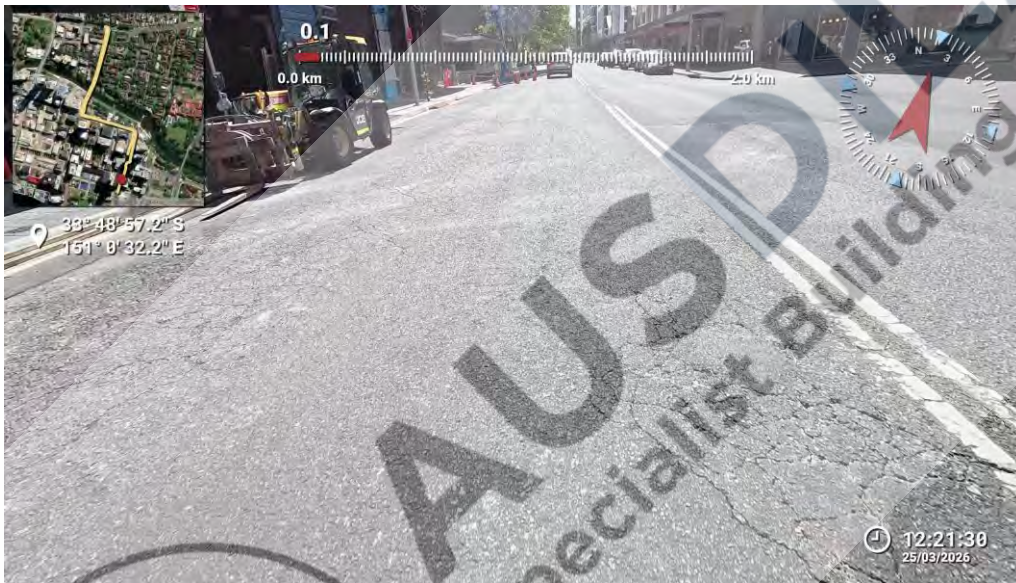
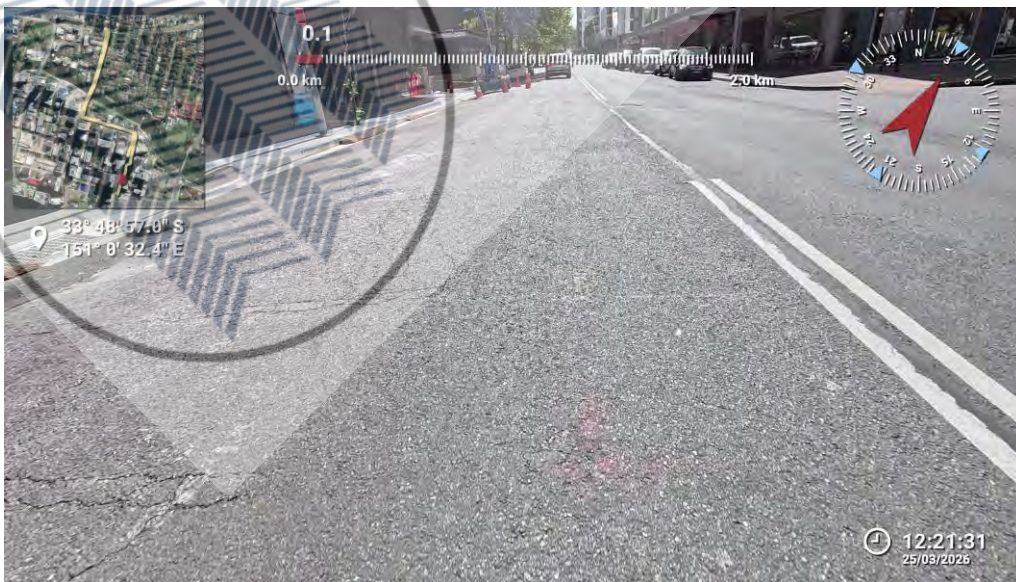
Figure 0011

Figure	Road Name	Direction	Defect	Classification	Condition Changes
0011-0012	Charles Street	North	Cracking - Alligator Cracking	Minor	Showing worsened condition
0014-0019	Charles Street	North	Cracking – Longitudinal Cracking	Minor	Showing worsened condition
0017	Charles Street	North	Cracking - Alligator Cracking	Minor	Showing worsened condition
0069-0071	Charles Street	North	Cracking – Longitudinal Cracking	Minor	Showing worsened condition
0117-0122	Phillip Street	West	Cracking – Longitudinal Cracking	Minor	Showing worsened condition
0123	Phillip Street	West	Cracking – Transverse Cracking	Minor	Showing worsened condition
0125	Phillip Street	West	Cracking – Transverse Cracking	Minor	Showing worsened condition
0152	Phillip Street	West	Cracking – Transverse Cracking	Minor	Showing worsened condition
0159	Wilde Avenue	North	Cracking - Alligator Cracking	Minor	Showing worsened condition
0161	Wilde Avenue	North	Cracking – Longitudinal Cracking	Minor	Showing worsened condition
