## PROPERTY CONDITION SURVEY - COMMERCIAL

AusDilaps was commissioned by XXXXXXXXXXXXXXXX to carry out pre-construction condition inspection and report in accordance with AS.4349.1 for the XXXXXXXXXXXXXXXX project.

Newtown Rail Corridor NEWTOWN NSW 2042

# NEWTOWN Rail Corridor Station Street

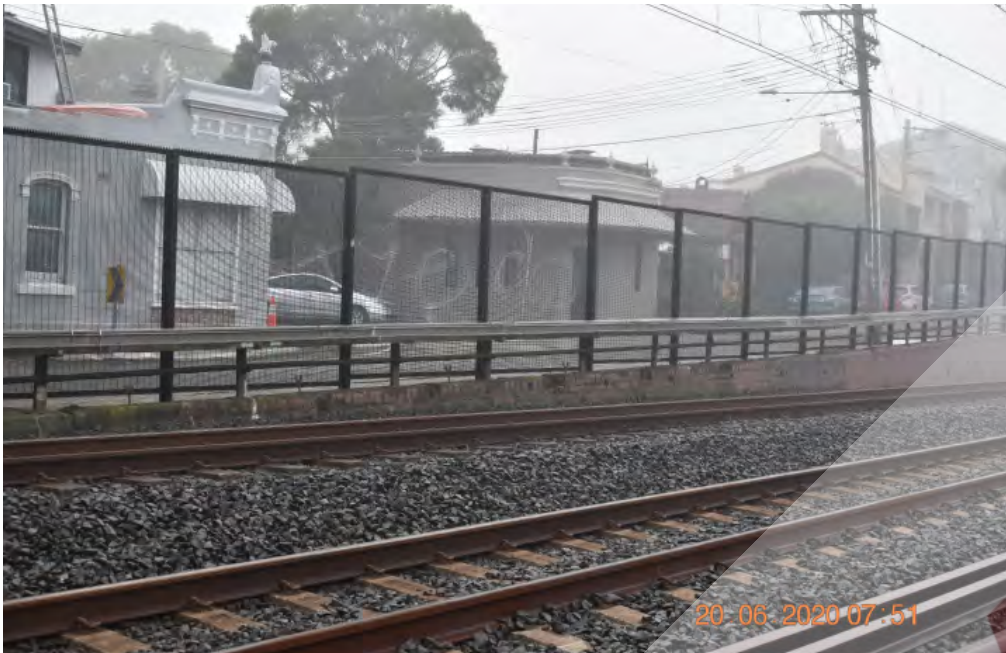
Figure: 0086

| Damage in the pit lid between the suburban up-track and the main down-track, at approximately 5 metres east of chainage 3+382. | 41 |

Damage in the pit lid between the suburban up-track and the main down-track, at approximately 5 metres east of chainage 3+382.

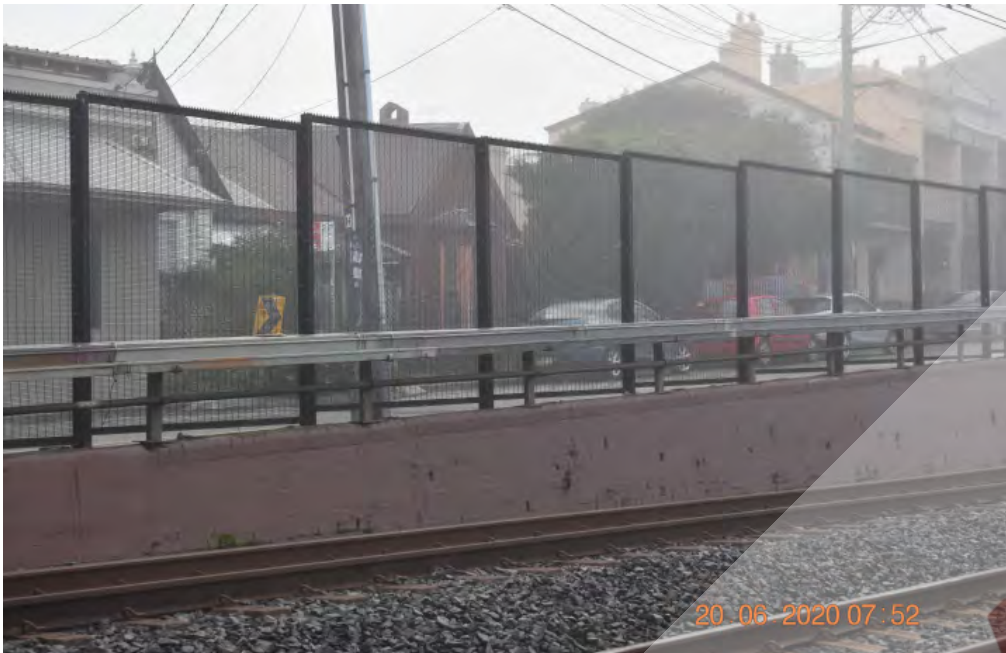
Figure: 0098

| Damage in the retaining wall along the main up-track, looking northeast from approximately 15 metres east of chainage 3+382. | 45 |

Damage in the retaining wall along the main up-track, looking northeast from approximately 15 metres east of chainage 3+382.

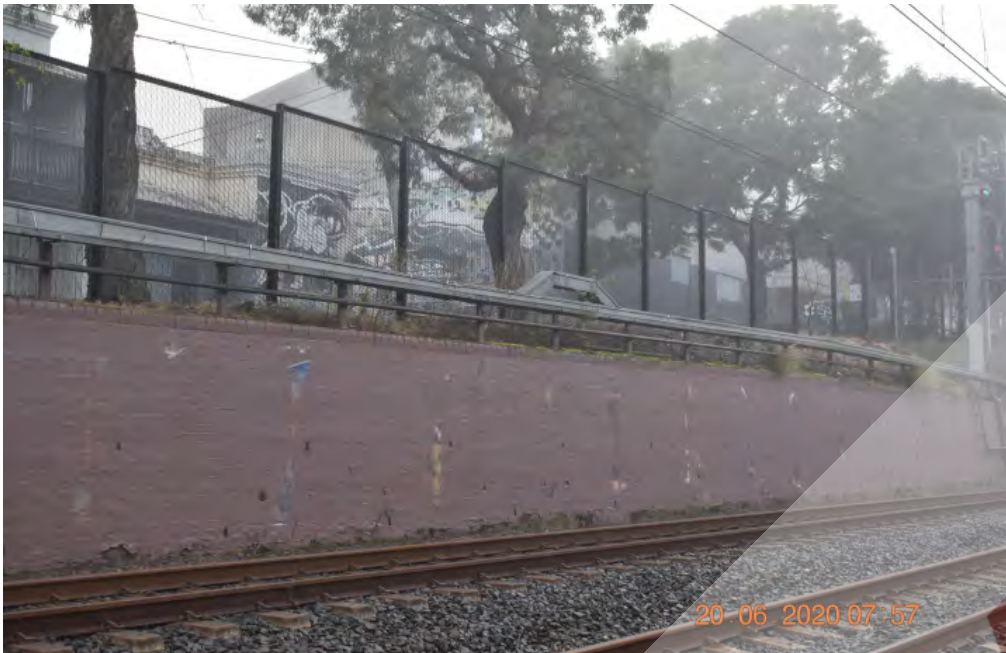
Figure: 0137

| Missing bricks in the retaining wall along the main up-track, looking northeast from chainage 3+312. | 58 |

Missing bricks in the retaining wall along the main up-track, looking northeast from chainage 3+312.

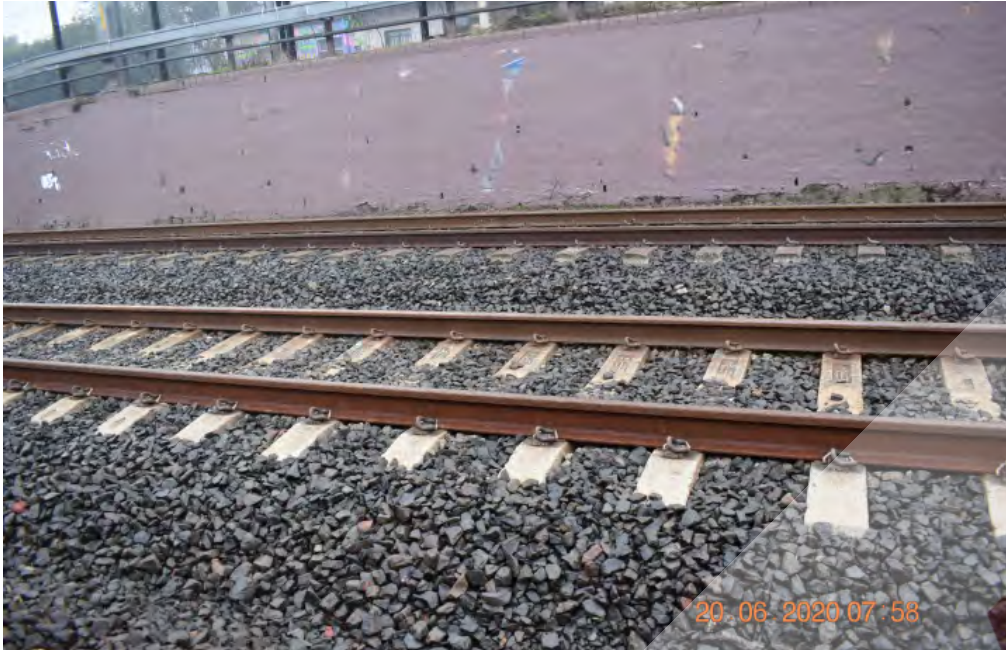
Figure: 0145

General view of the main up-track and down-track, looking northwest from approximately 15 metres east of chainage 3+312.

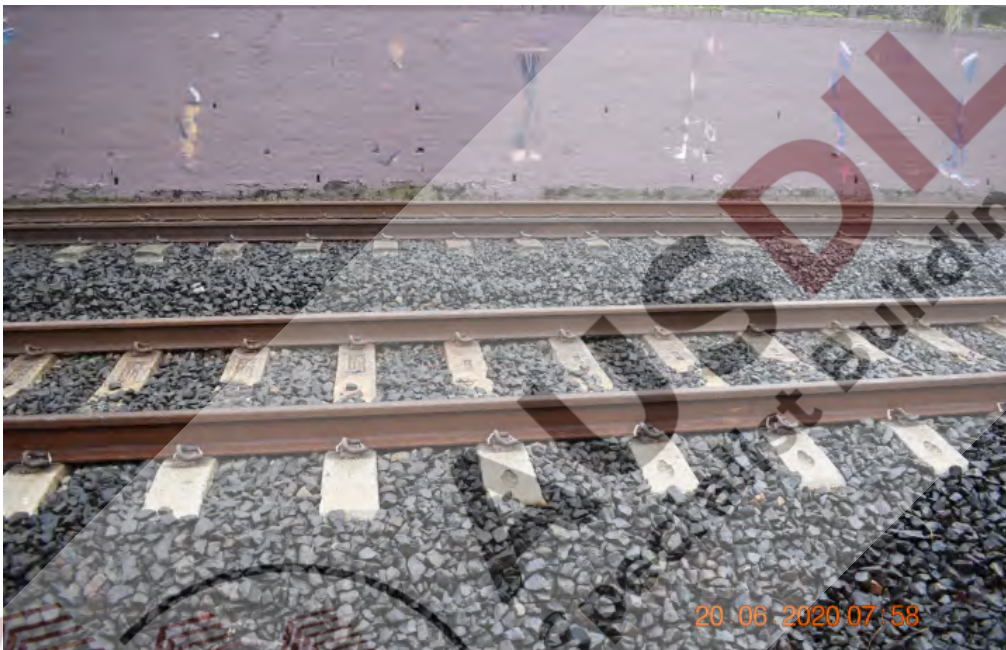
Figure: 0146

General view of the main up-track and down-track, looking north from approximately 15 metres east of chainage 3+312.

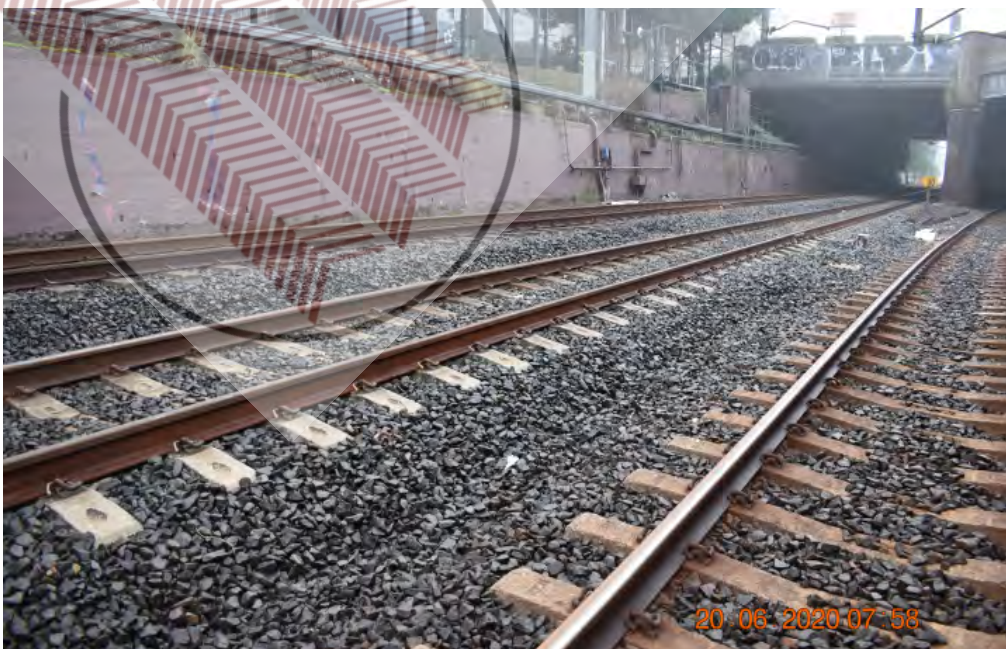
Figure: 0147

General view of the main up-track and down-track, looking northeast from approximately 15 metres east of chainage 3+312.

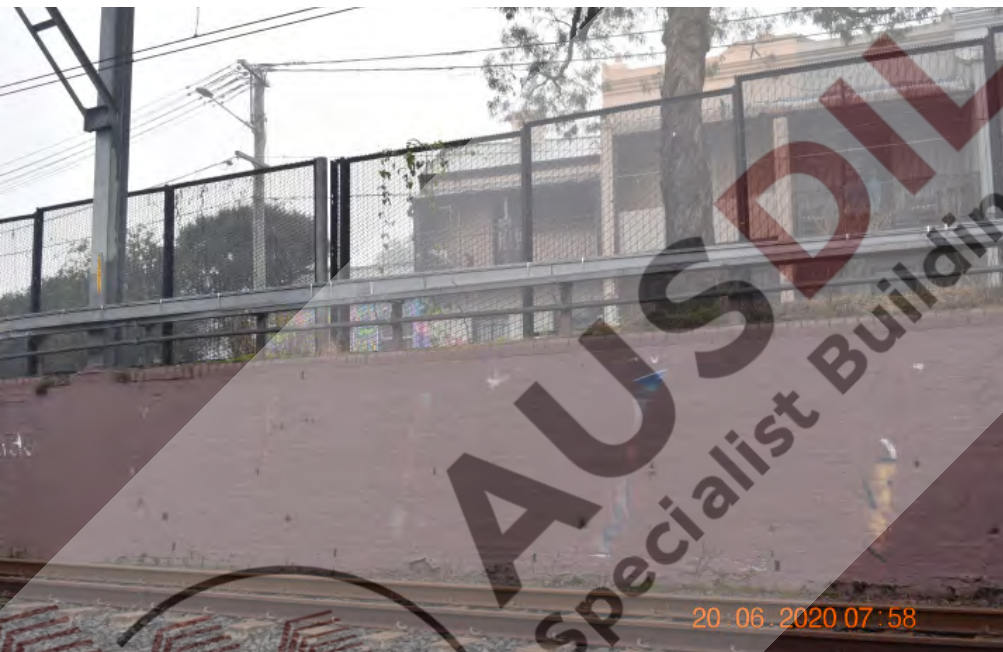
Figure: 0148

General view of the fence and retaining wall along the main up-track, looking northwest from approximately 15 metres east of chainage 3+312.

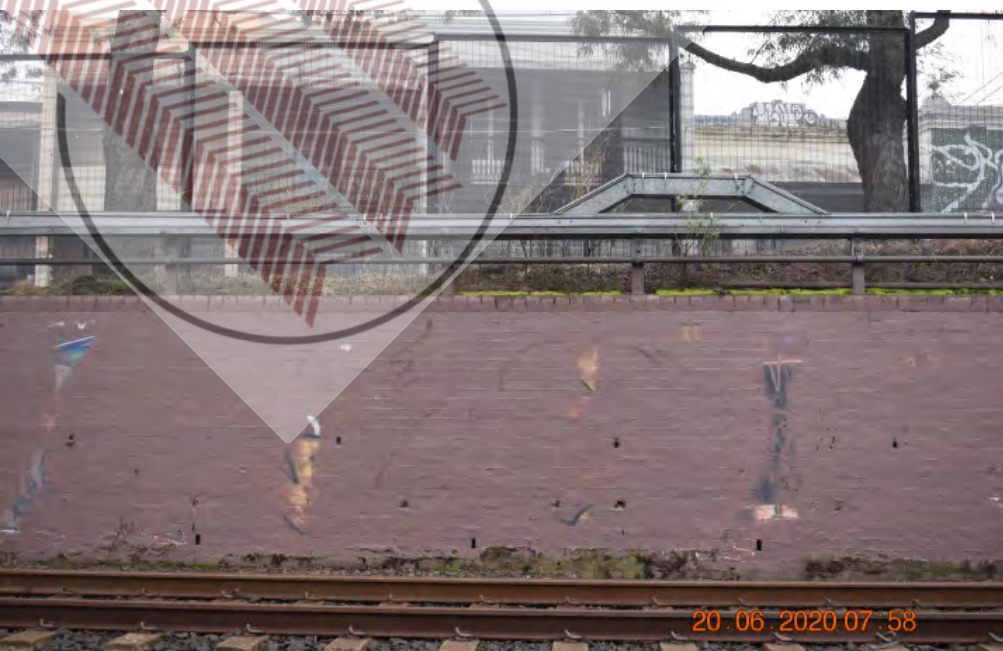
Figure: 0149

General view of the fence and retaining wall along the main up-track, looking northwest from approximately 15 metres east of chainage 3+312.

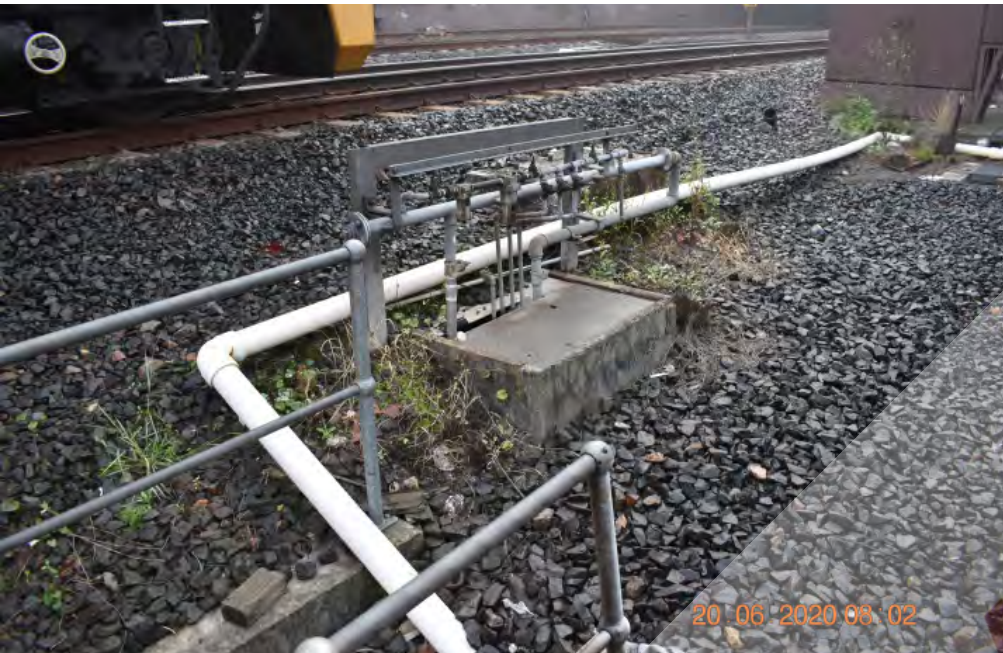
Figure: 0174

General view of the drainage pit between the suburban down-track and local up-track, at approximately 10 metres west of chainage 3+276.

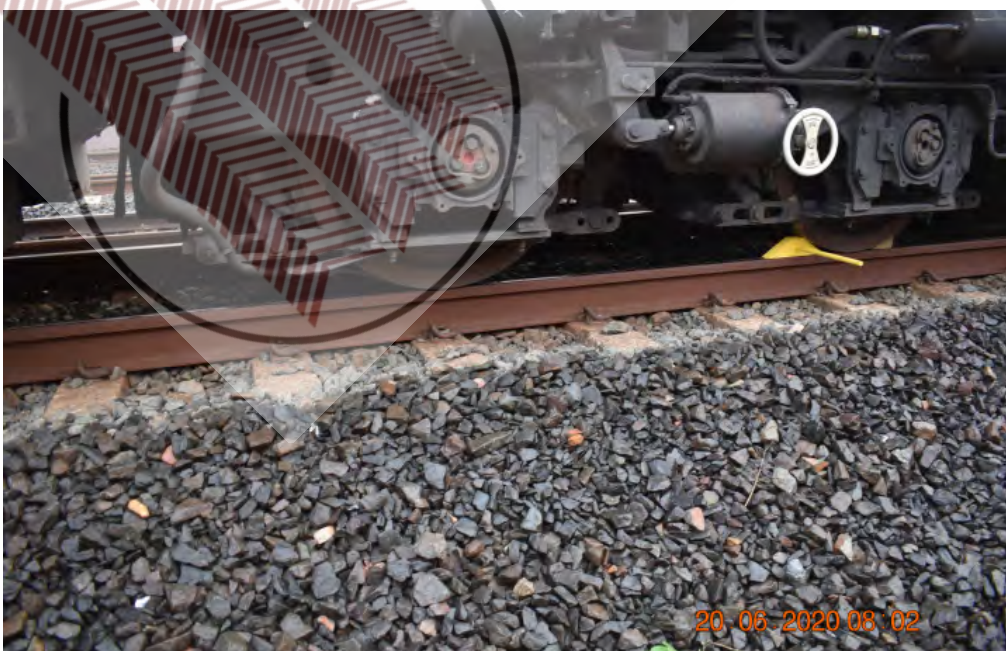
Figure: 0176

General view of the suburban down-track, looking north from approximately 10 metres west of chainage 3+276. Showing obstructed view.

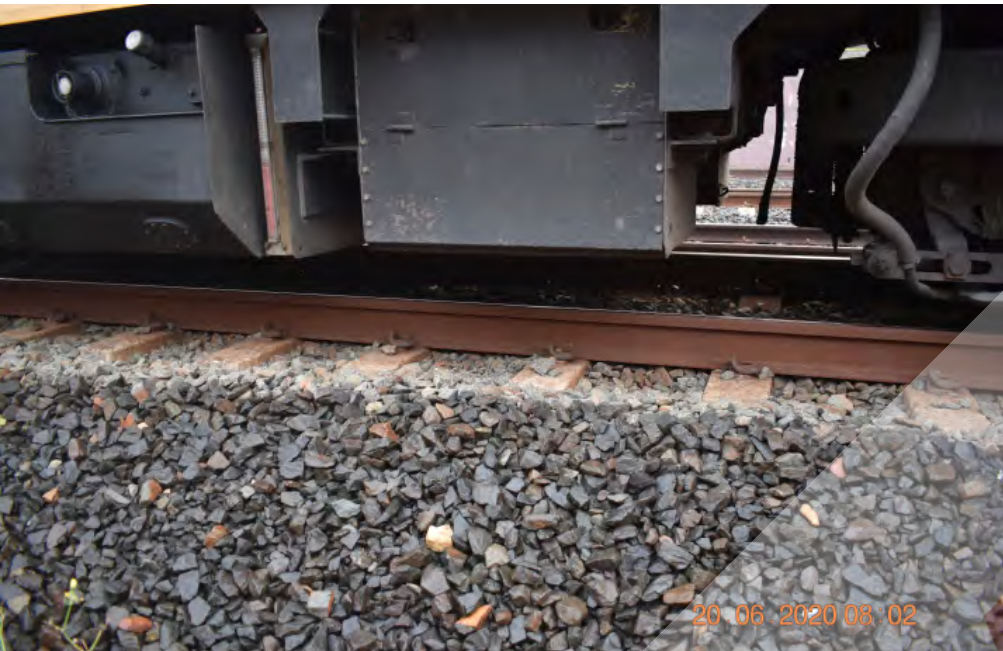
Figure: 0177

General view of the suburban down-track, looking north from approximately 10 metres west of chainage 3+276. Showing obstructed view.

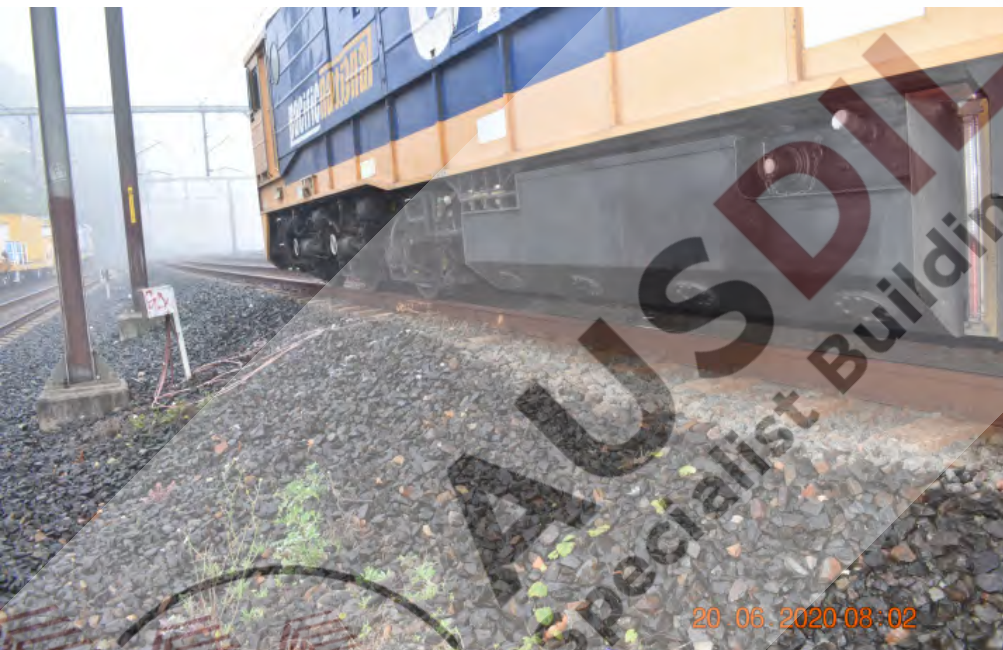
Figure: 0178

General view of the suburban down-track, looking north from approximately 10 metres west of chainage 3+276. Showing obstructed view.

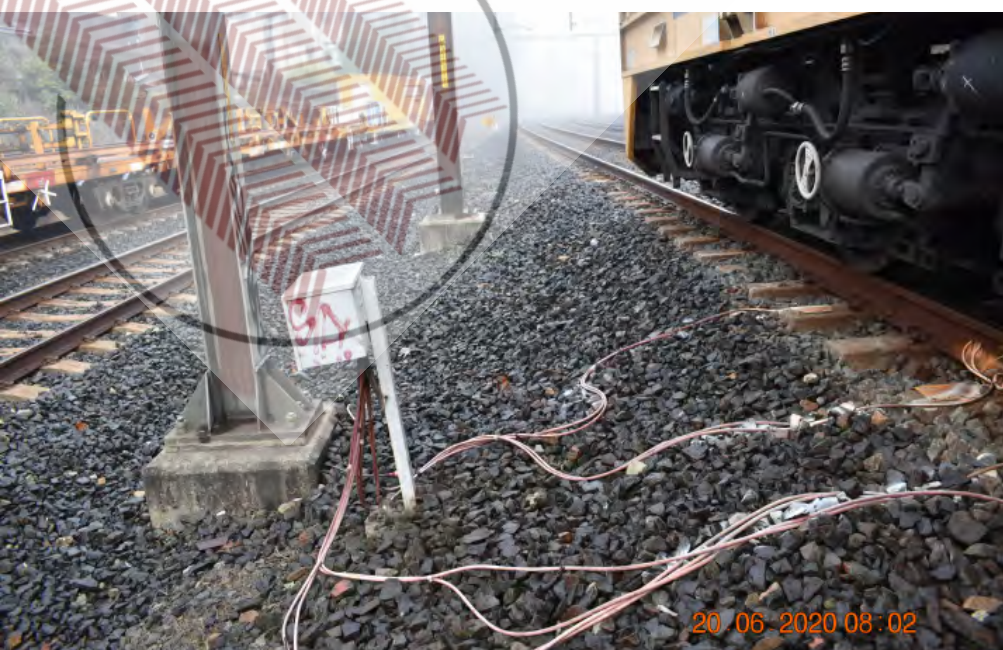
Figure: 0179

General view of the suburban down-track, looking north from approximately 10 metres west of chainage 3+276. Showing obstructed view.

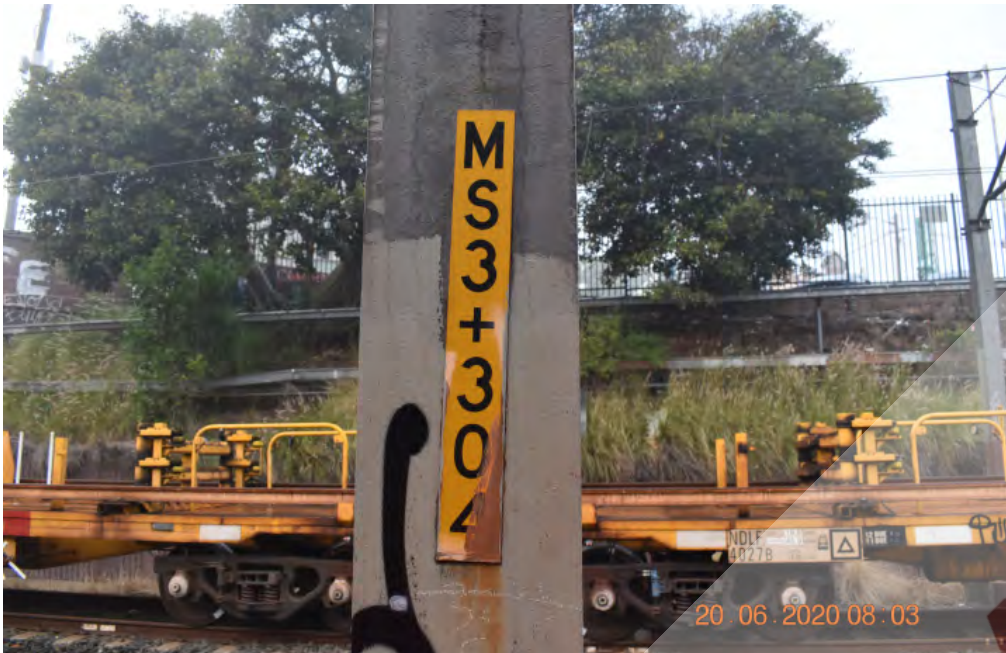
Figure: 0181

General view of the sign for chainage 3+304.

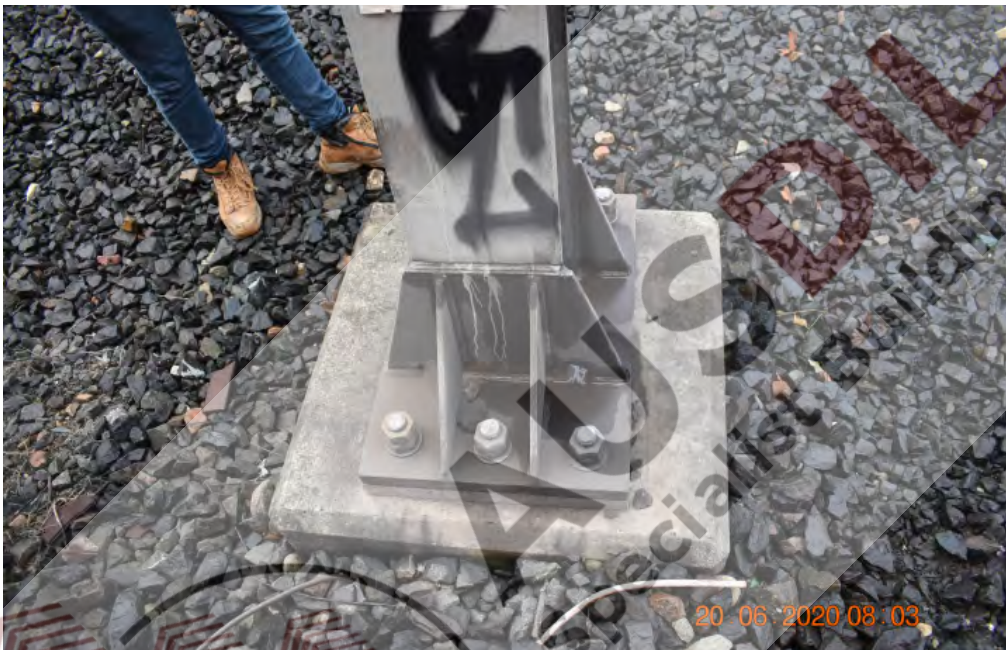
Figure: 0182

General view of the overhead power line post between the local up-track and the suburban down-track, at chainage 3+304.

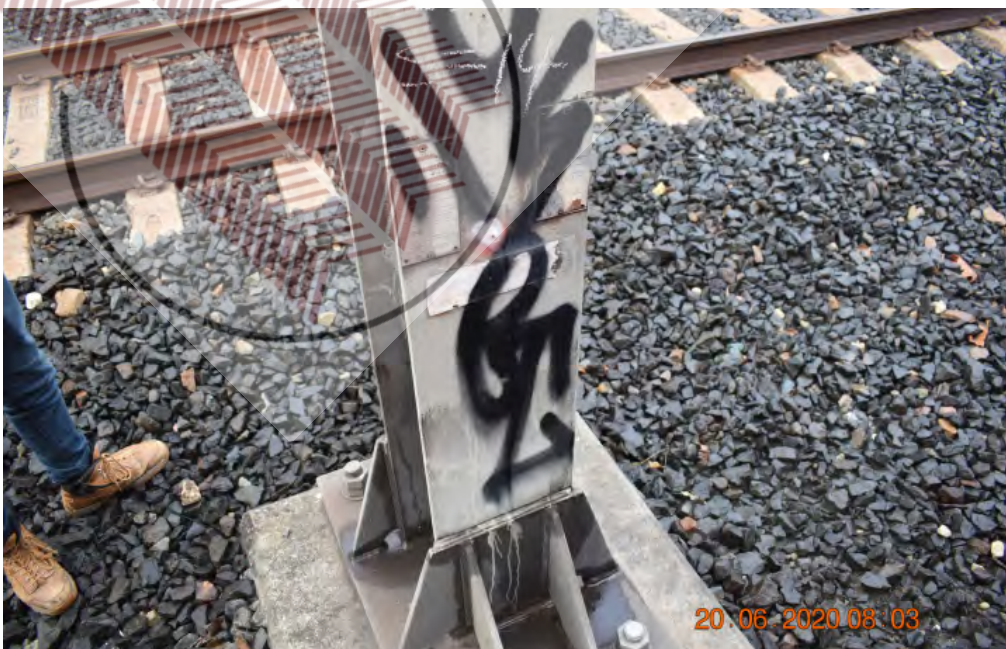
Figure: 0183

General view of the overhead power line post between the local up-track and the suburban down-track, at chainage 3+304.

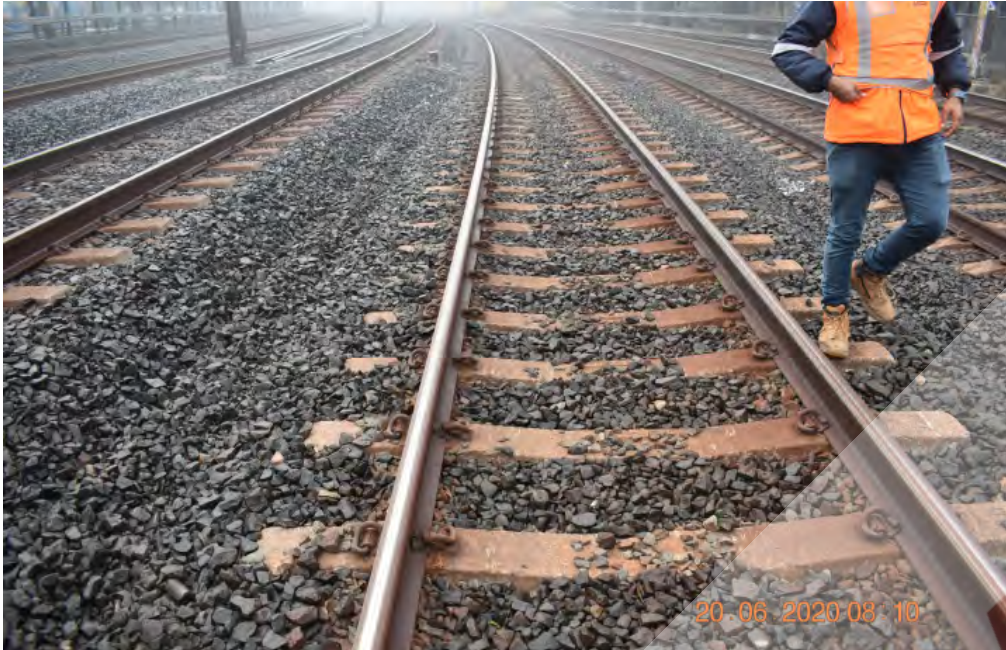
Figure: 0229

General view of the suburban down-track, looking east from approximately 15 metres west of chainage 3+456.

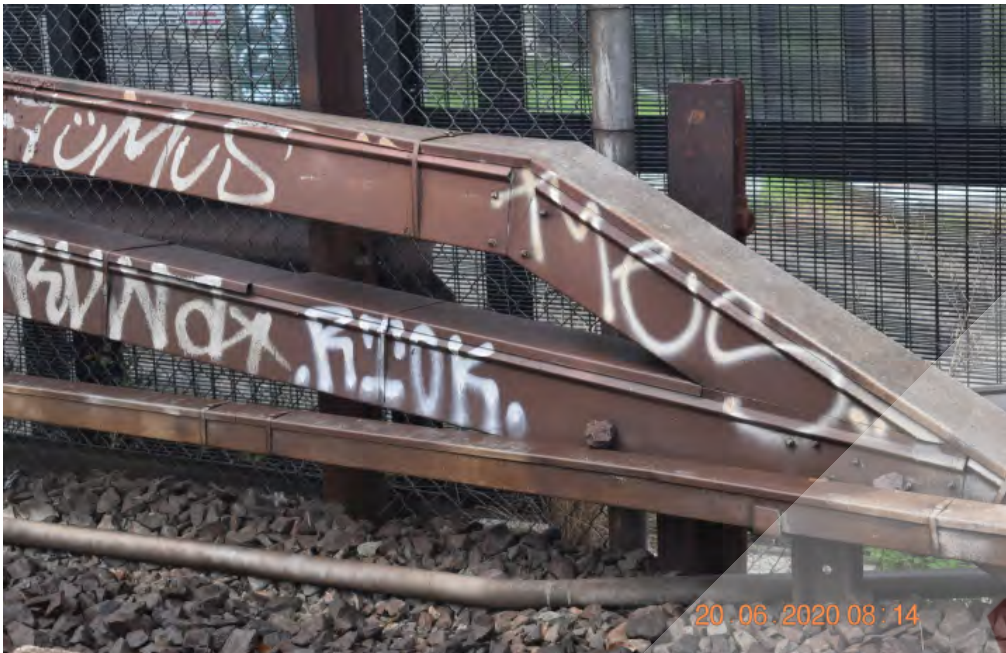
Figure: 0280

General view of the services along the local down-track, at approximately 20 metres east of chainage 3+491.

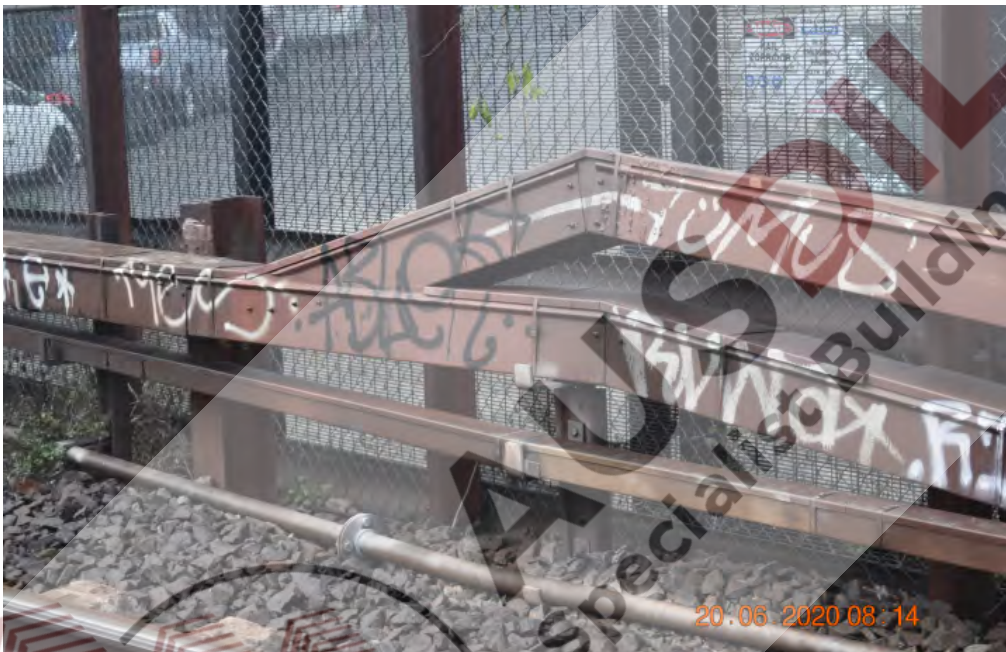
Figure: 0281

General view of the services along the local down-track, at approximately 20 metres east of chainage 3+491.

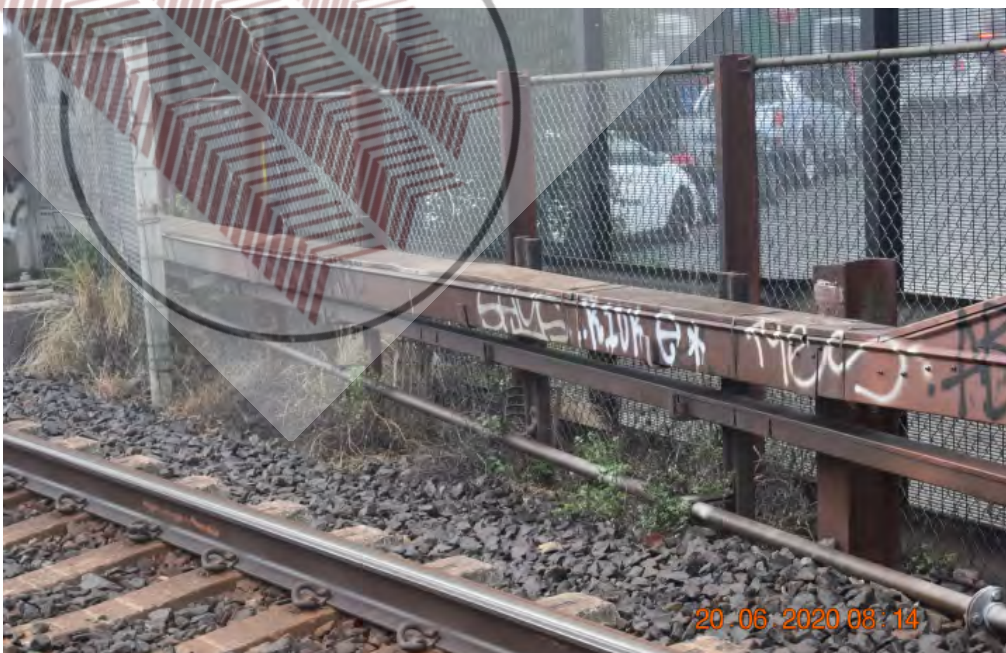
Figure: 0282

General view of the services along the local down-track, at approximately 20 metres east of chainage 3+491.

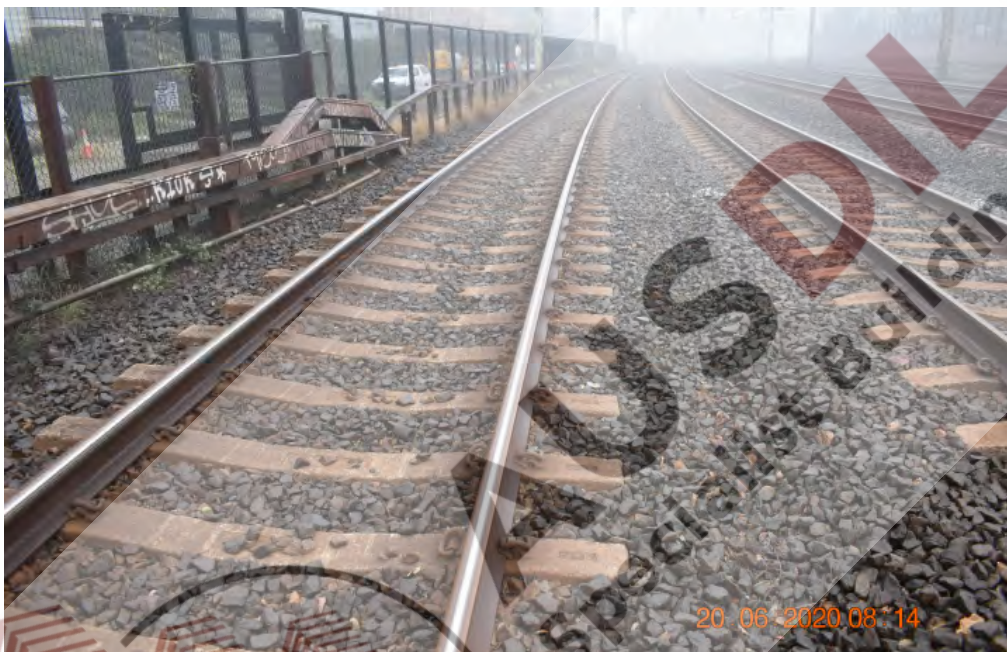
Figure: 0286

General view of the wires between the local up-track and suburban down-track, at chainage 3+456.

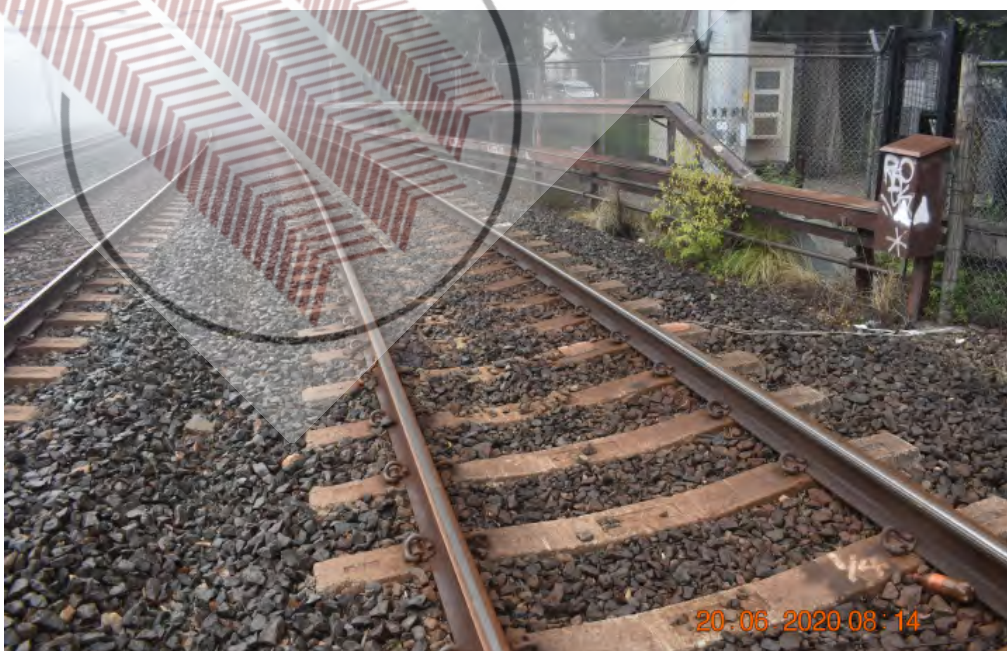
Figure: 0287

General view of the local down-track, looking west from chainage 3+456.

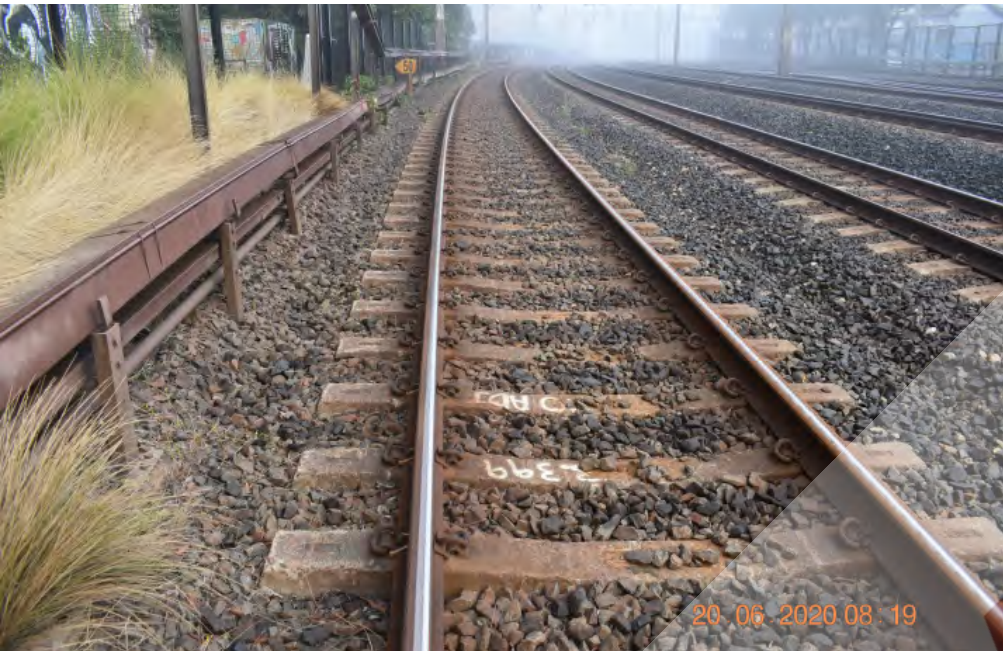
Figure: 0288

General view of the local down-track, looking east from chainage 3+456.

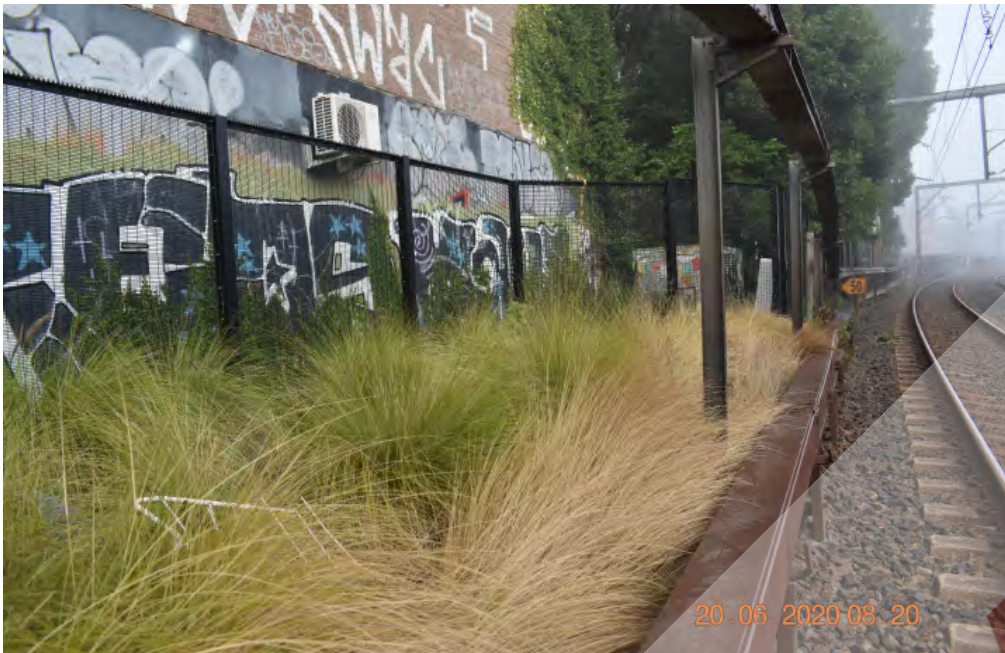
Figure: 0361

General view of the fence along the local down-track, looking southwest from chainage 3+382. Showing obstructed view.

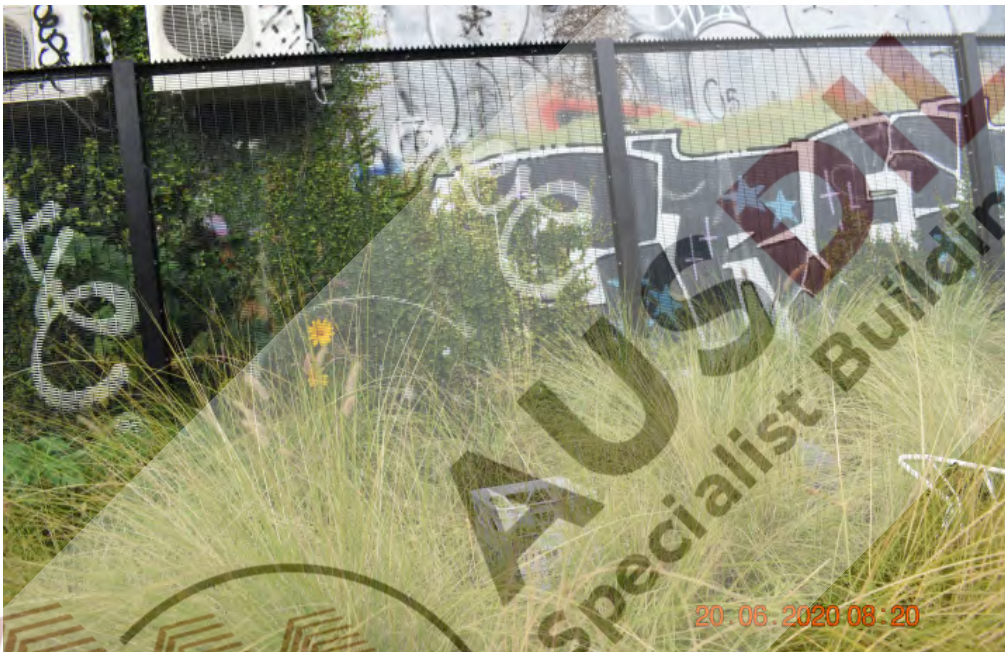
Figure: 0362

General view of the fence along the local down-track, looking south from chainage 3+382. Showing obstructed view.

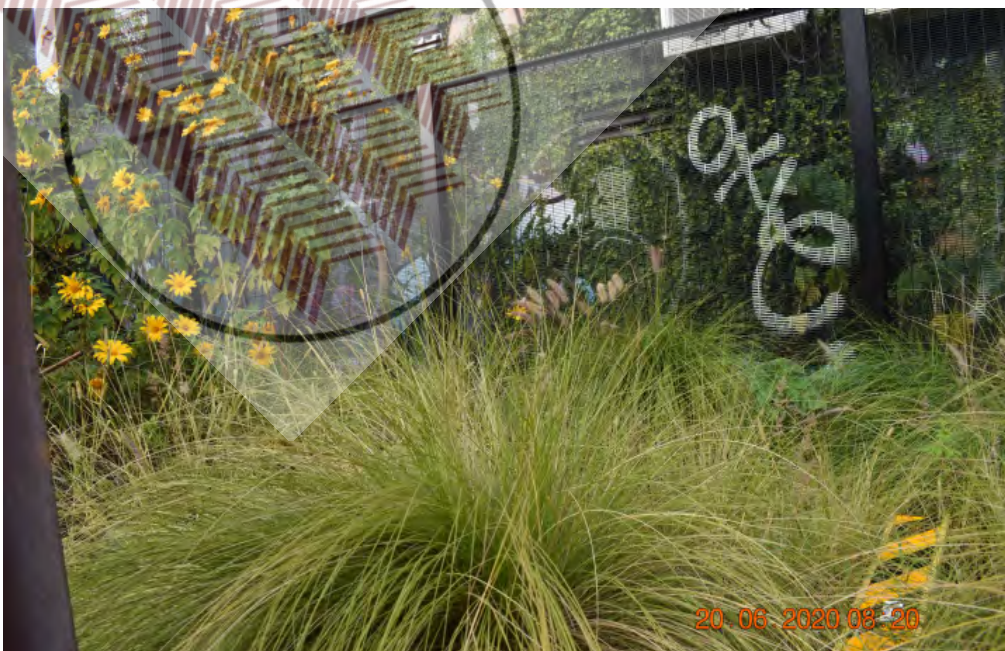
Figure: 0363

General view of the fence along the local down-track, looking southeast from chainage 3+382. Showing obstructed view.

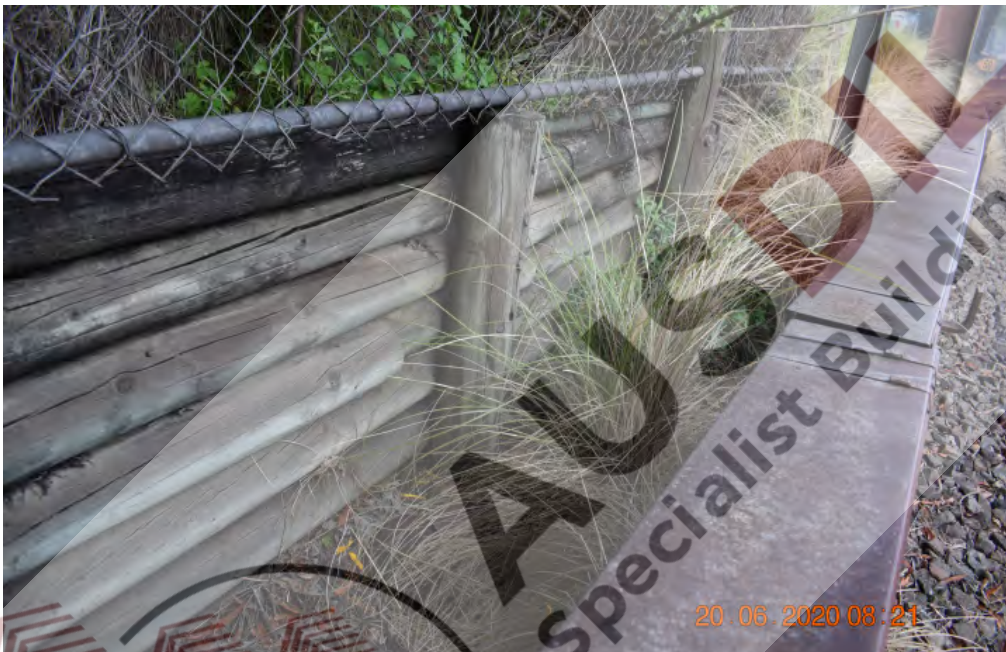
Figure: 0371

General view of the timber retaining wall along the local down-track, at approximately 5 metres east of chainage 3+382.

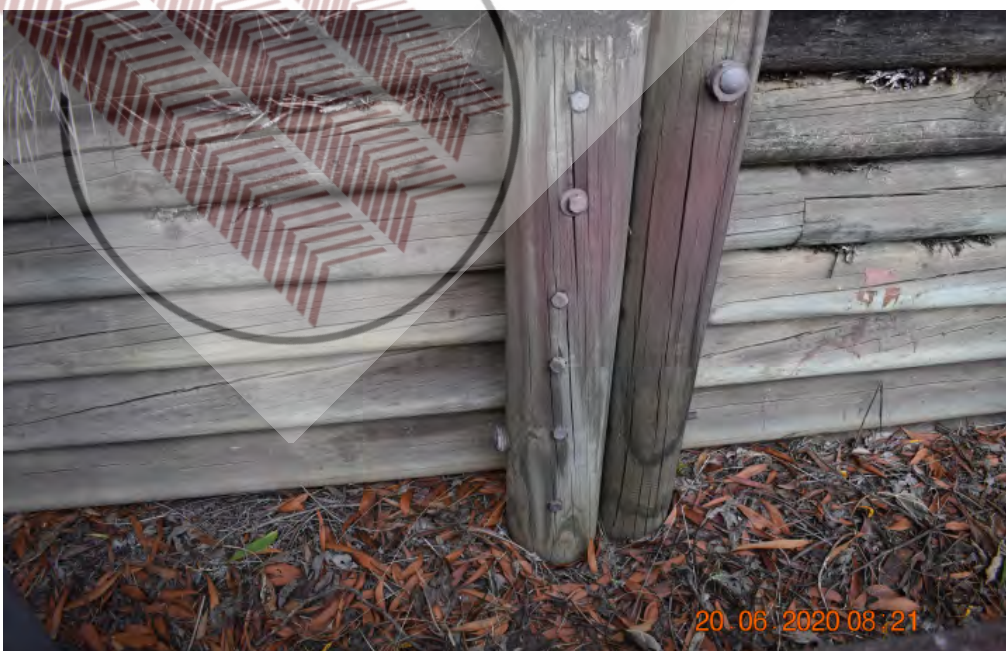
Figure: 0372

General view of the timber retaining wall along the local down-track, at approximately 5 metres east of chainage 3+382.

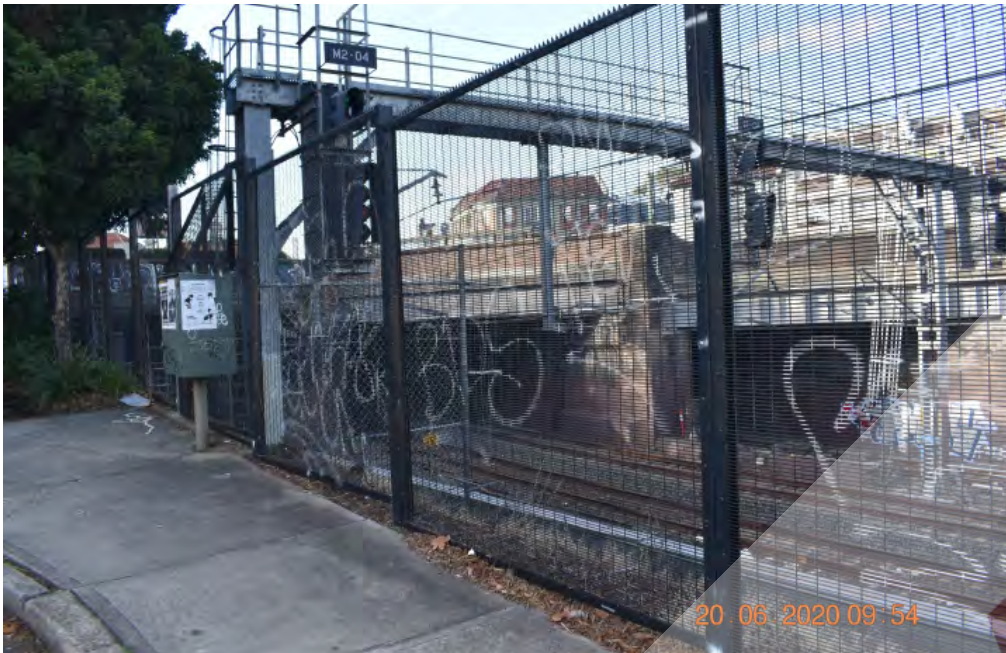
Figure: 0658

General view of the base of the north fence, looking south-east from approximately 20 metres east of chainage 3+312.

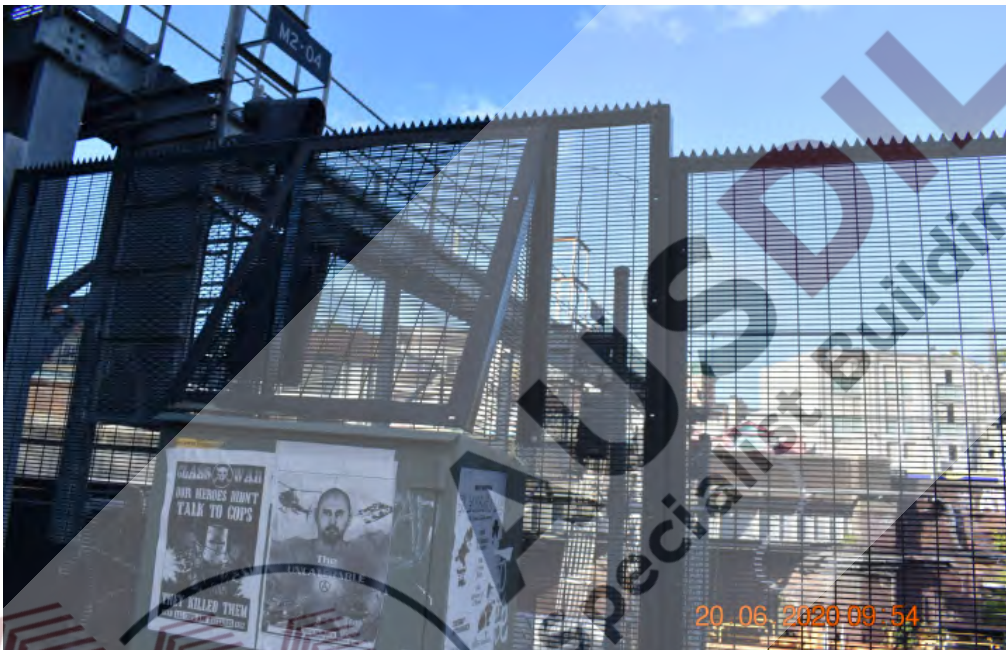
Figure: 0659

General view of the switchboard box along the north fence, at approximately 25 metres east of chainage 3+312.

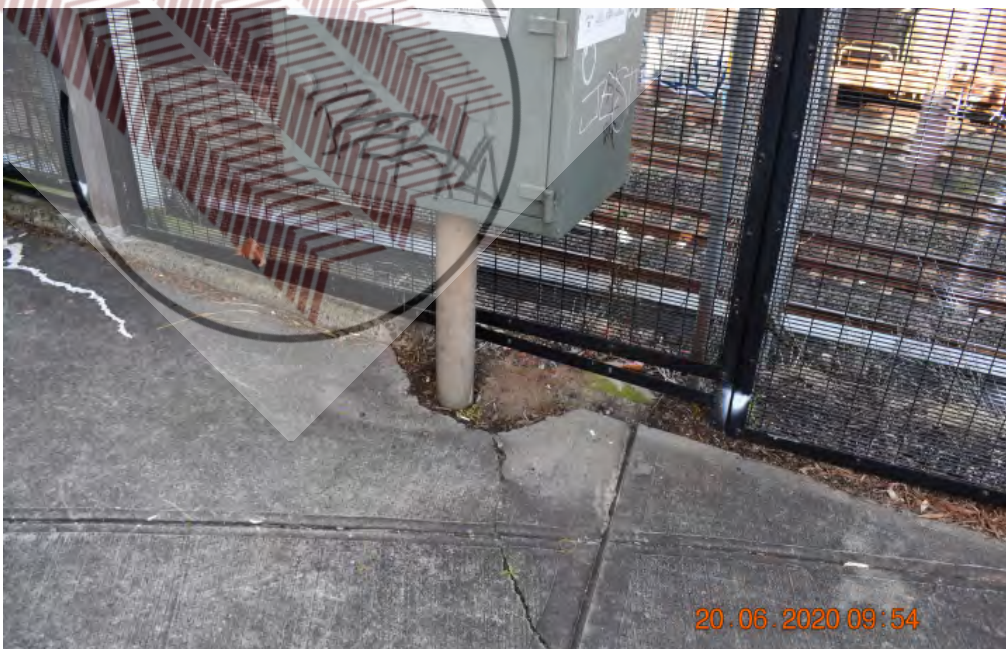
Figure: 0660

General view of the switchboard box along the north fence, at approximately 25 metres east of chainage 3+312.
