PROPERTY CONDITION SURVEY - COMMERCIAL

AustDilaps was commissioned by {Client Name} to carry out a pre-construction condition inspection and report in accordance with AS.4349.1 for the {Project Name}

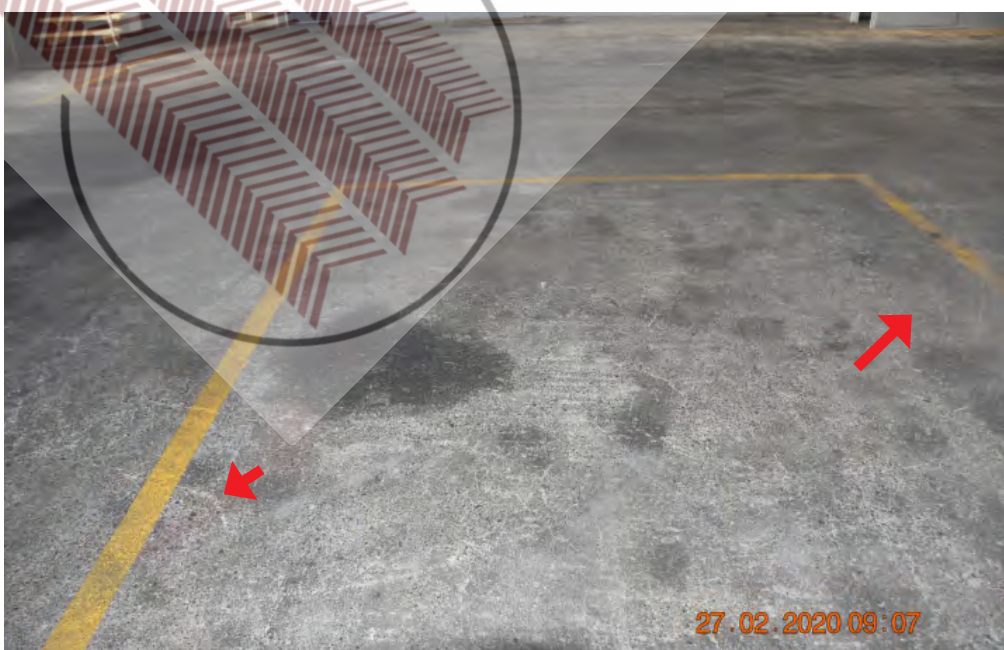
Figure: 0003

Cracking showing in the concrete flooring in the warehouse.

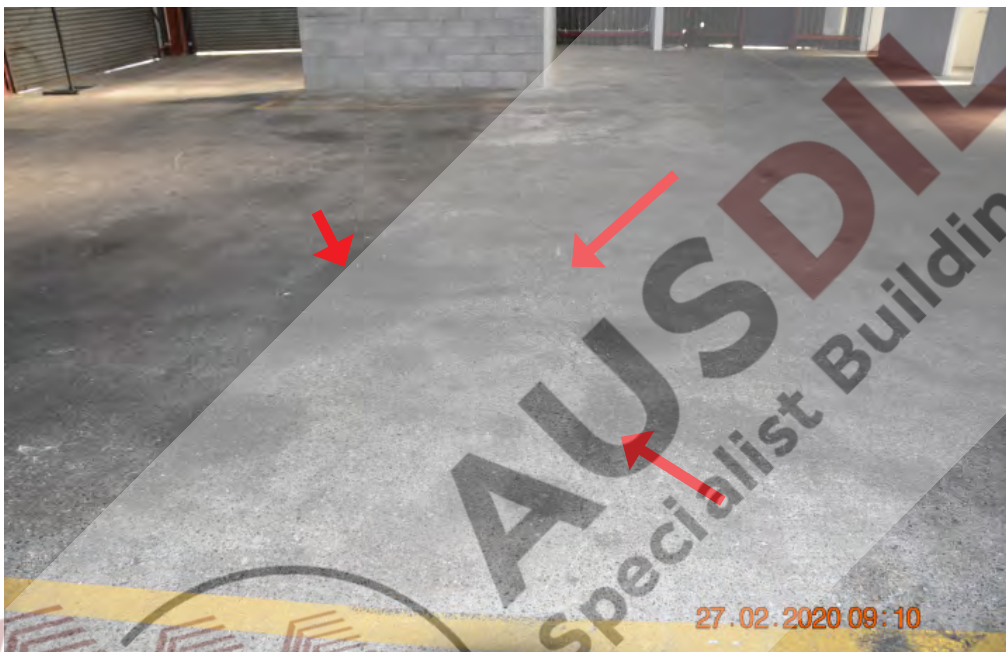
Figure: 0014

Cracking in the concrete flooring in the warehouse.

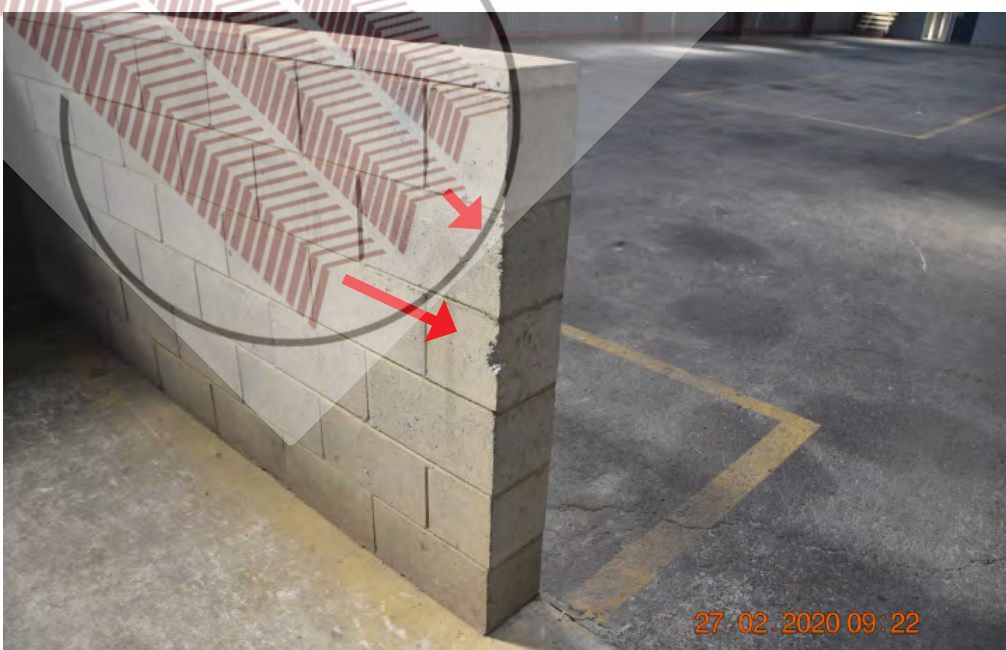
Figure: 0066

Chipping in the brick wall in the warehouse.

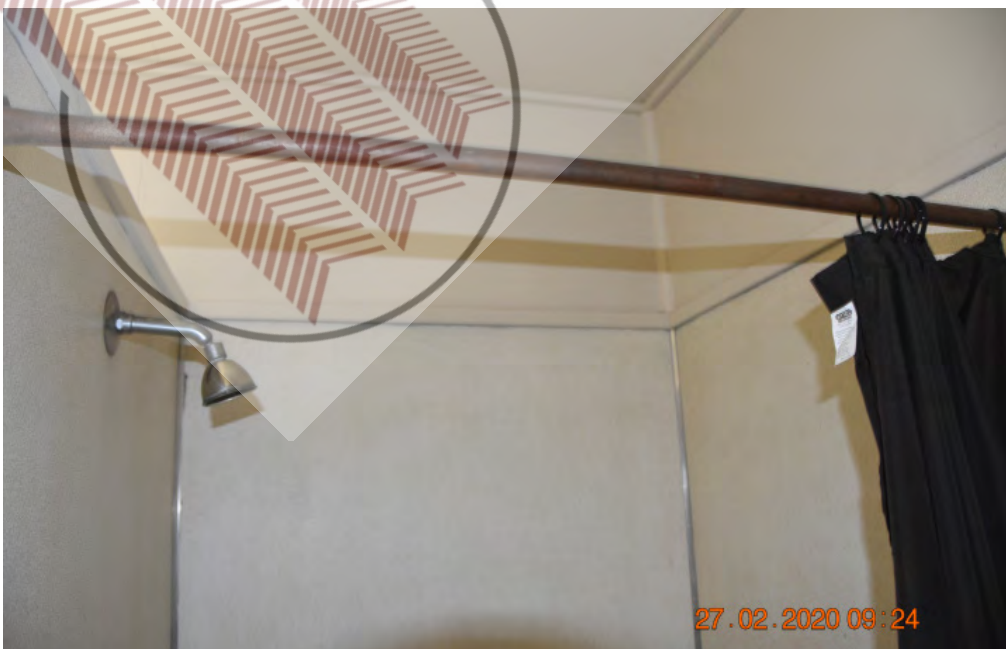
Figure: 0069

Right wall in the shower room, front side.

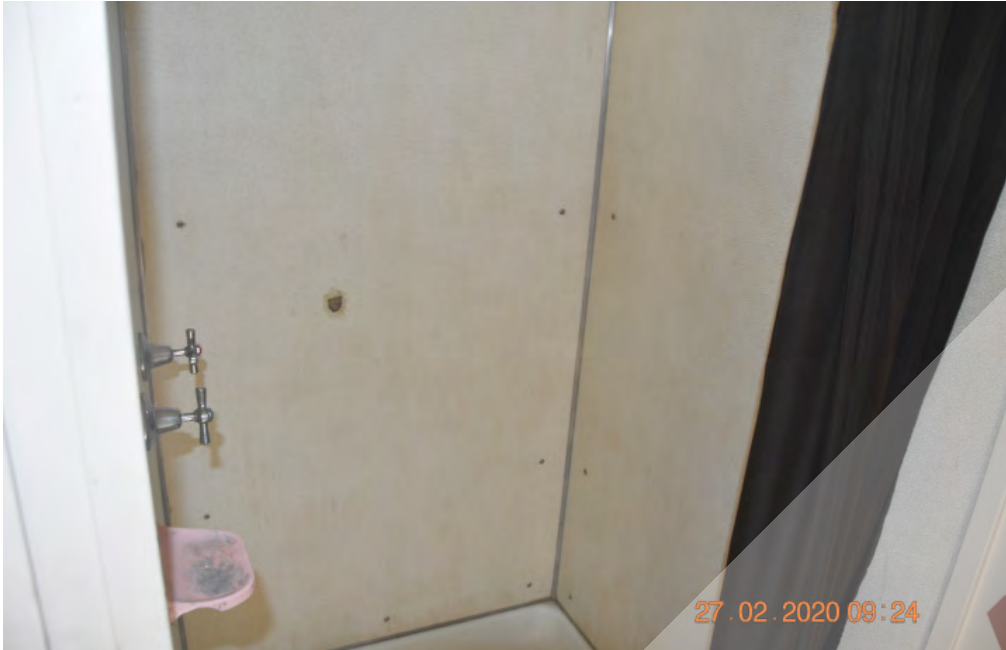
Figure: 0070

Right wall in the shower room, front side.

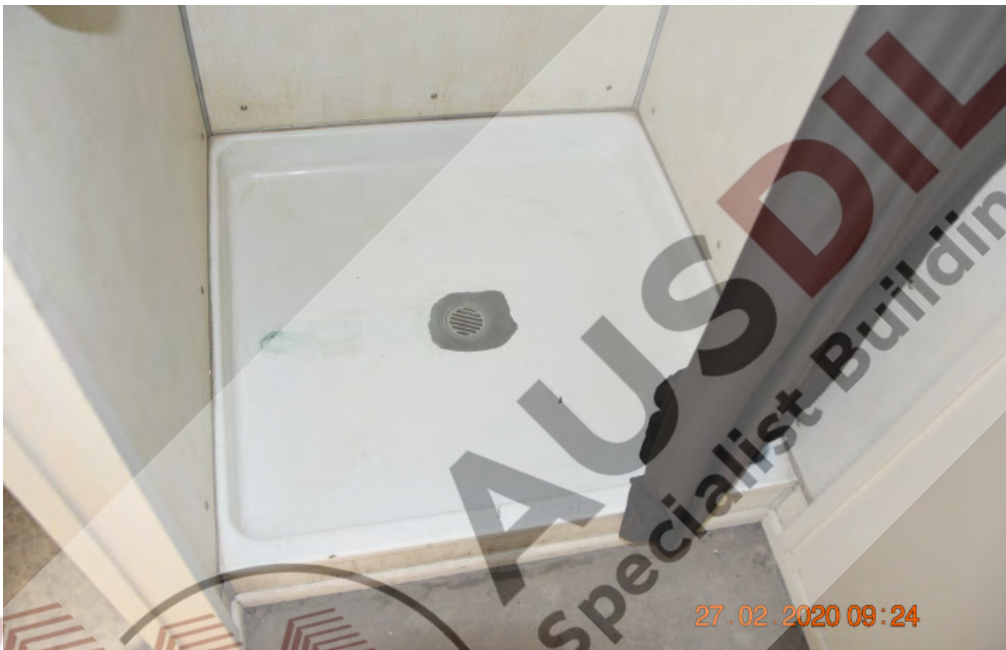
Figure: 0071

Flooring in the shower room, front side.

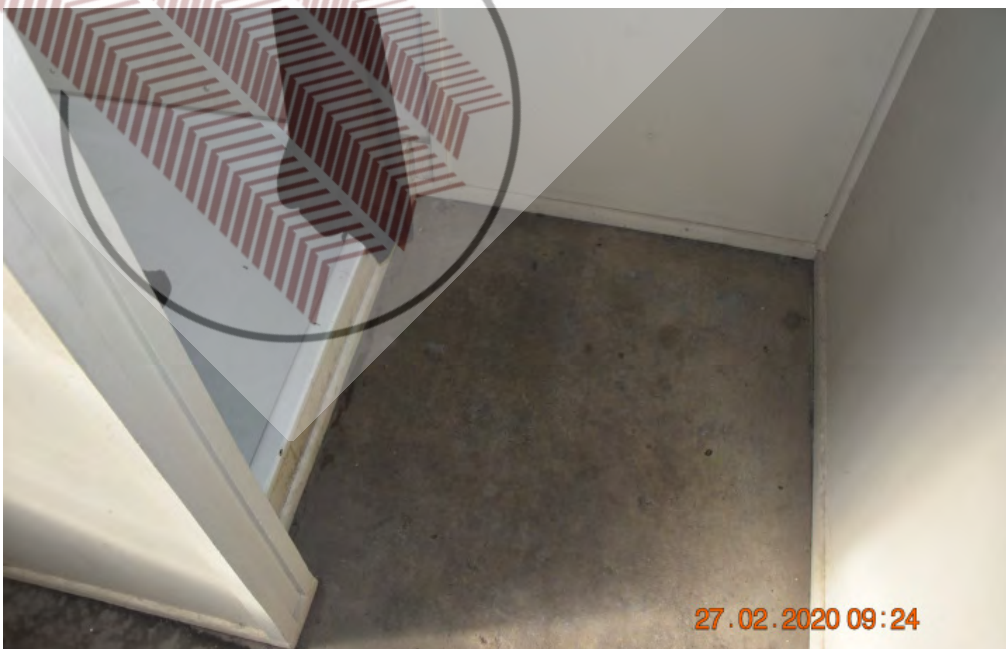
Figure: 0072

Concrete flooring in the shower room.

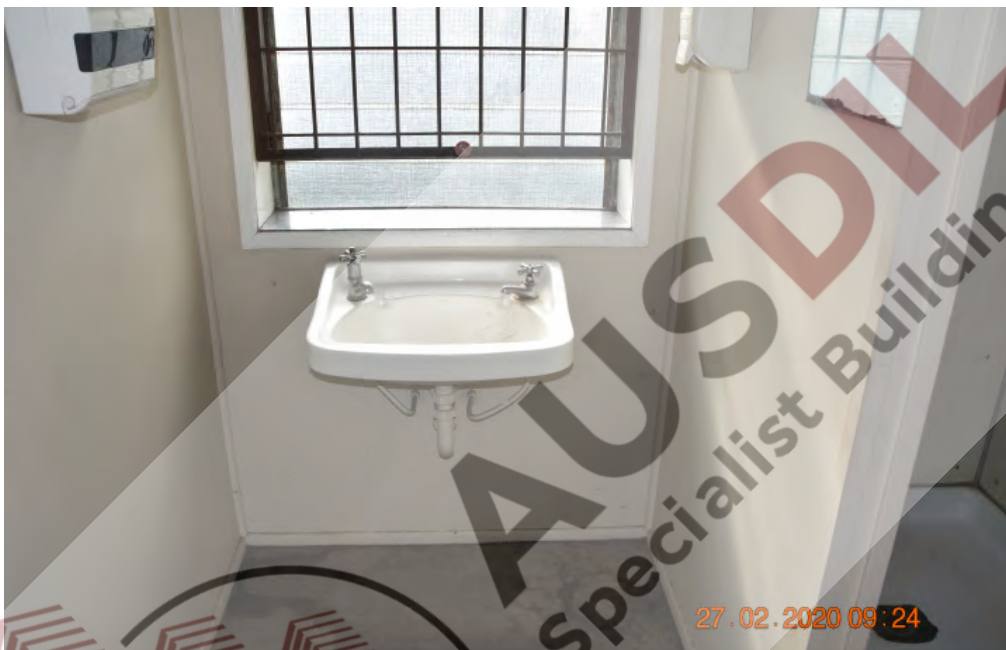
Figure: 0073

Right wall in the shower room, rear side.

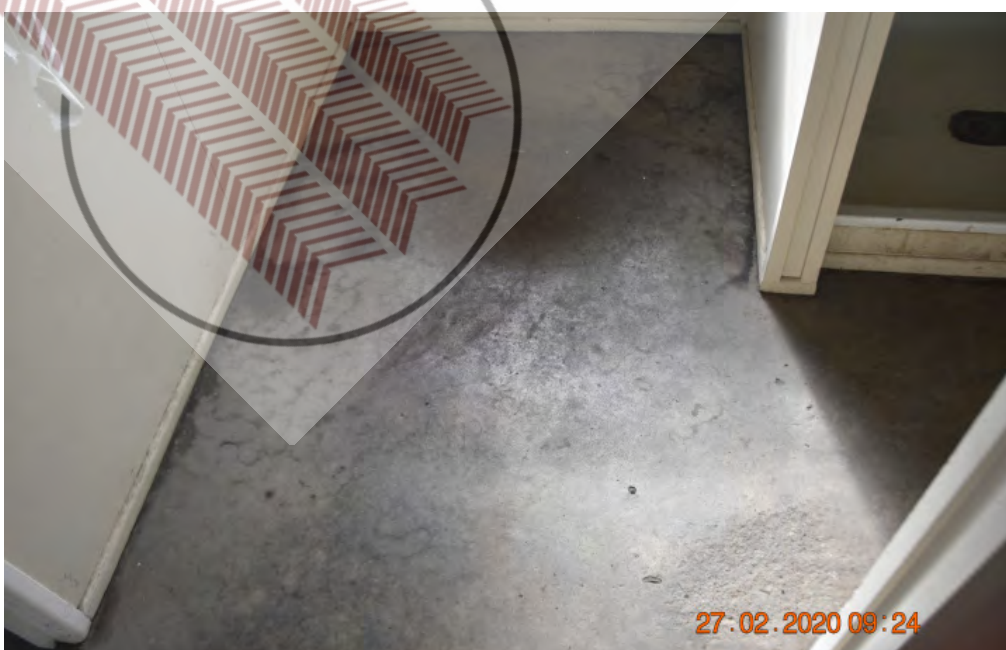
Figure: 0074

Right wall in the shower room, rear side.

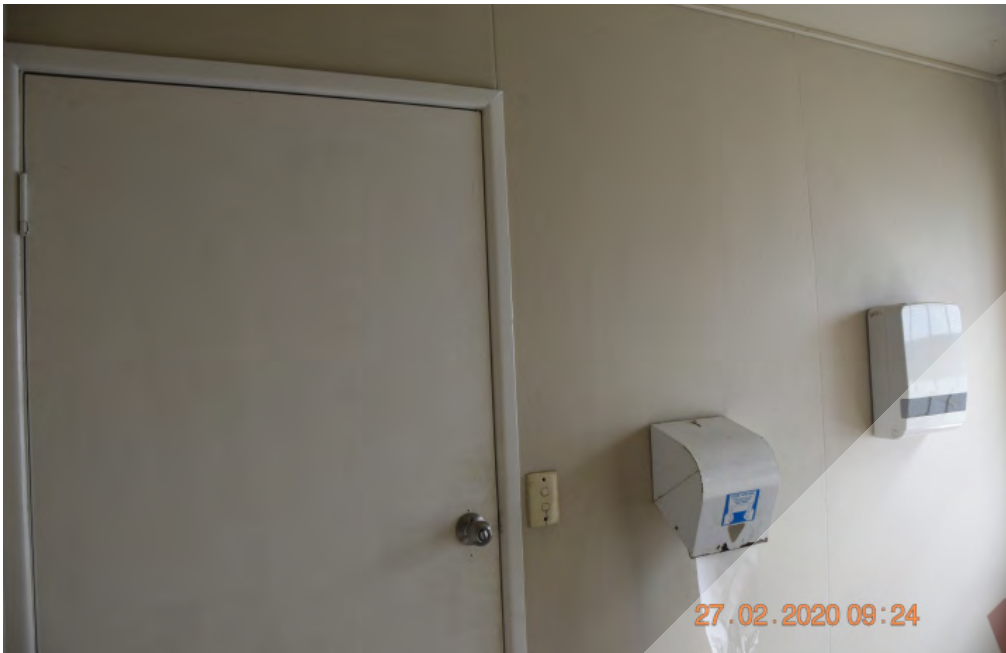
Figure: 0076

Rear wall in the shower room.

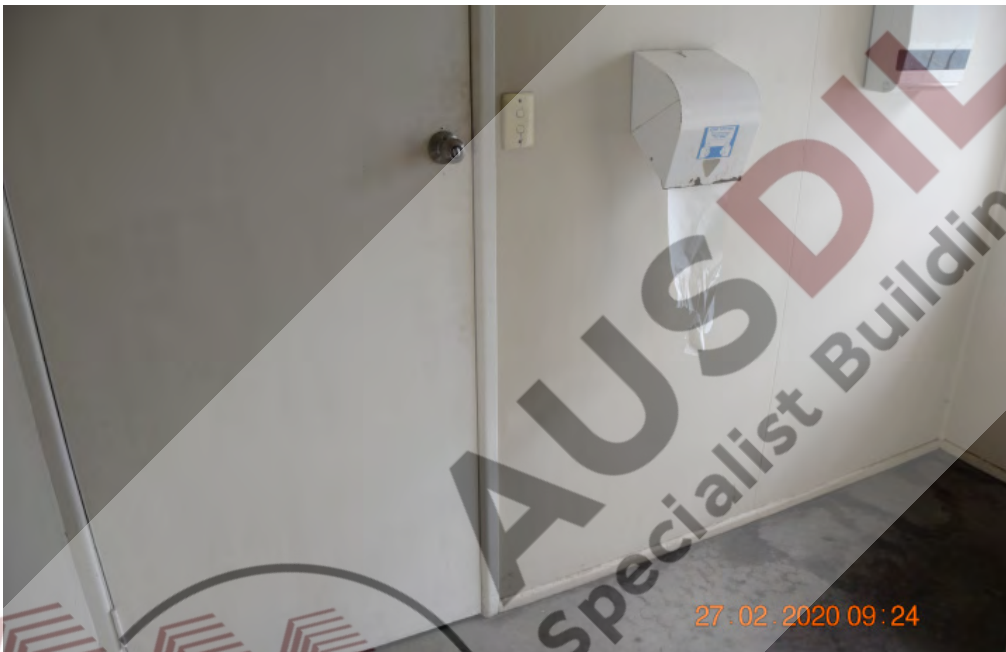
Figure: 0077

Rear wall in the shower room.

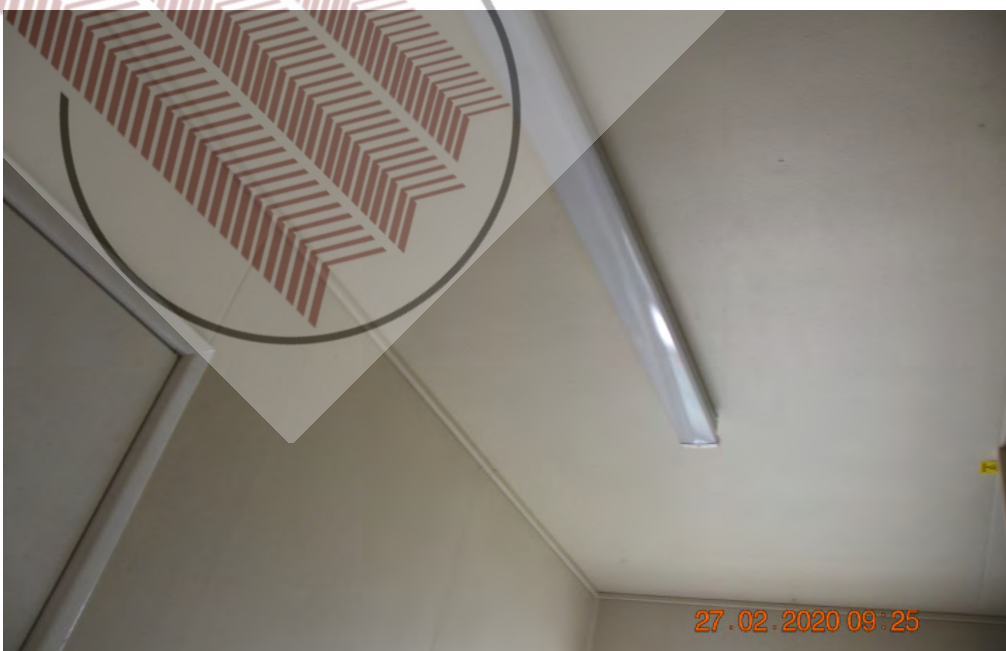
Figure: 0078

Ceiling in the shower room.

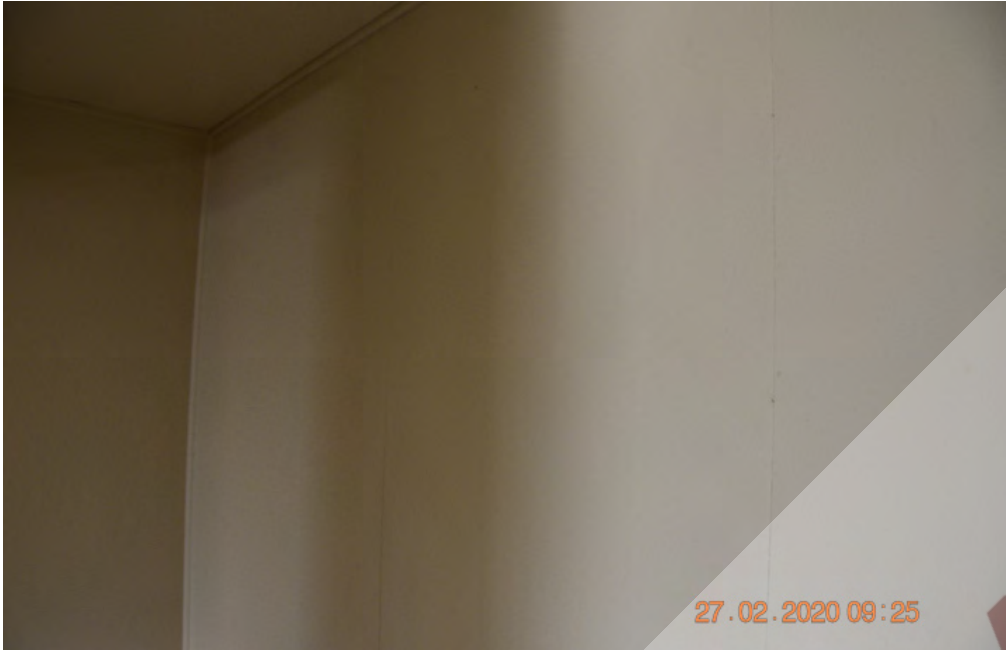
Figure: 0082

Left wall in the shower room, front side.

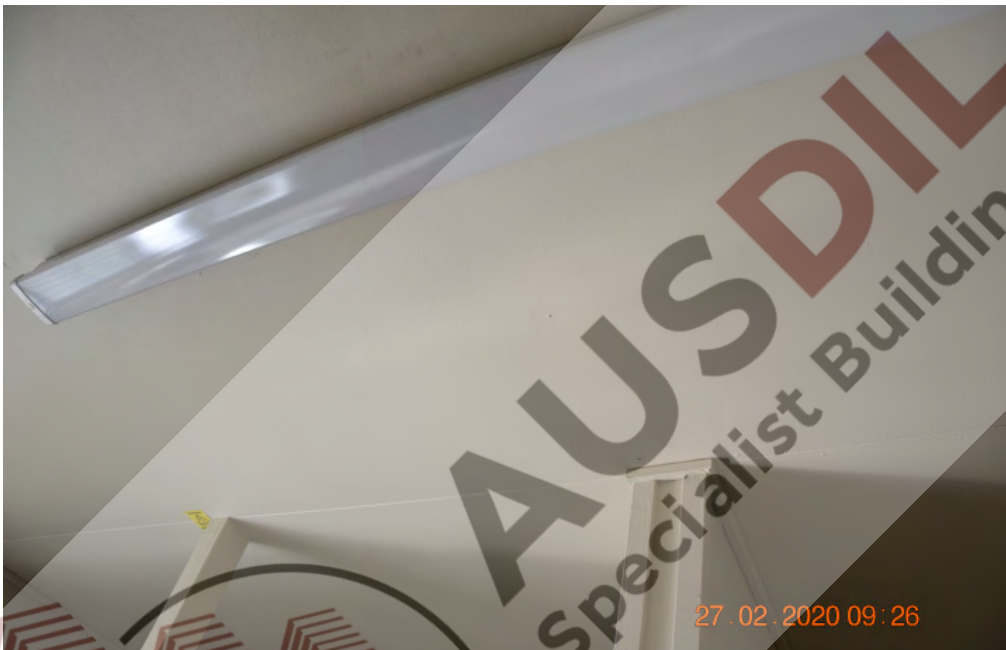
Figure: 0083

Ceiling in the shower room.

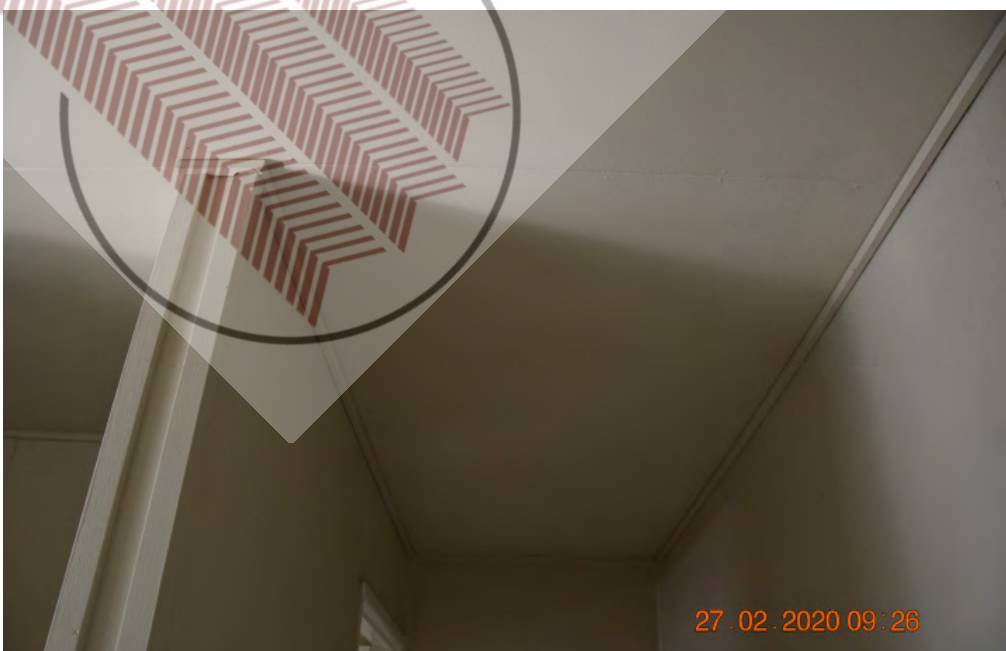
Figure: 0084

Ceiling in the shower room.

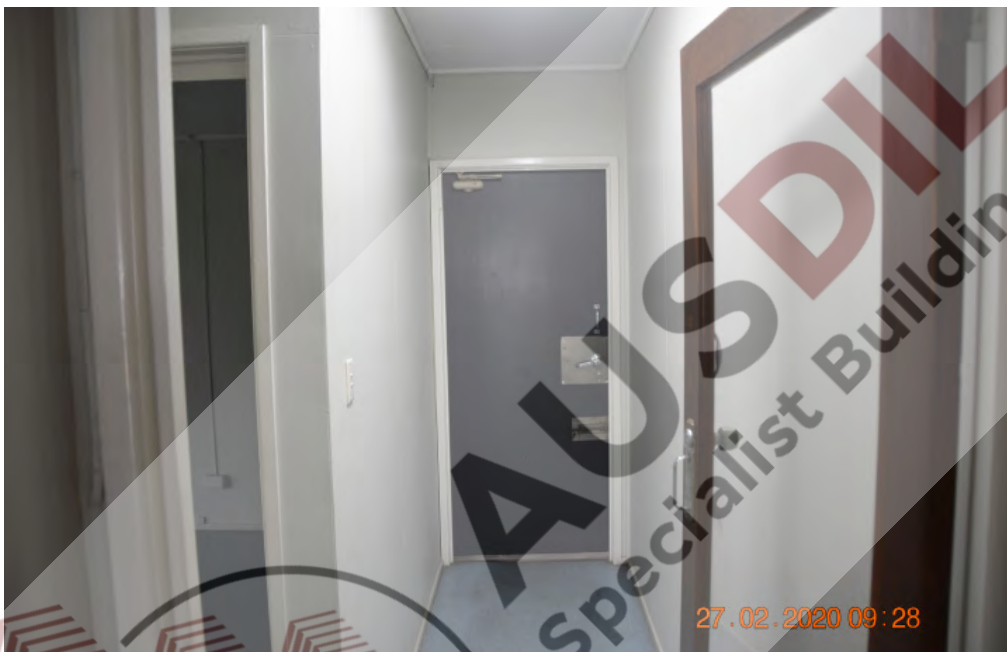
Figure: 0088

Wall adjacent to toilet
2.

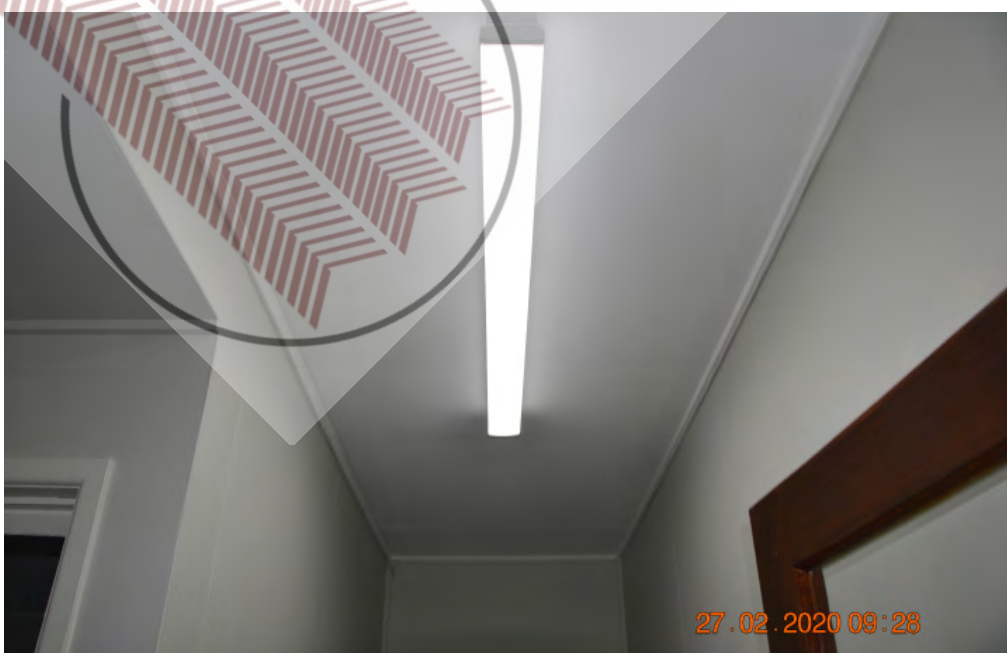
Figure: 0089

General view in the
hallway, outside the
workshop.

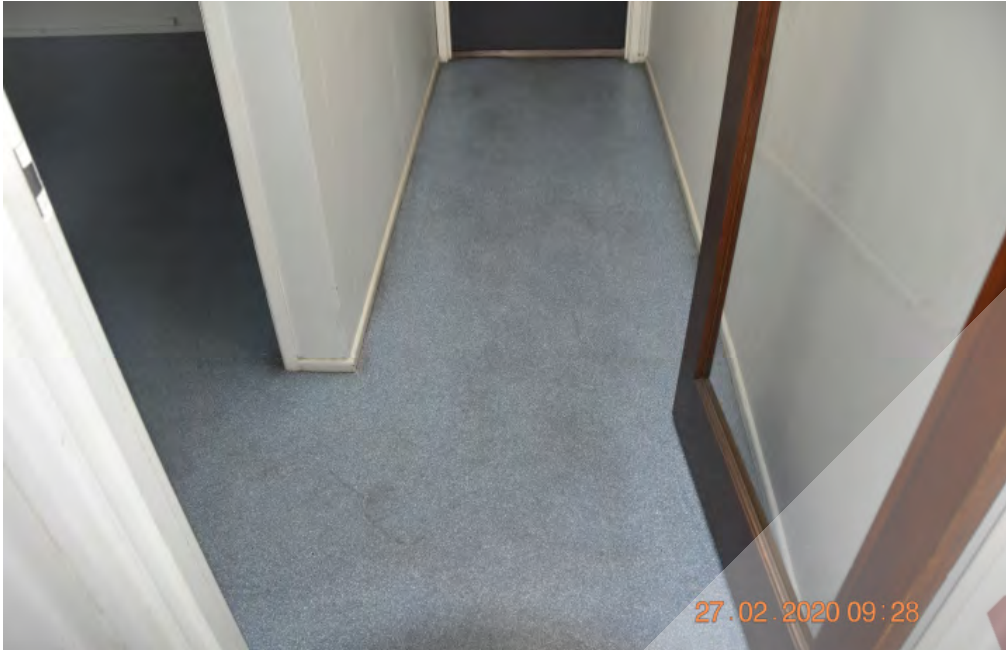
Figure: 0091

Tile flooring in the hallway, outside the workshop.

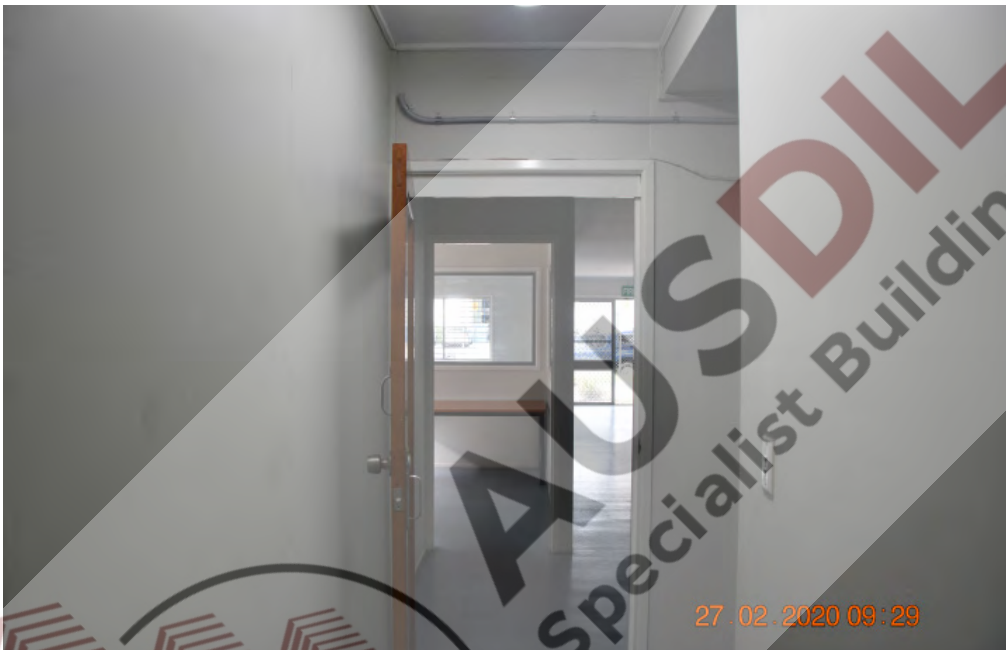
Figure: 0092

Front wall in the hallway, outside the workshop.

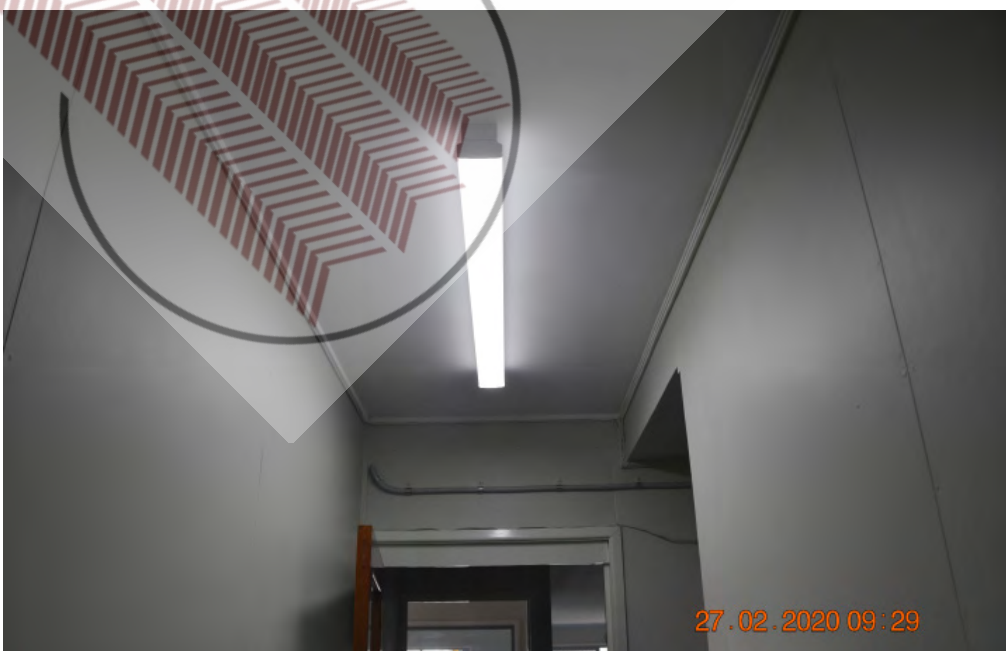
Figure: 0093

Ceiling in the hallway, outside the workshop.

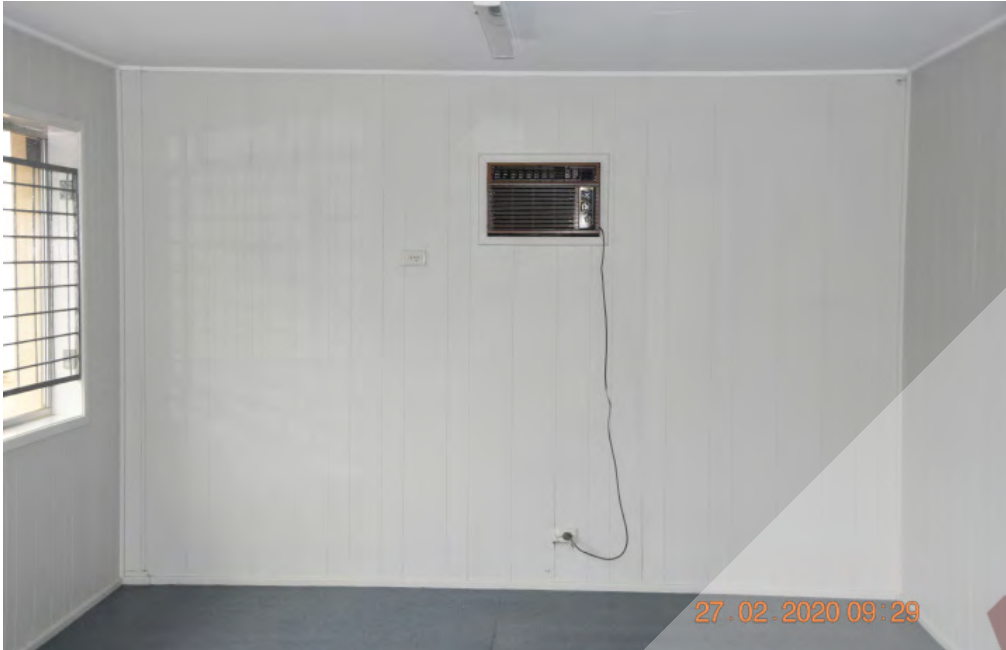
Figure: 0094

Left wall in office 1.

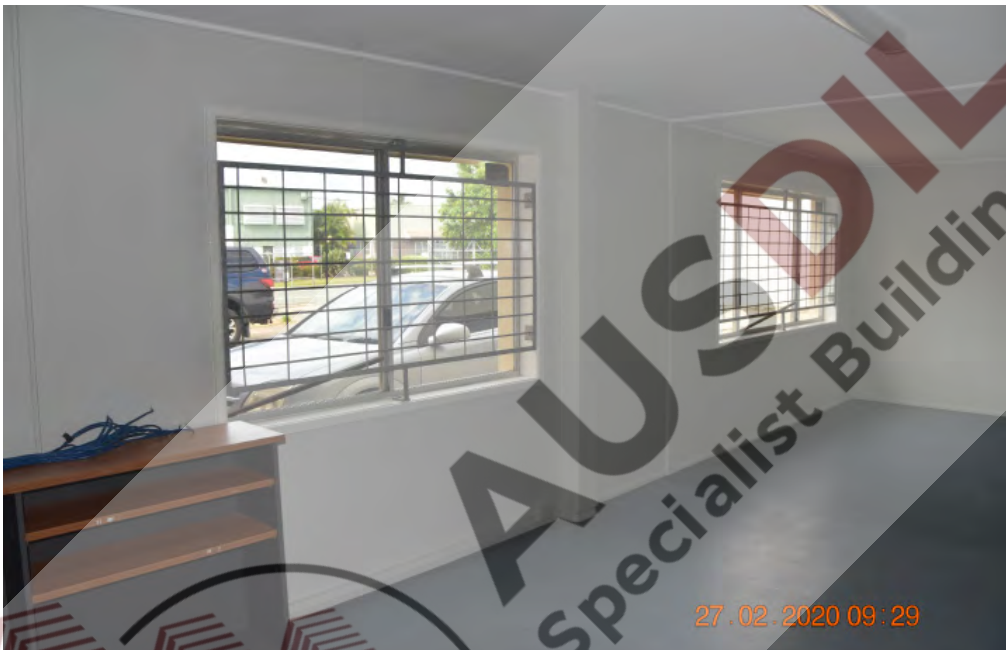
Figure: 0095

Front wall in office 1, left side.

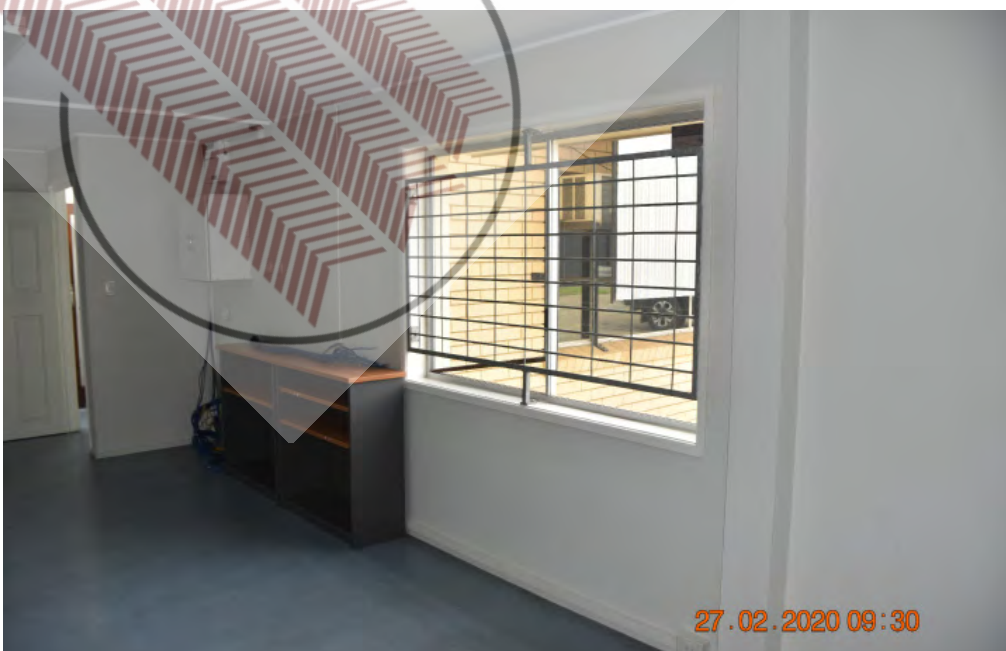
Figure: 0096

Front wall in office 1, right side.

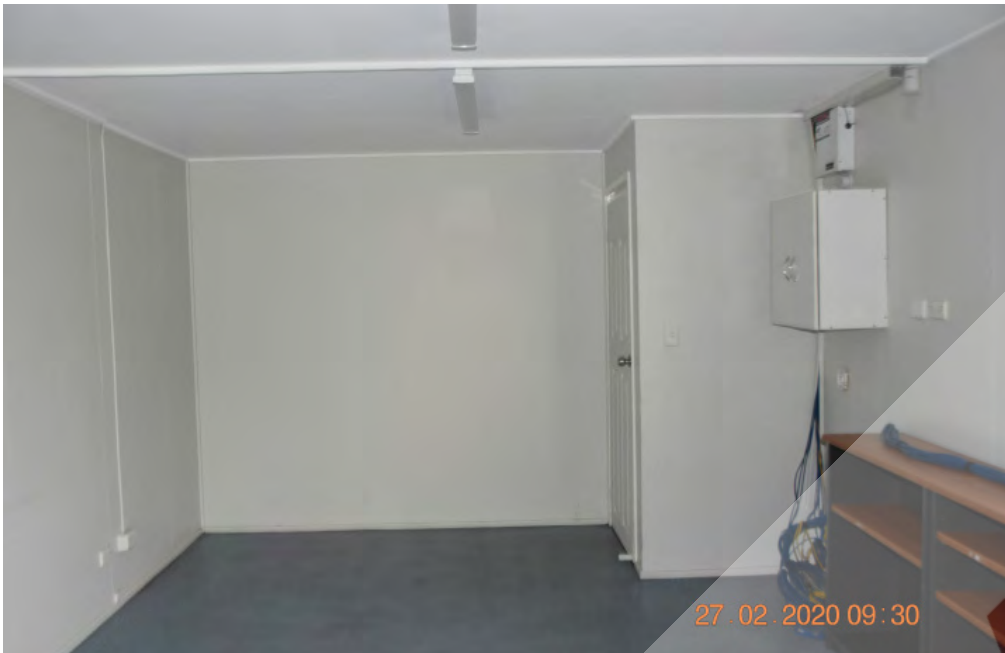
Figure: 0097

Right wall in office 1.

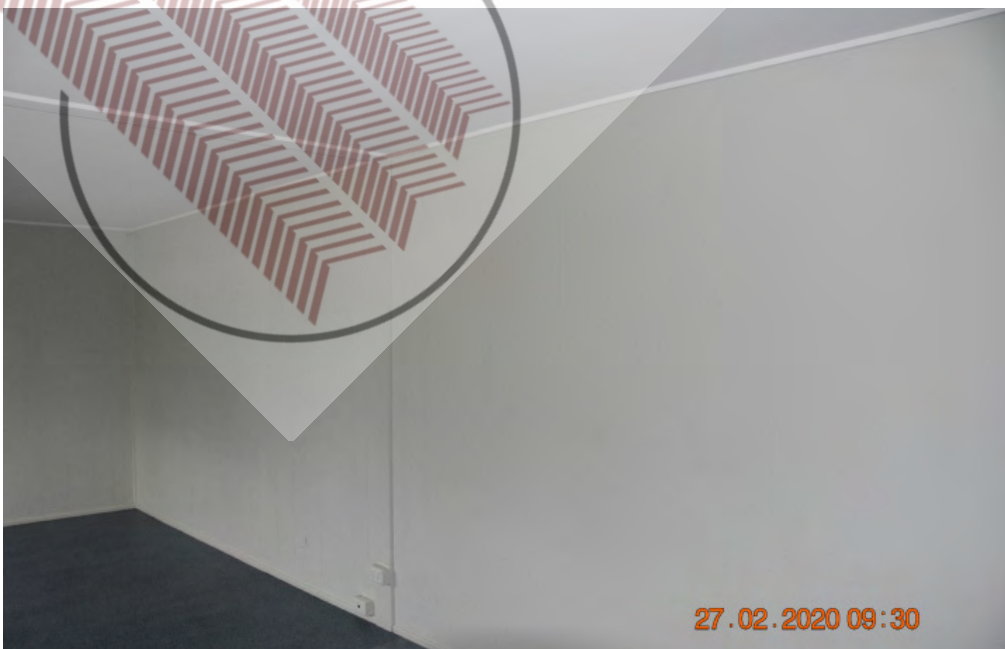
Figure: 0099

Rear wall in office 1,
left side.

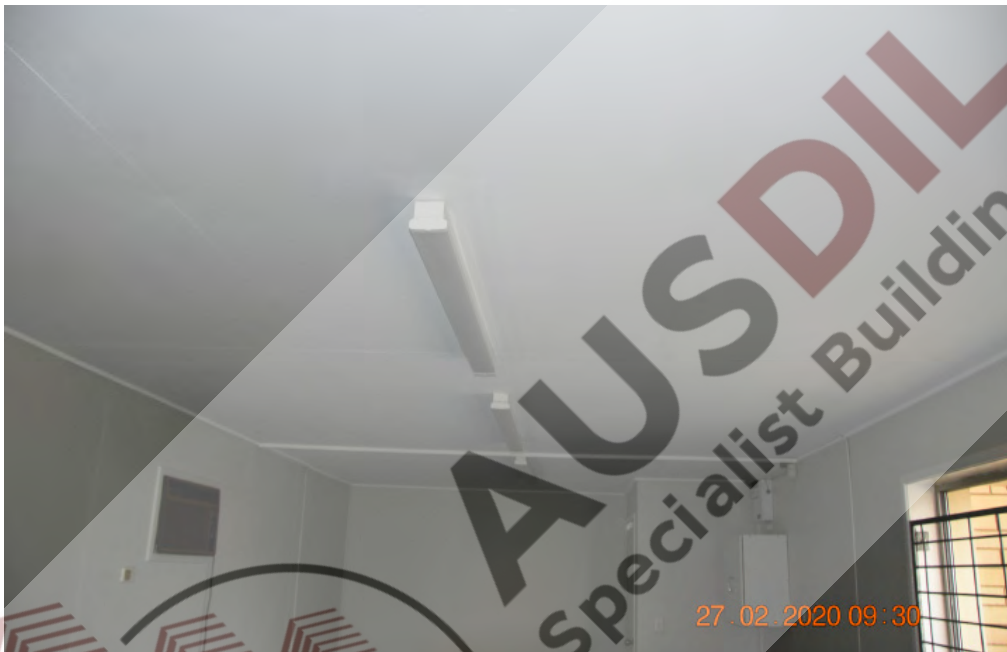
Figure: 0100

Ceiling in office 1.

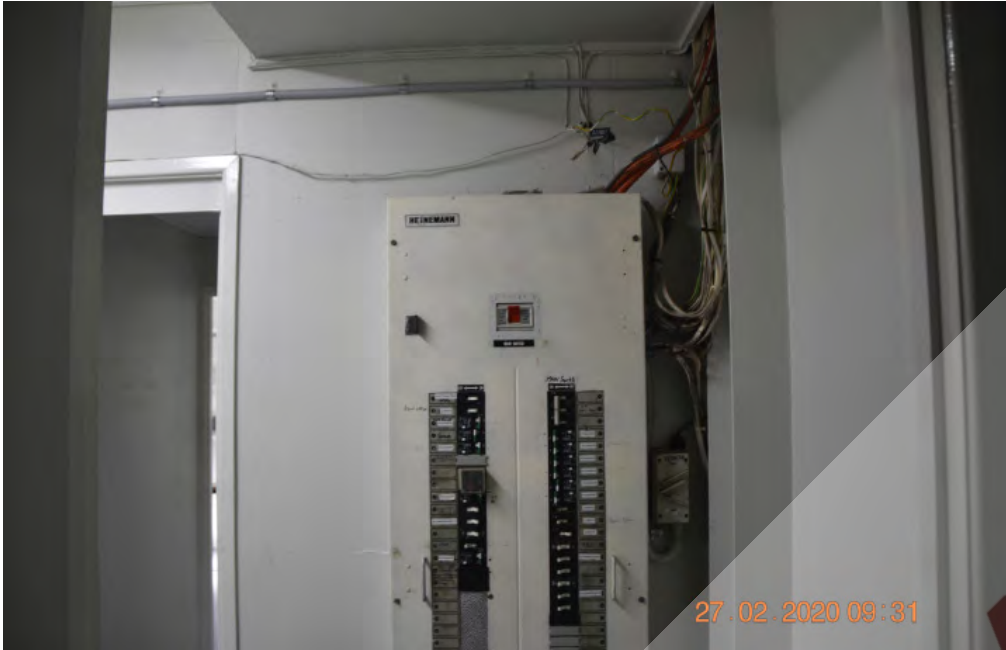
Figure: 0103

Front wall in the hallway, outside office 1.

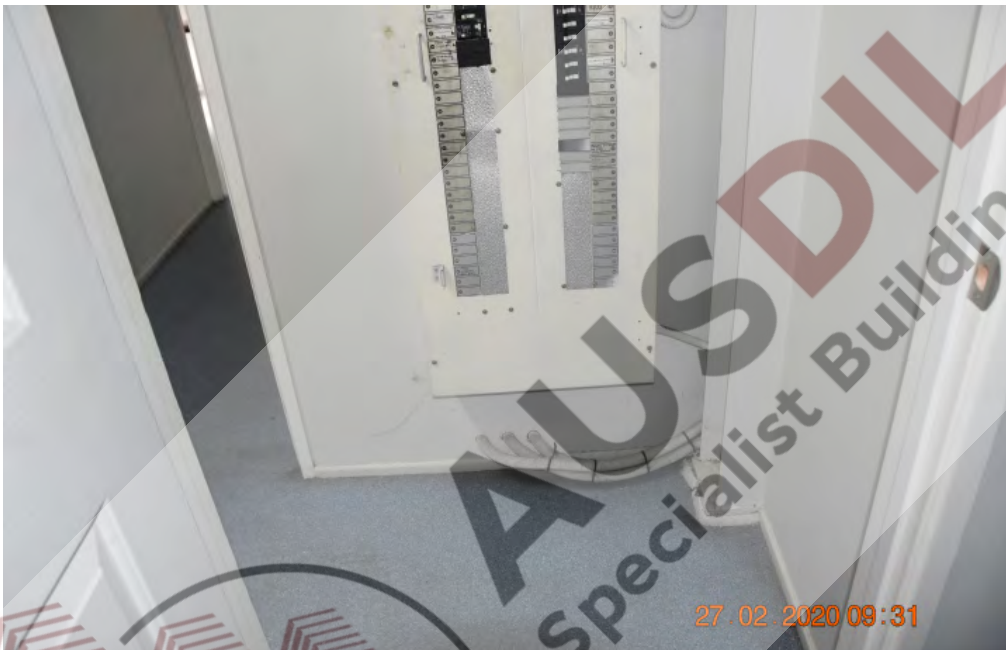
Figure: 0104

Front wall in the hallway, outside office 1.

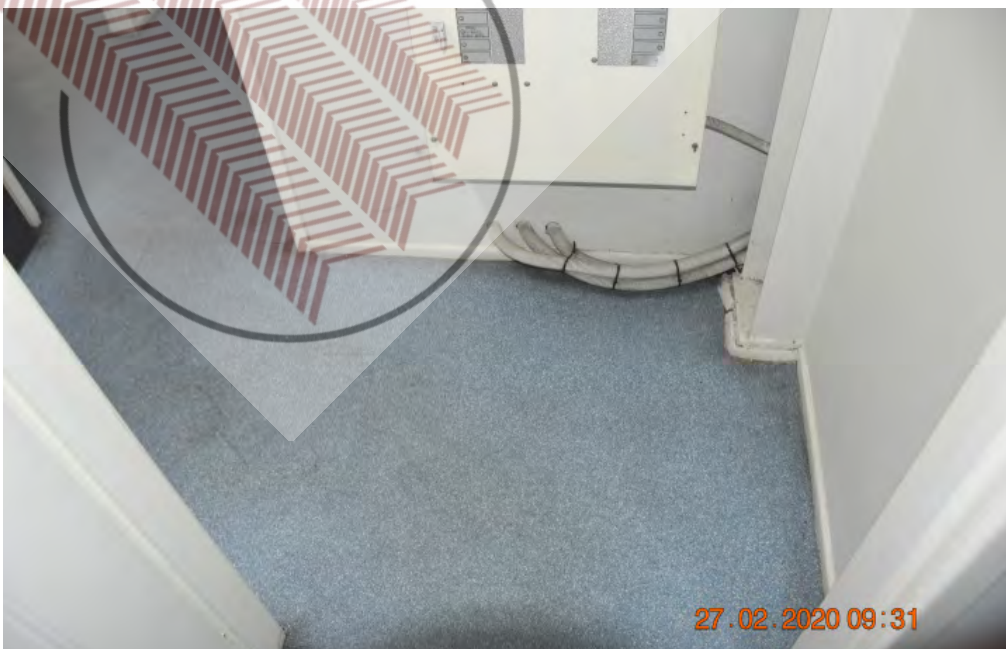
Figure: 0105

Front wall in the hallway, outside office 1.

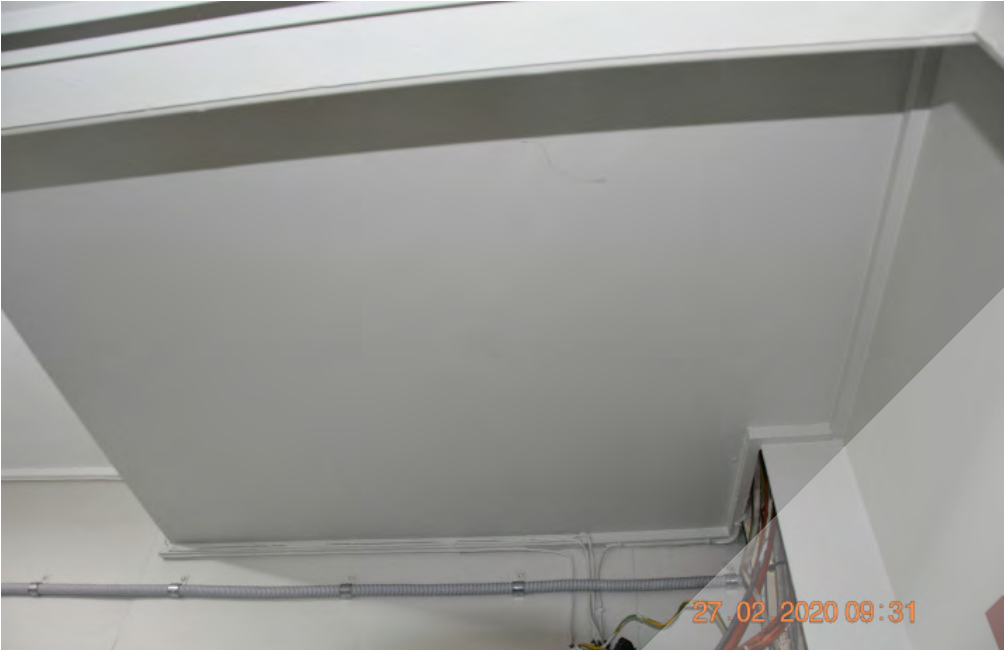
Figure: 0106

Ceiling in the hallway,
outside toilet 3.

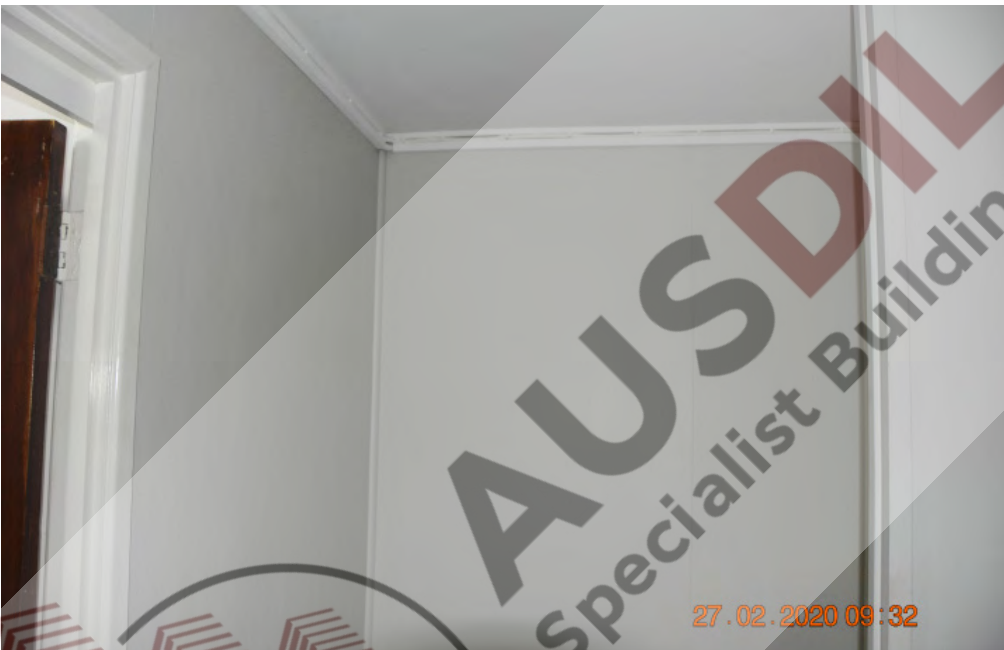
Figure: 0107

Rear wall in the hall-
way, outside toilet 3.

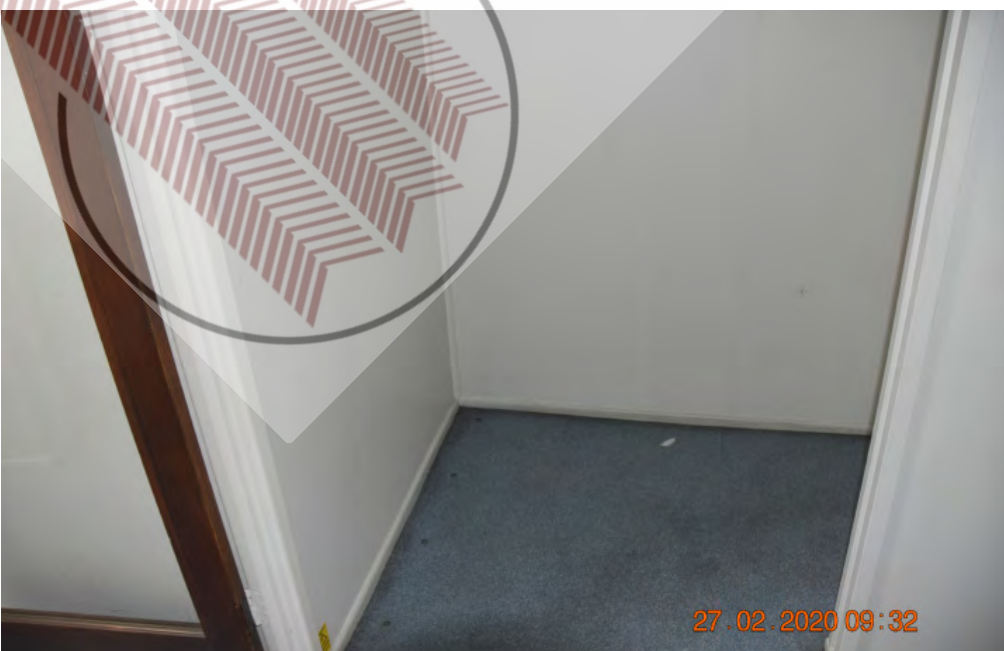
Figure: 0108

Rear wall in the hall-
way, outside toilet 3.

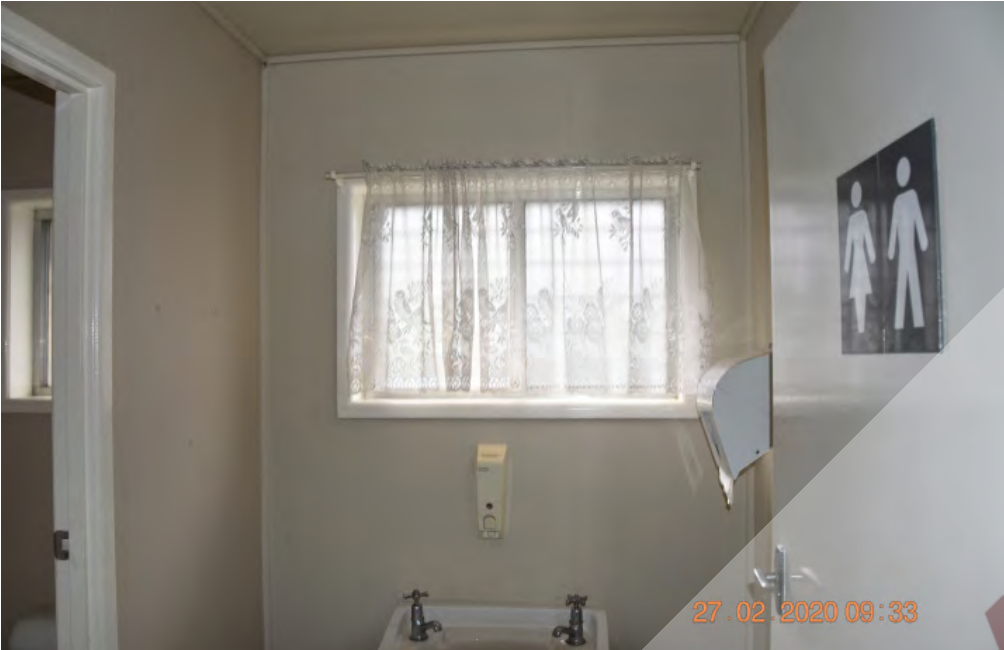
Figure: 0112

Right wall in toilet 3,
front side.

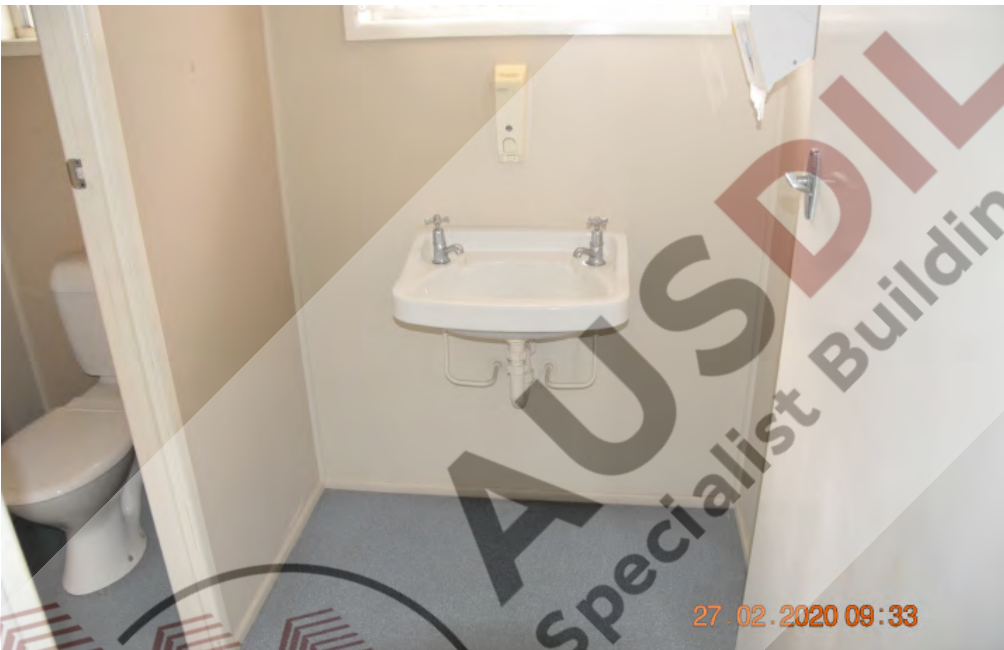
Figure: 0113

Right wall in toilet 3,
front side.
