PROPERTY CONDITION SURVEY - COMMERCIAL

AustDilaps was commissioned by {Client Name} to carry out a pre-construction condition inspection and report in accordance with AS.4349.1 for the {Project Name}

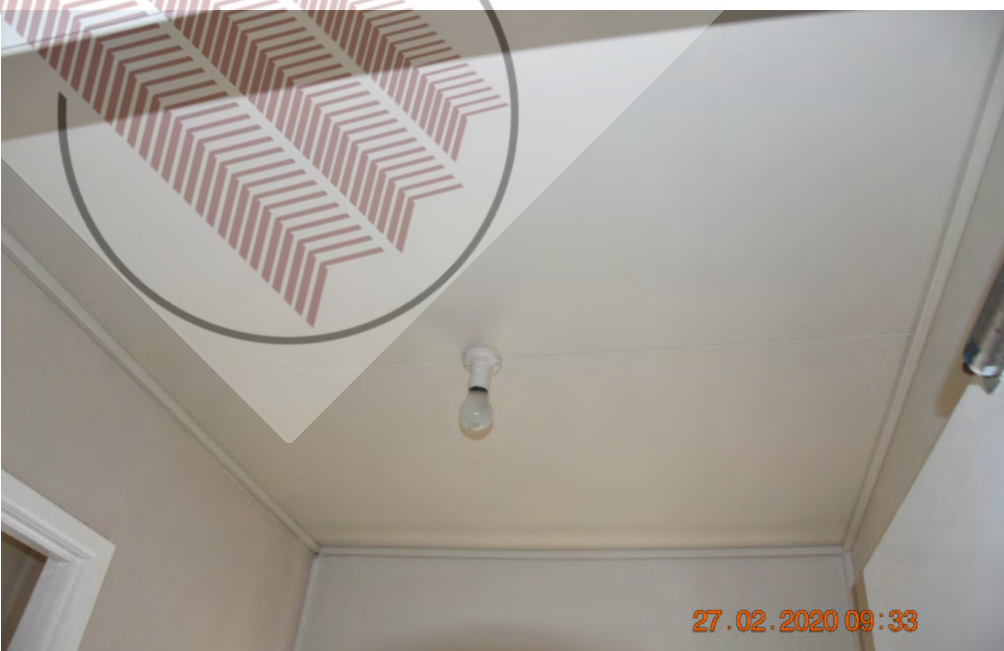
Figure: 0114

Ceiling wall in toilet 3.

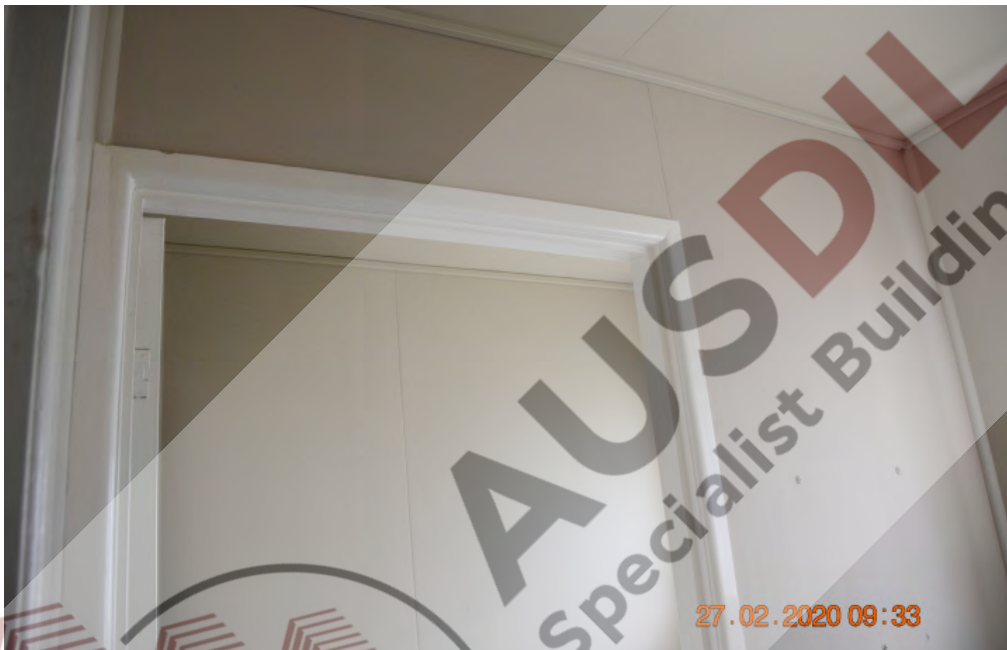
Figure: 0115

Rear wall in toilet 3.

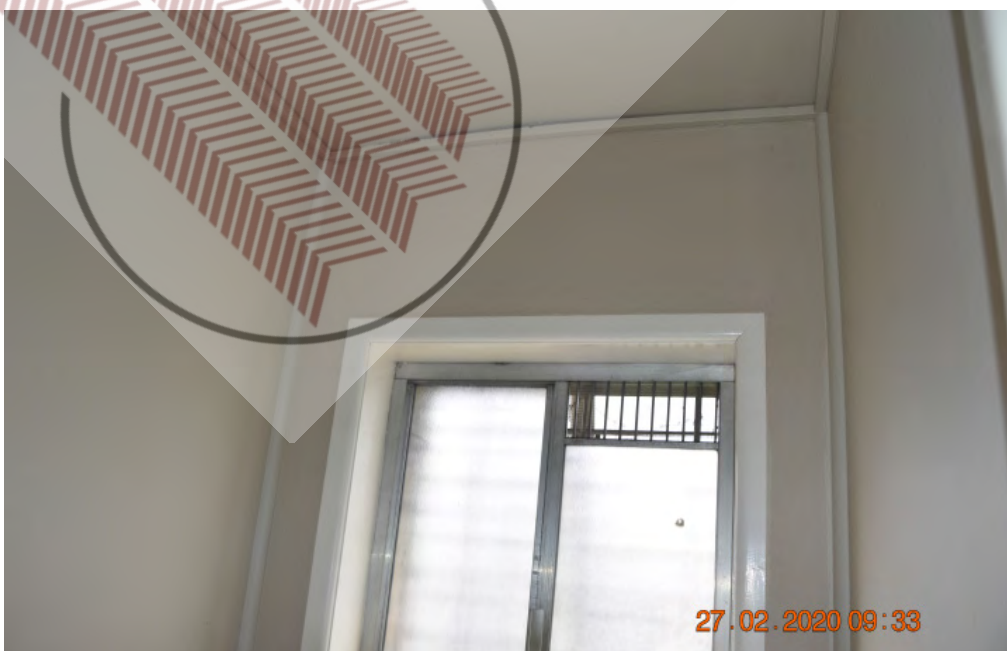
Figure: 0116

Rear wall in toilet 3.

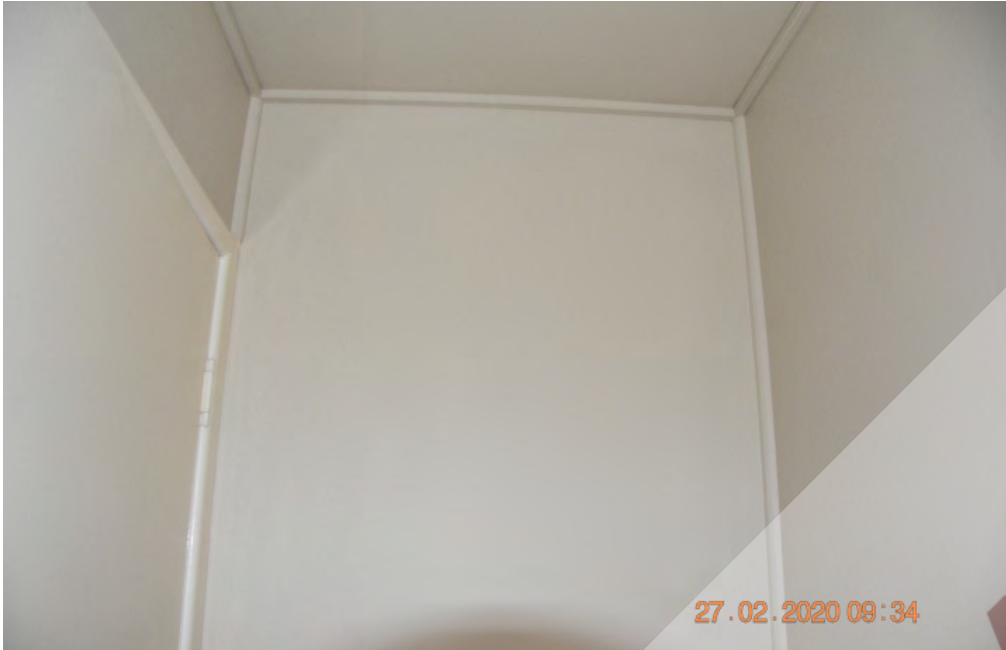
Figure: 0121

Left wall in toilet 3,
rear side.

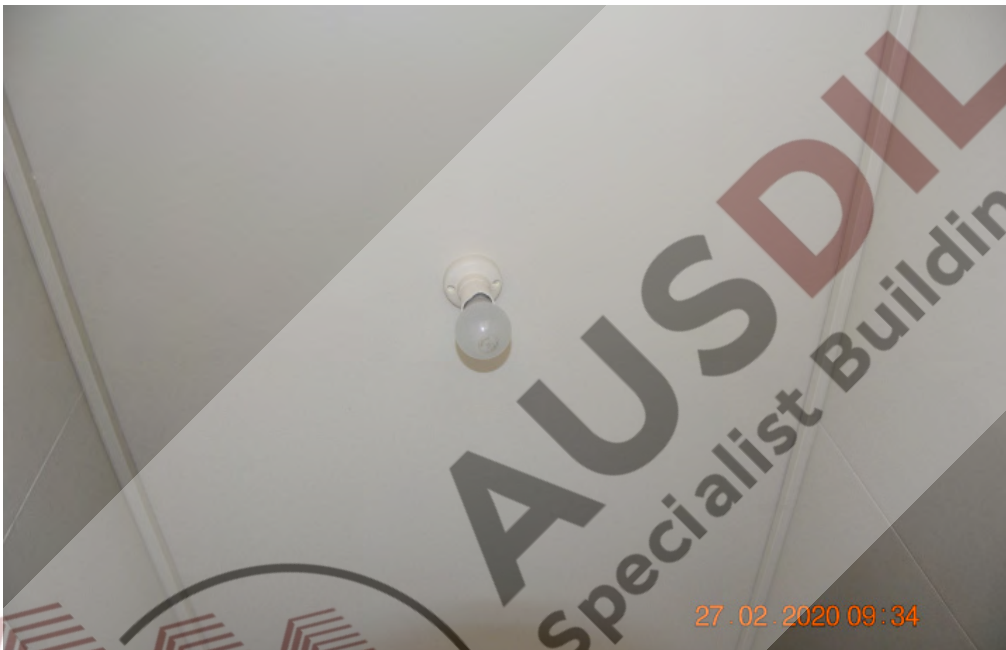
Figure: 0122

Ceiling in toilet 3.

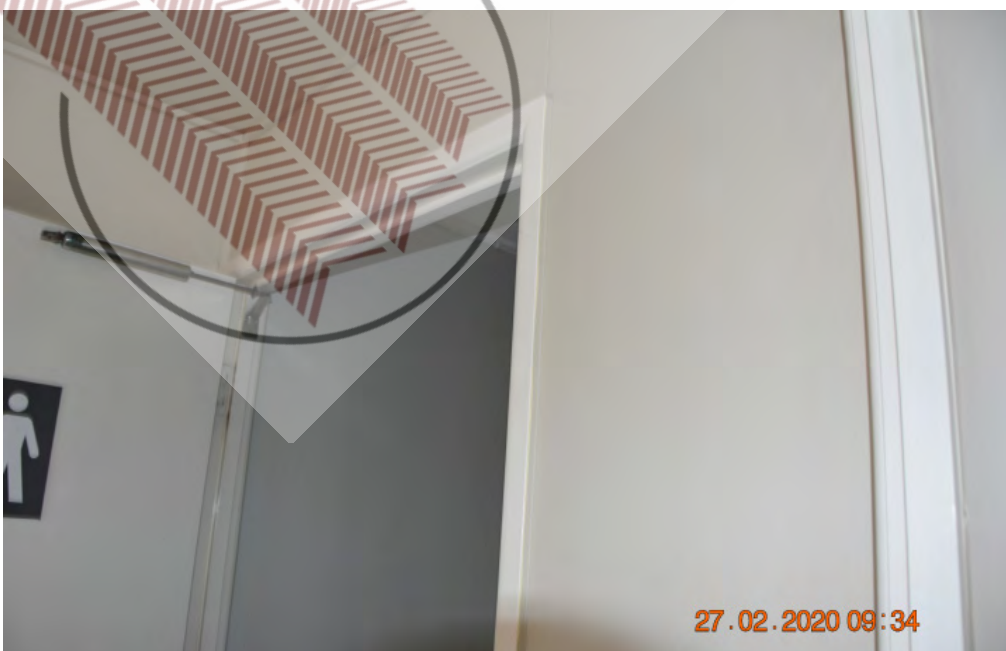
Figure: 0123

Left wall in toilet 3,
front side.

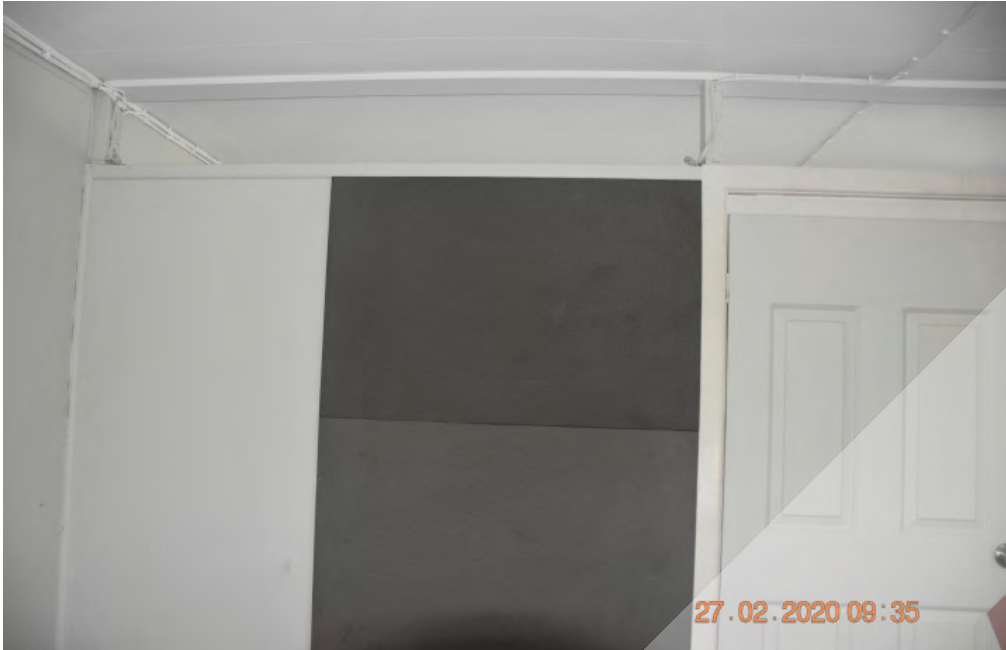
Figure: 0130

Right wall in office 2,
rear side.

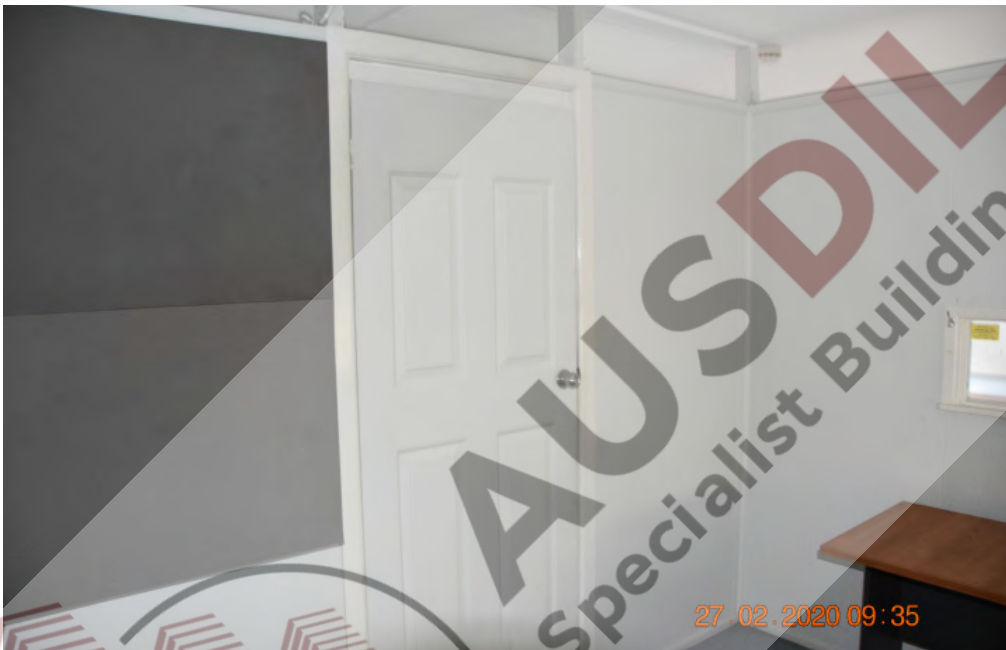
Figure: 0131

Right wall in office 2,
front side.

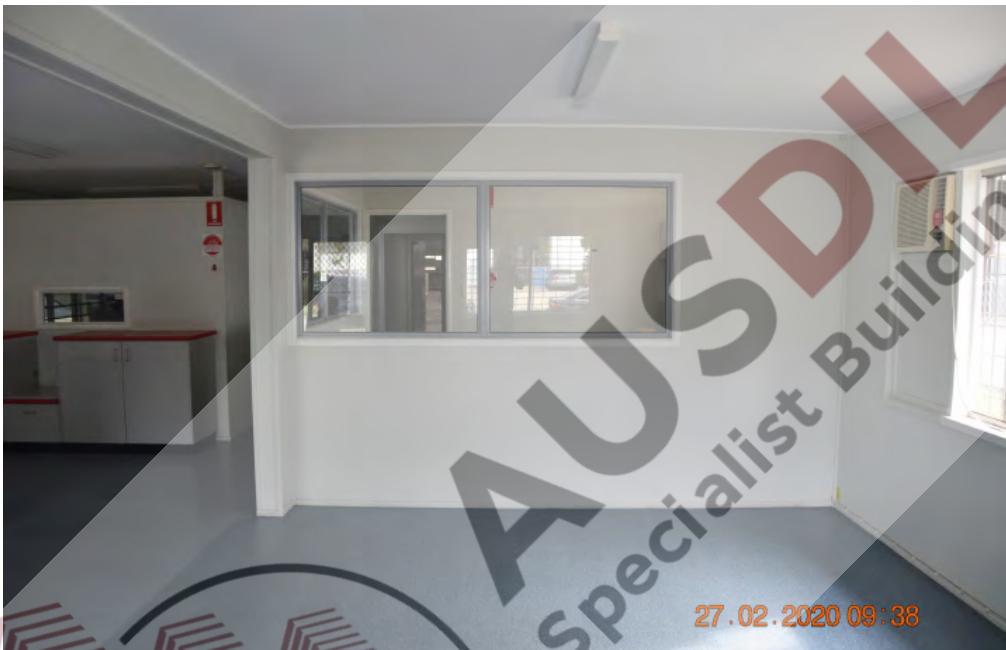
Figure: 0143

Rear wall in the reception area, right side.

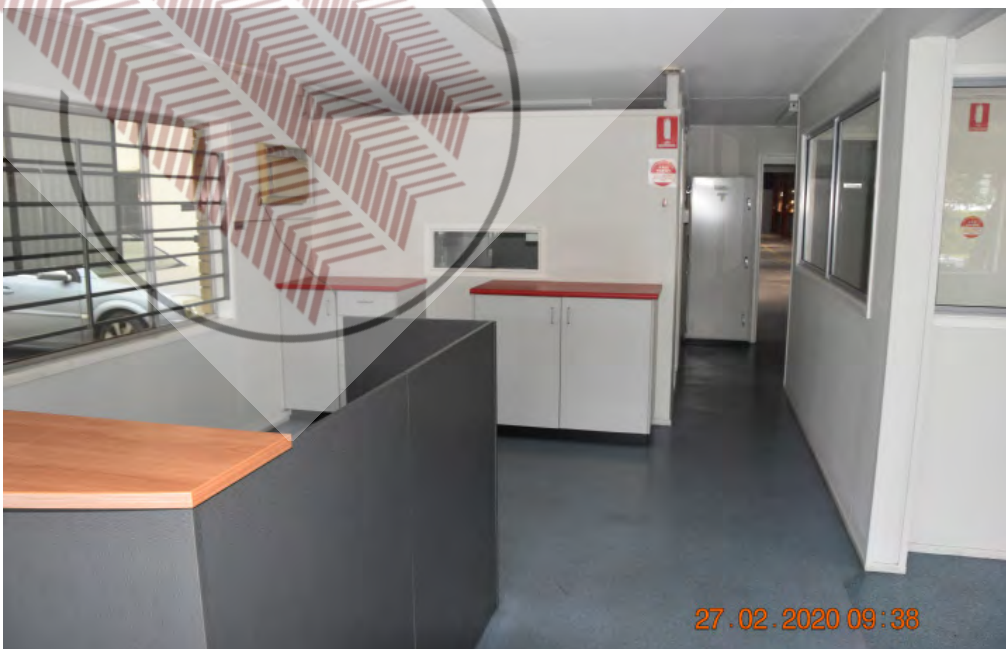
Figure: 0144

Rear wall in the reception area, left side.

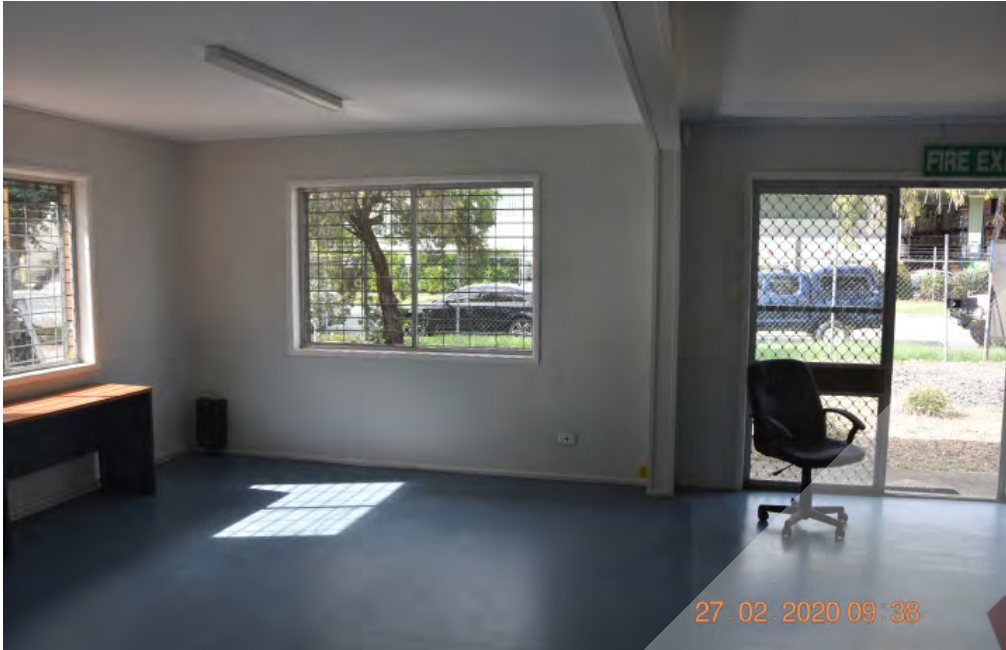
Figure: 0148

Front wall in the reception area, right side.

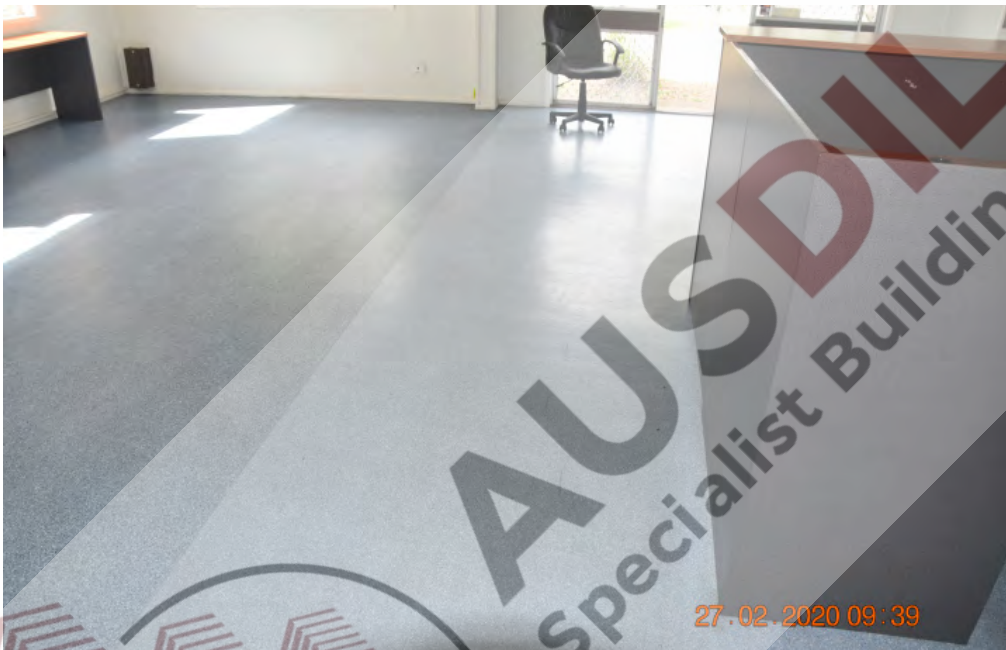
Figure: 0149

Tile flooring in the reception area.

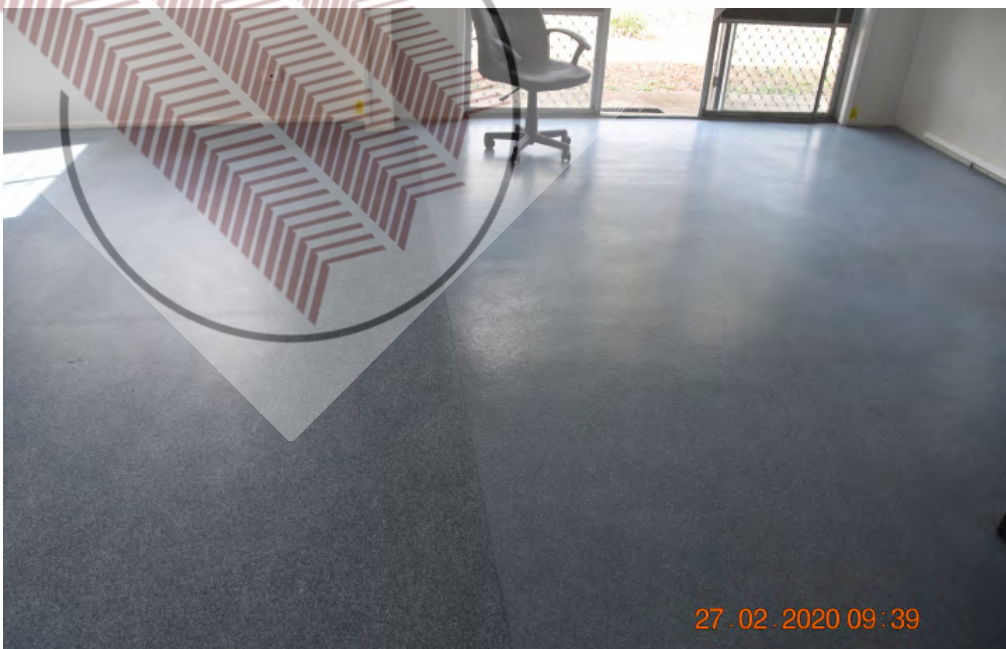
Figure: 0150

Tile flooring in the reception area.

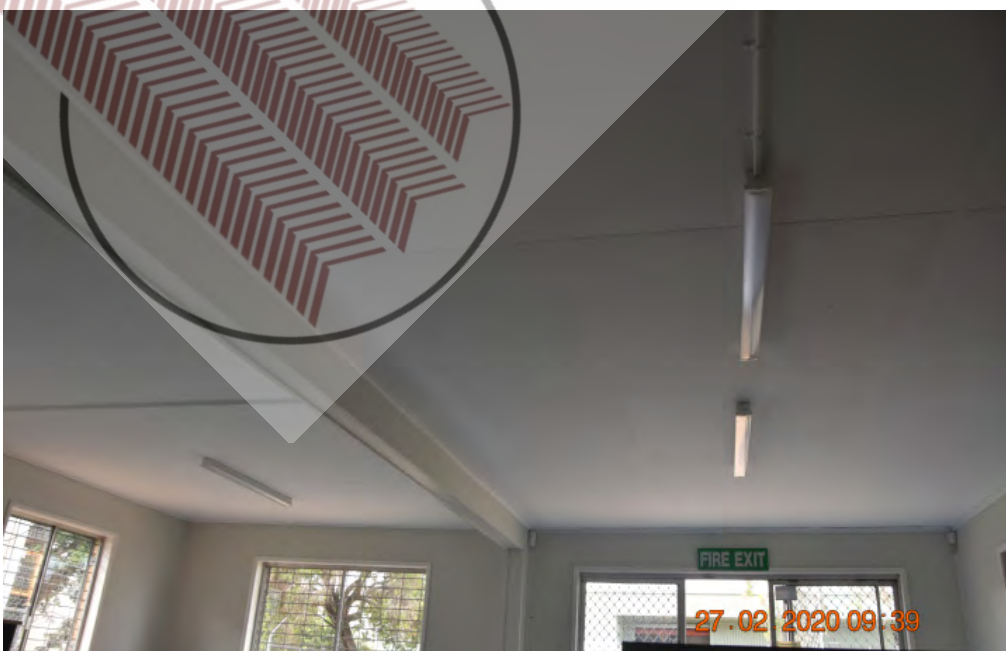
Figure: 0152

Ceiling in the reception area.

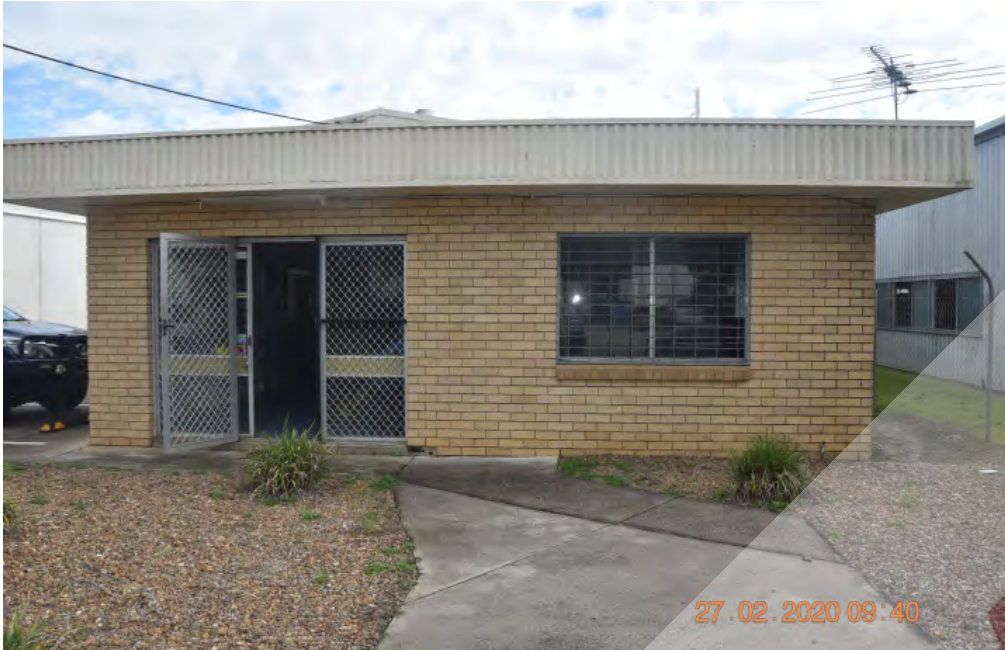
Figure: 0154

Front wall of the office building.

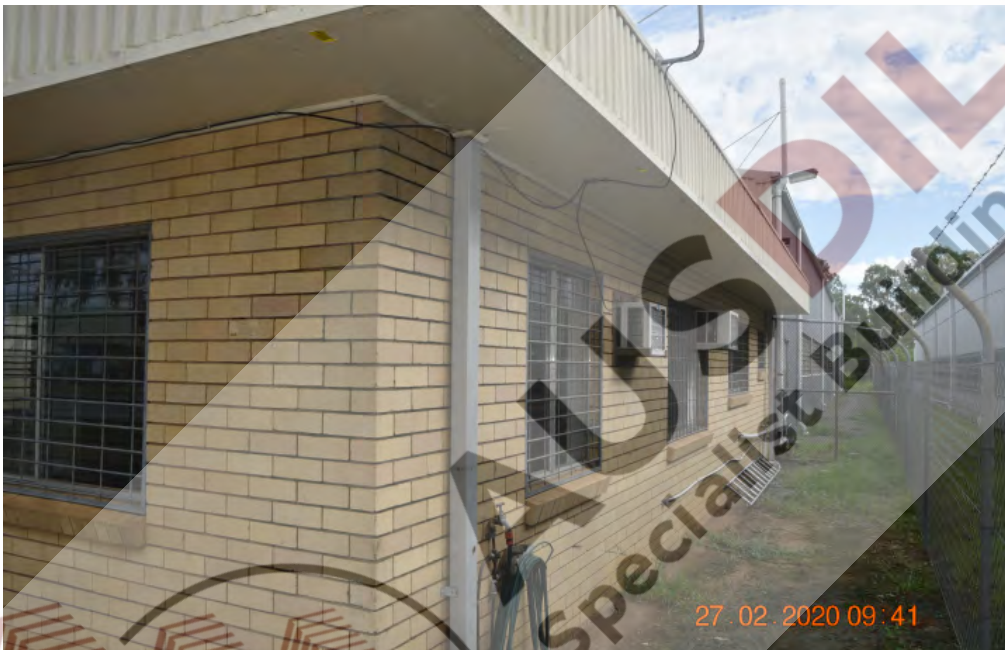
Figure: 0155

Right wall of the office building, looking from the front.

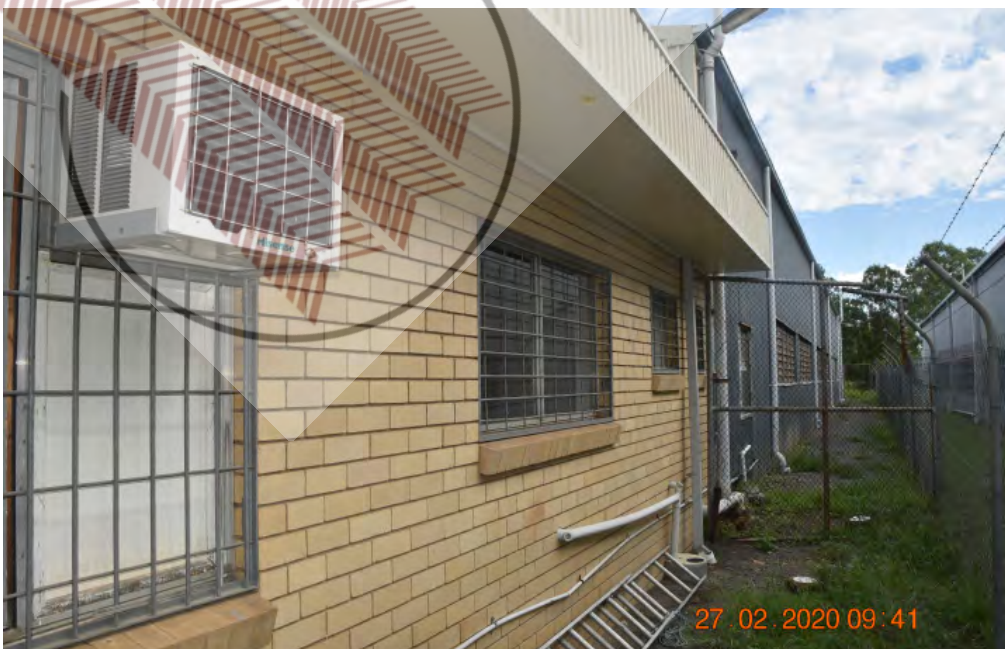
Figure: 0156

Right wall of the office building.

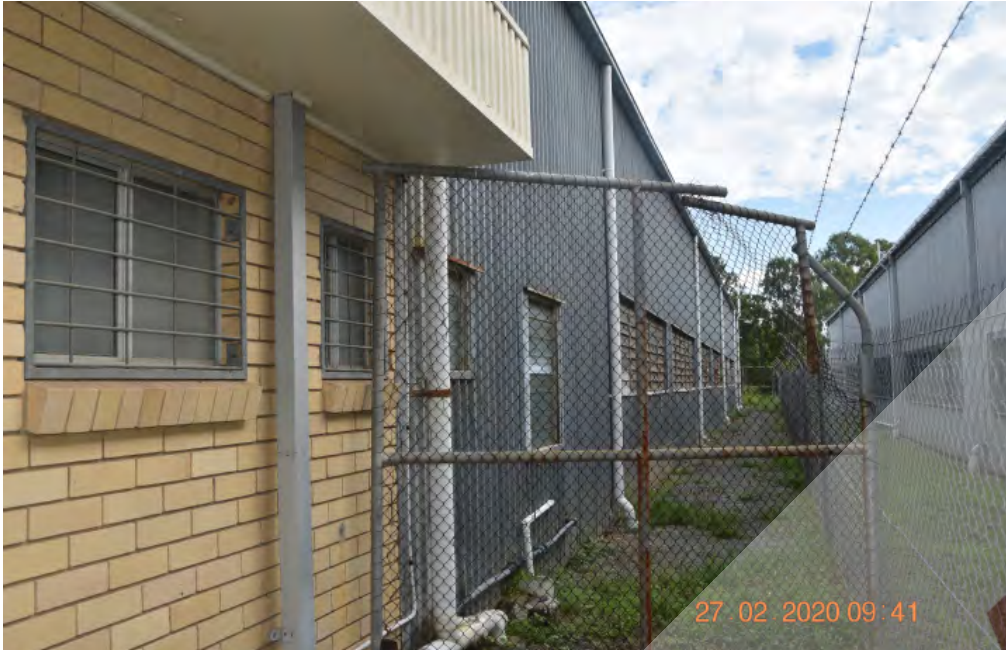
Figure: 0157

Right wall of the office building.

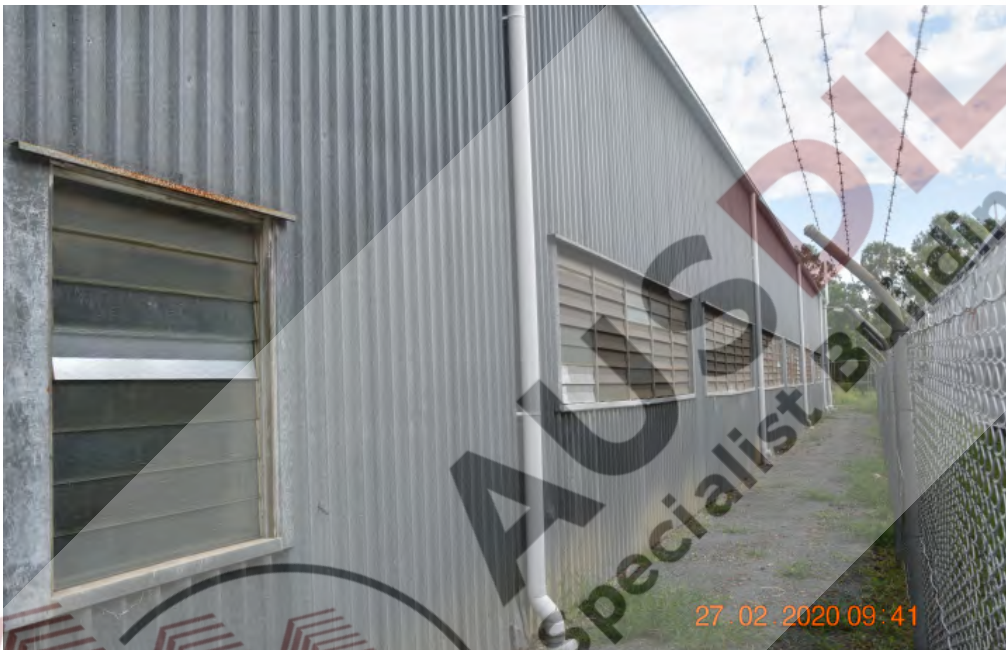
Figure: 0158

Right wall of the building.

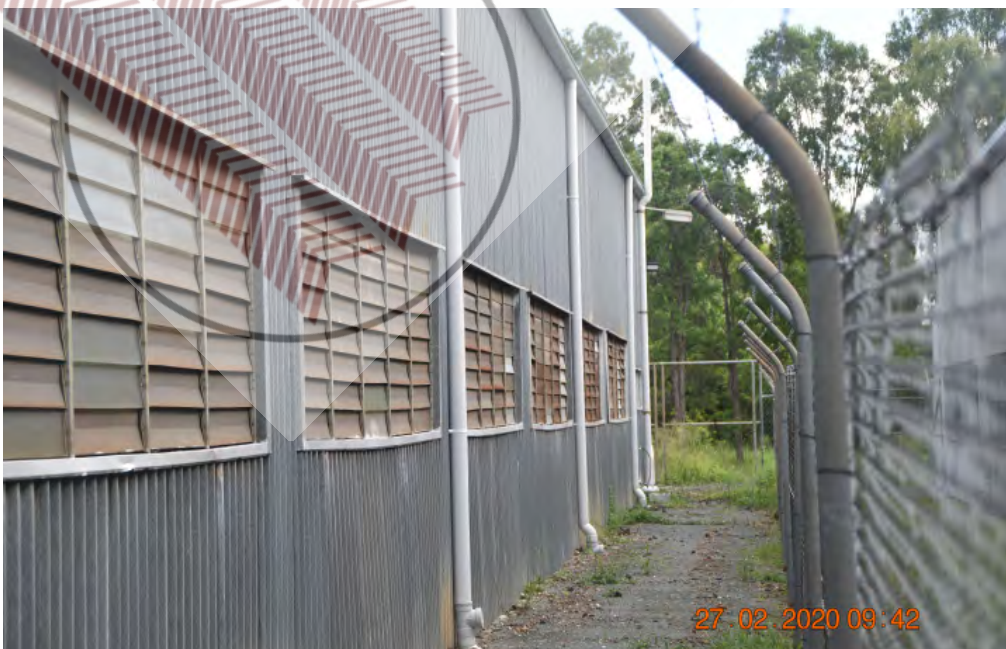
Figure: 0159

Right wall of the building, rear side.

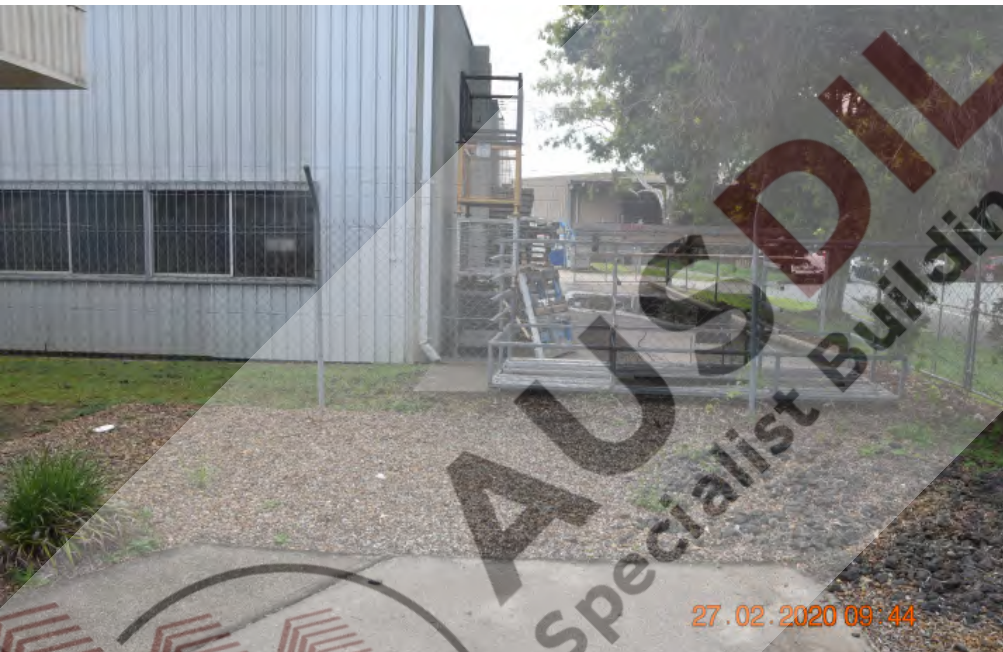
Figure: 0160

General view on the front side of the building, looking from the left.

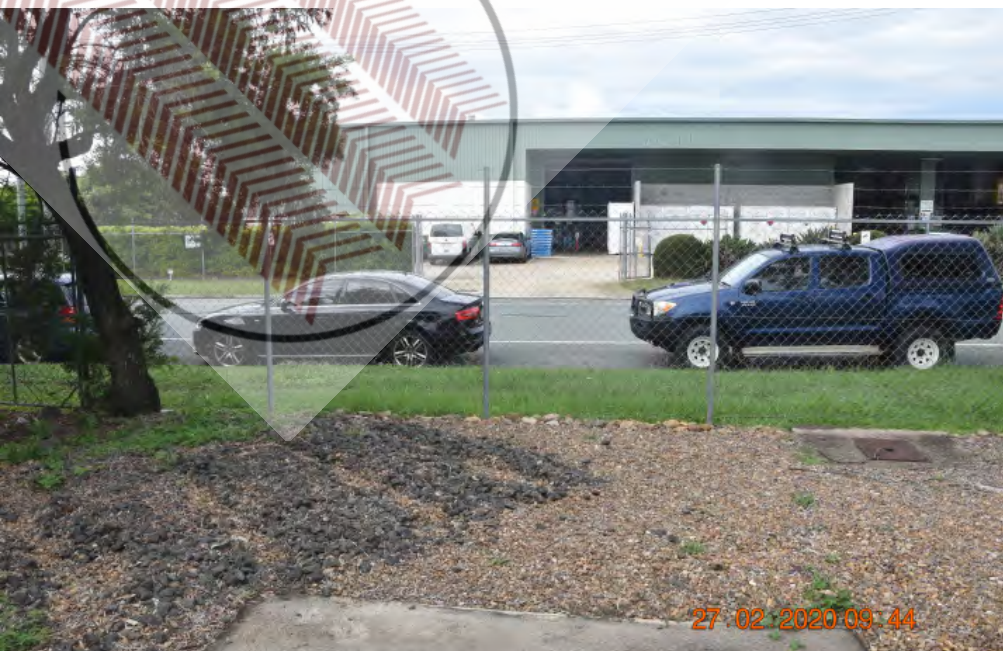
Figure: 0161

General view on the front side of the building, right side.

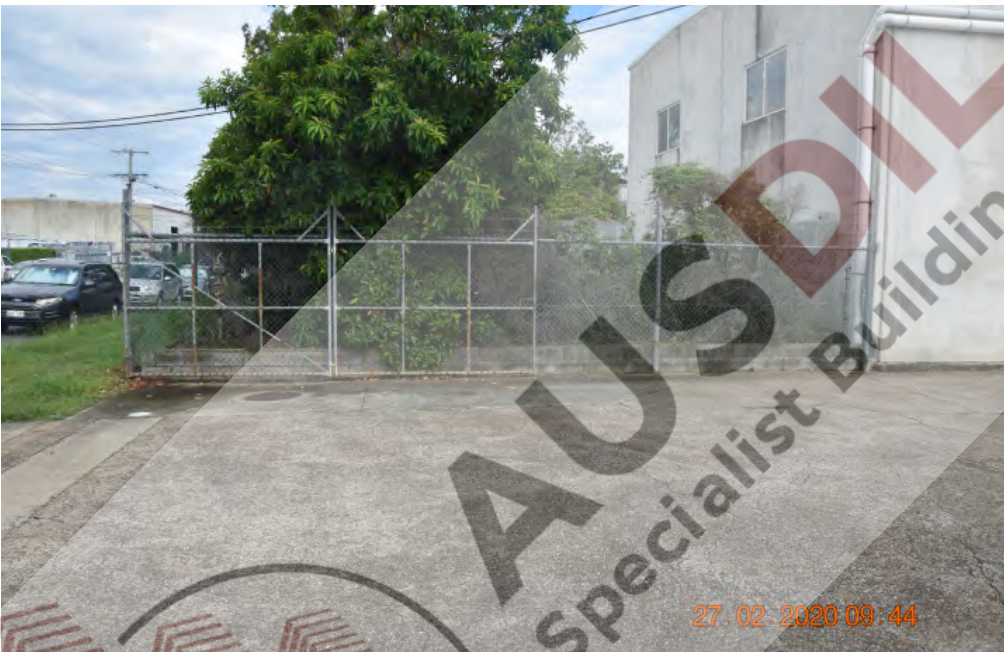
Figure: 0167

Left boundary fence, front side.

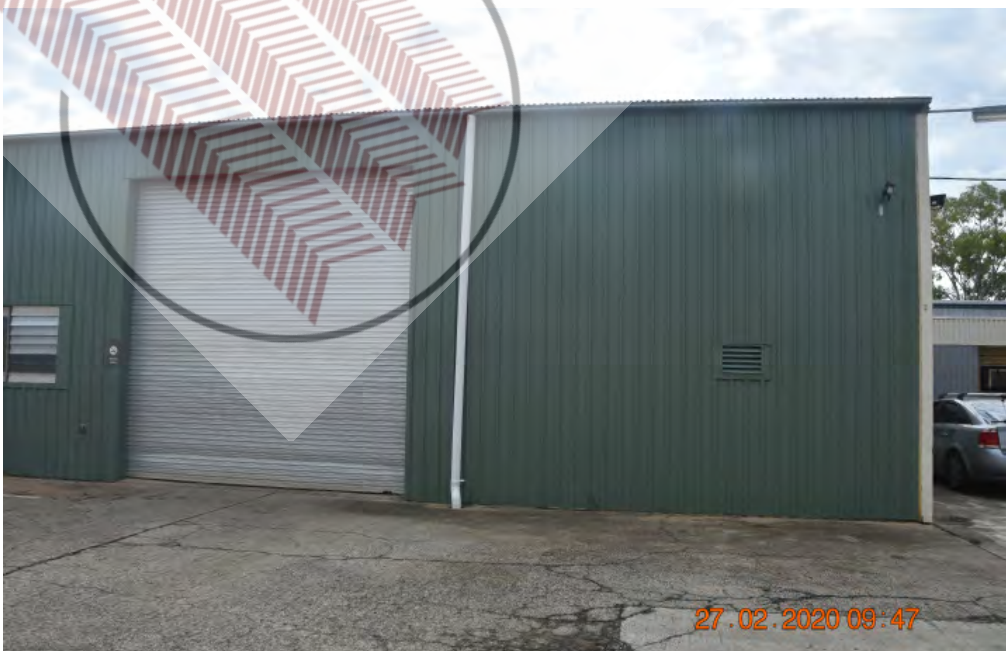
Figure: 0177

Left wall of the building, front side.

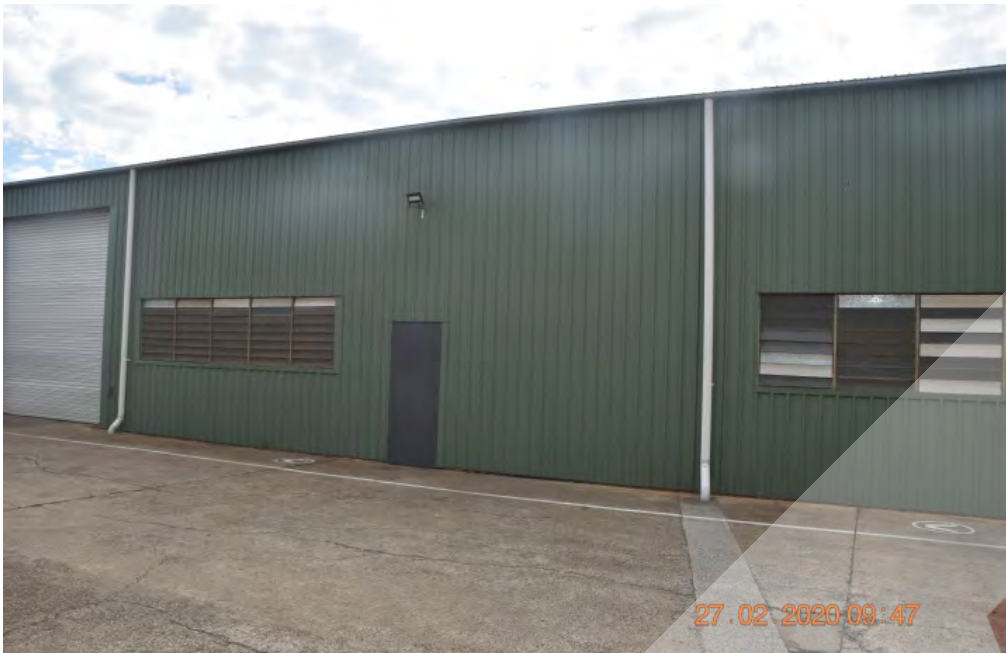
Figure: 0178

Left wall of the building.

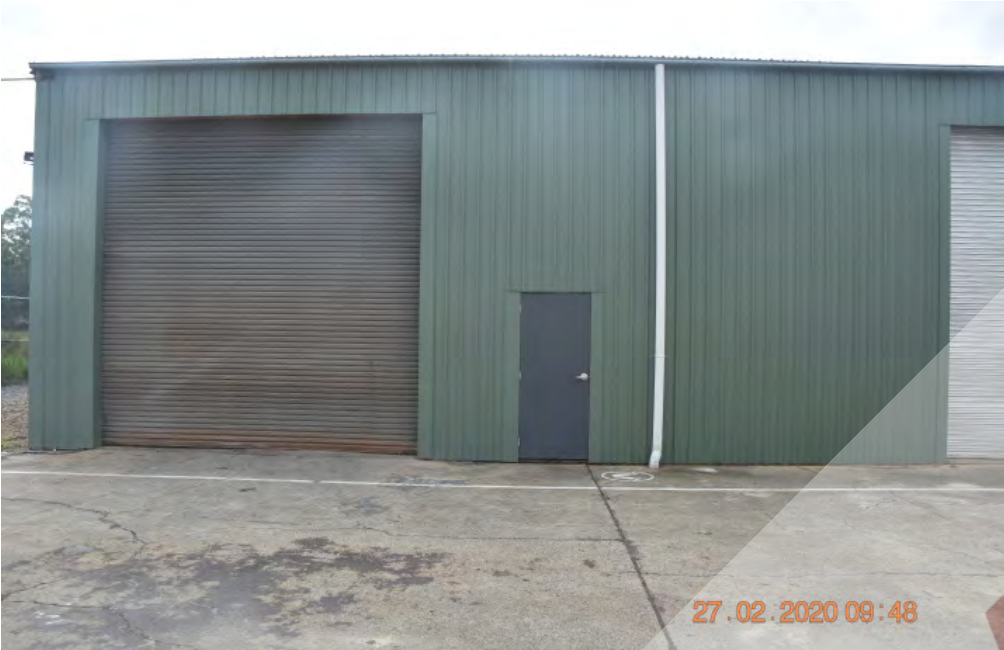
Figure: 0181

Left wall of the building, rear side.

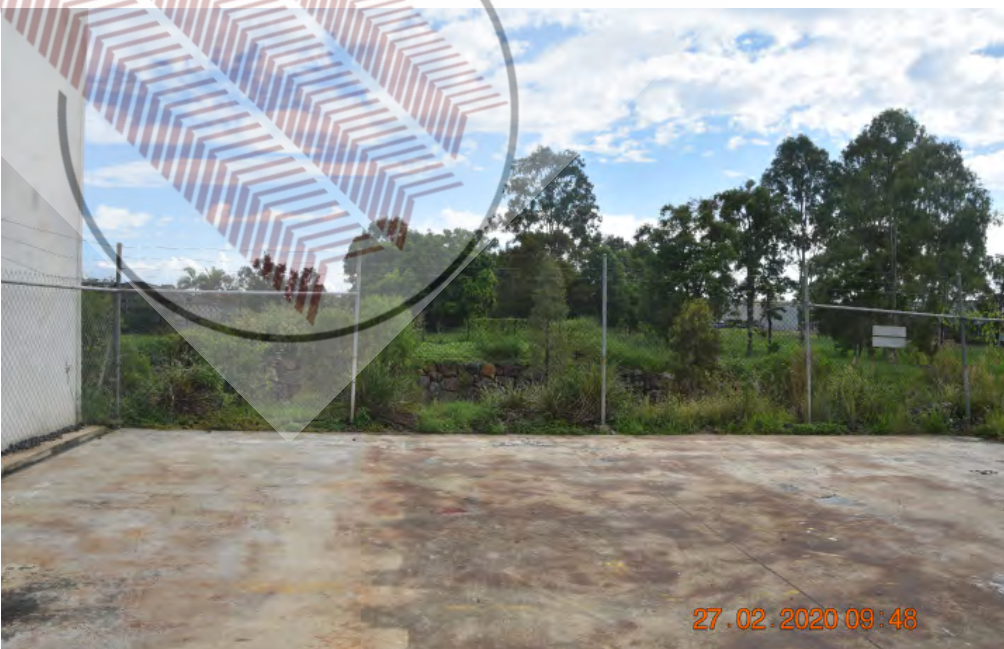
Figure: 0183

Rear boundary fence, left side.

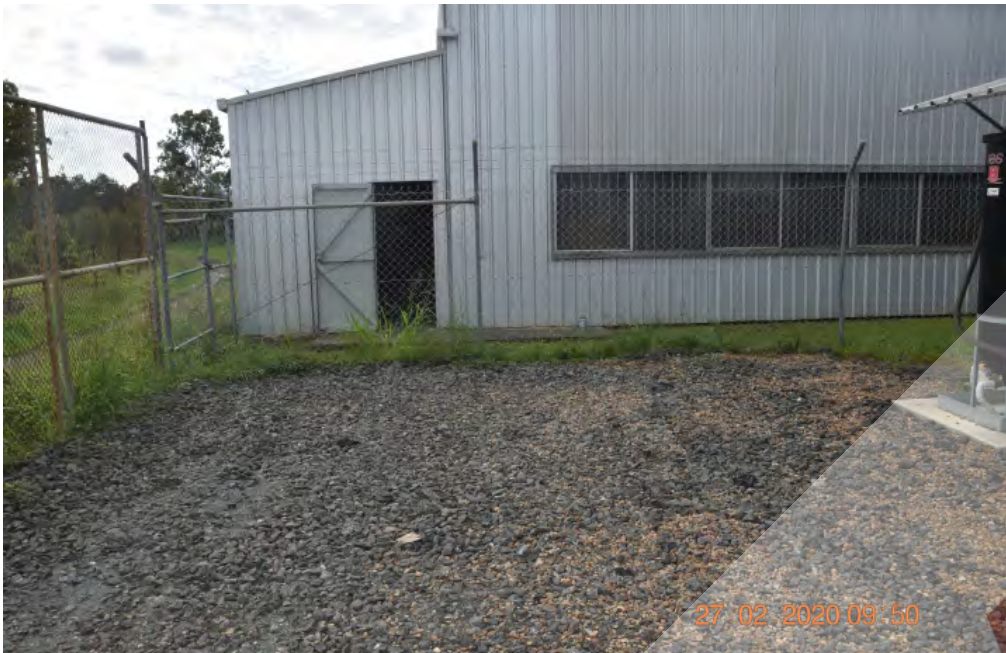
Figure: 0187

Right boundary fence, rear side.

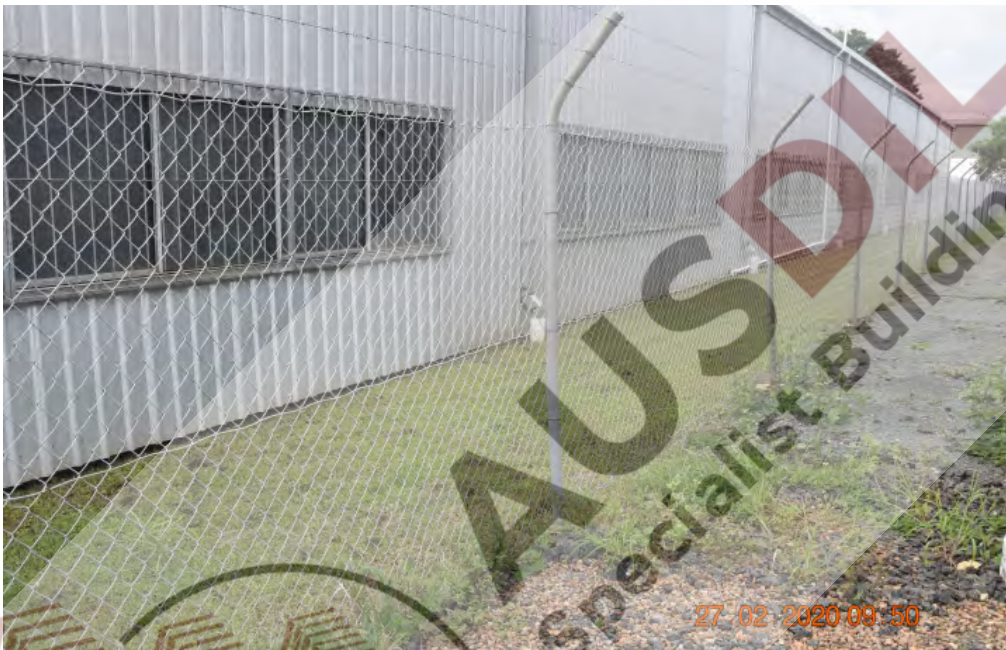
Figure: 0188

Right boundary fence, looking from the rear.

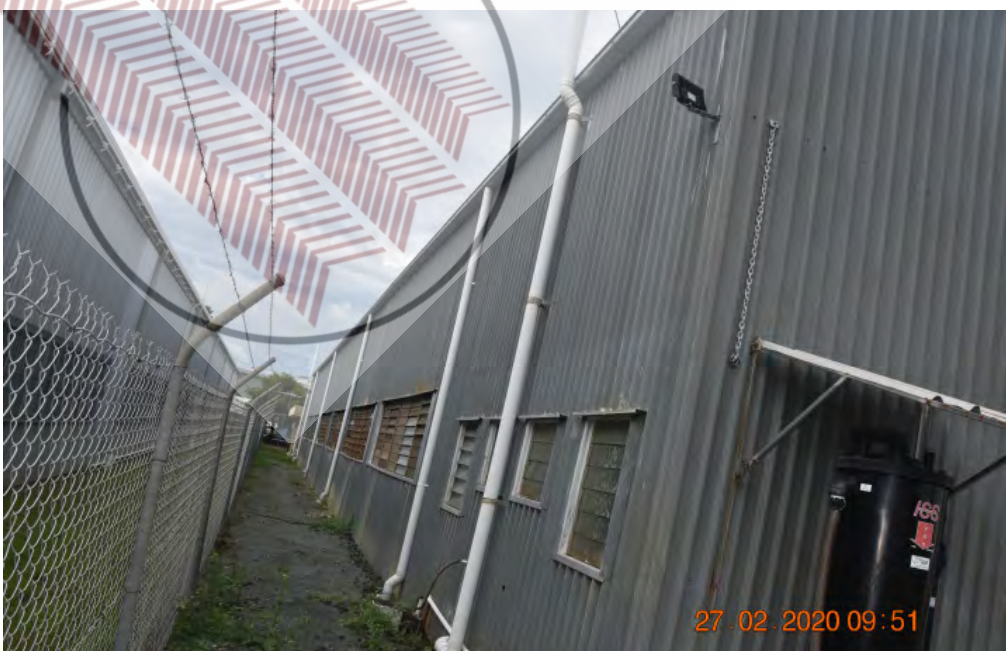
Figure: 0189

Right wall of the building, looking from the rear.

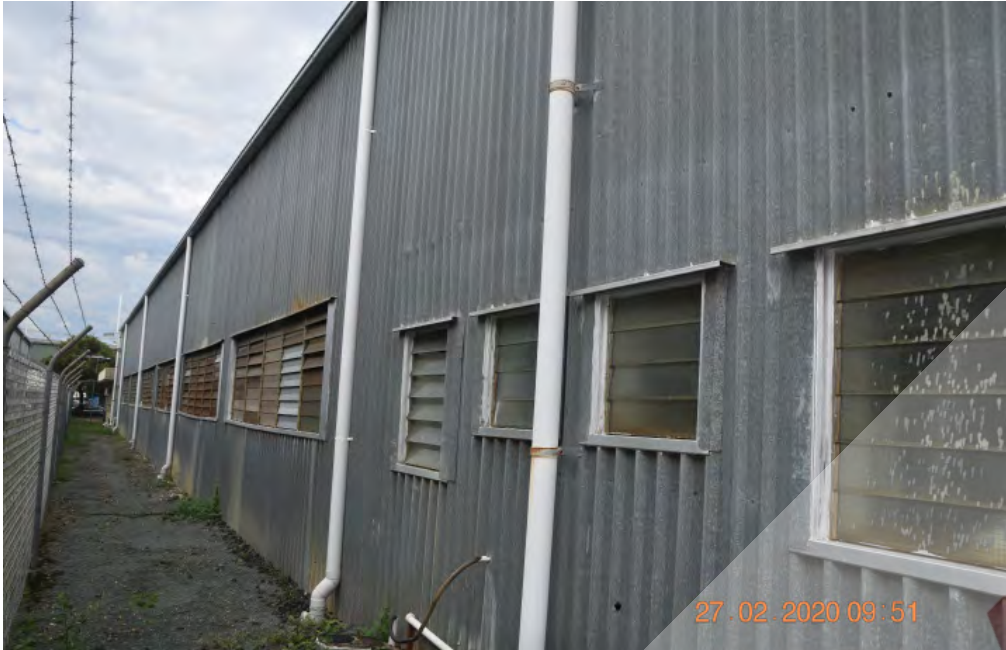
Figure: 0190

Right wall of the building.

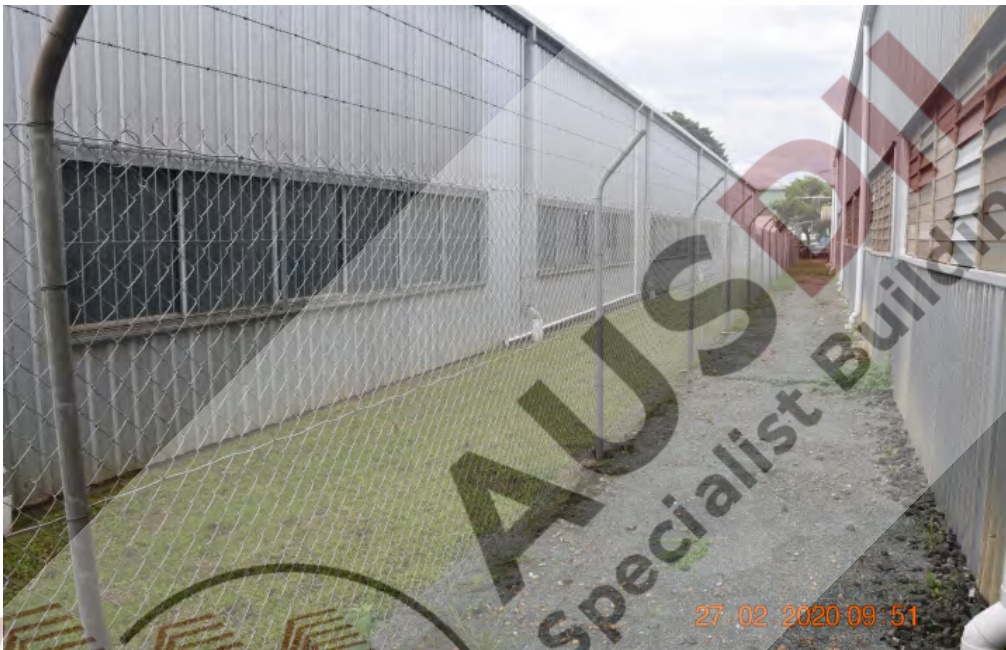
Figure: 0191

General view of the pathway on the right side of the building.

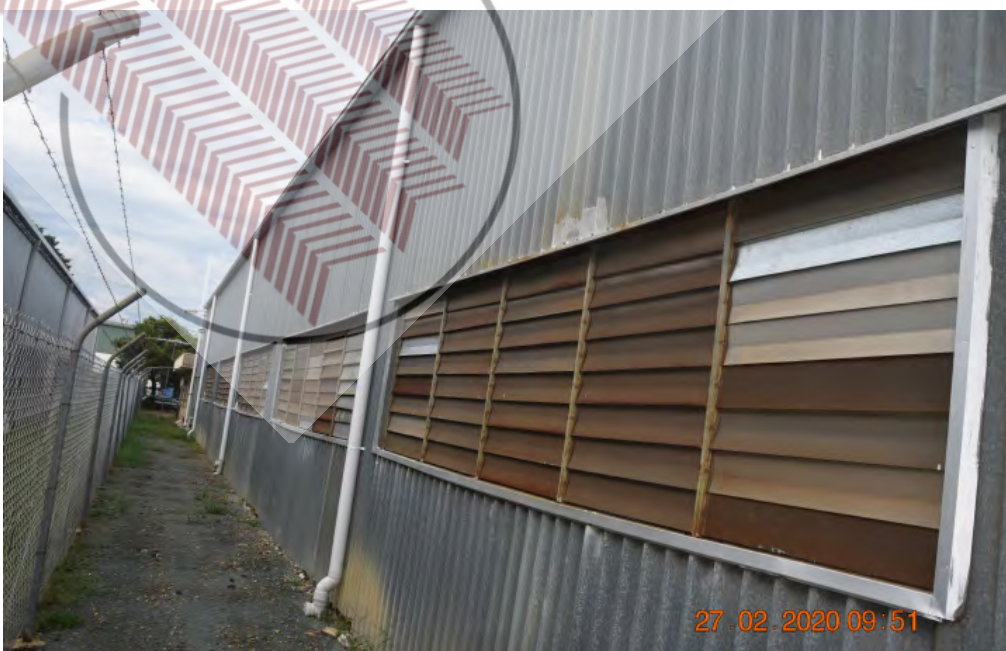
Figure: 0192

Right wall of the building.

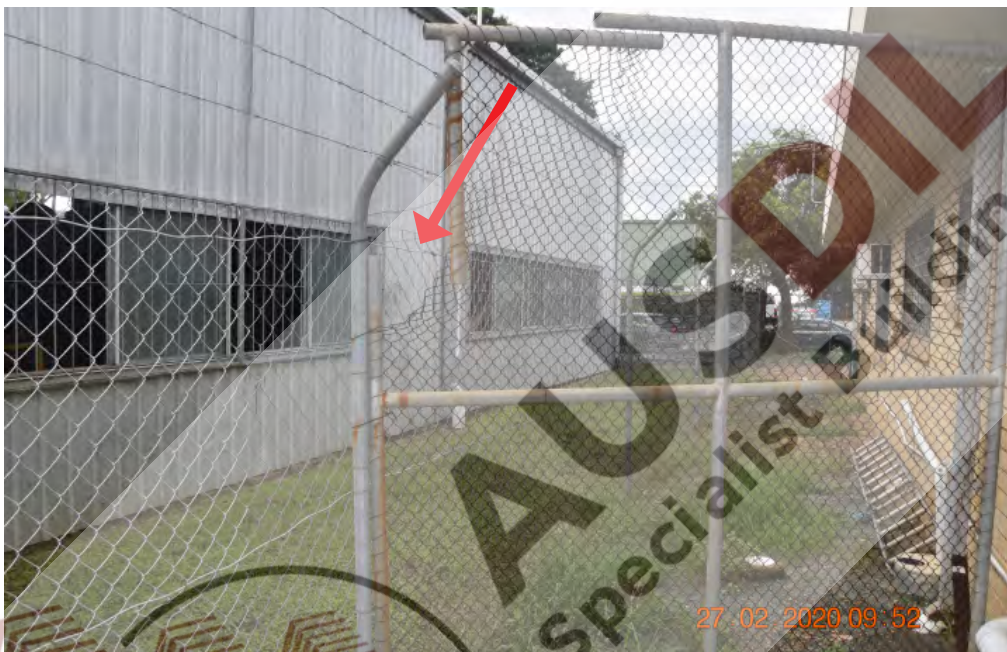
Figure: 0193

Right boundary fence.
