AUSDILAPS
Specialist Building Inspections

PRE-CONSTRUCTION CONDITION SURVEY

INSPECTION DATE: November 28, 2024

INSPECTOR: Niroshan Rudrakumar
B.Eng, MIEAust | Civil
Civil Engineer

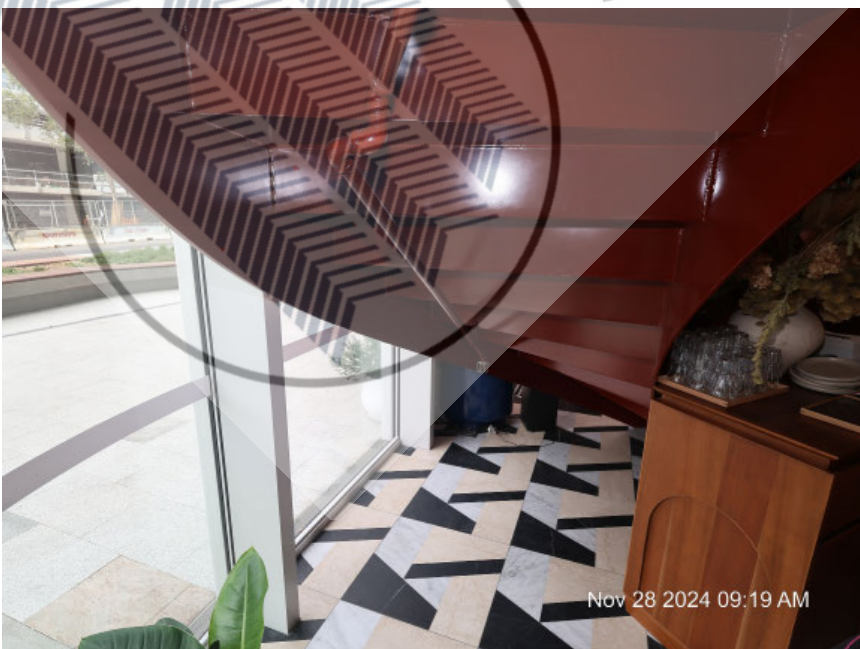
Figure: 0047

South wall in the shop, adjacent to the stairway.

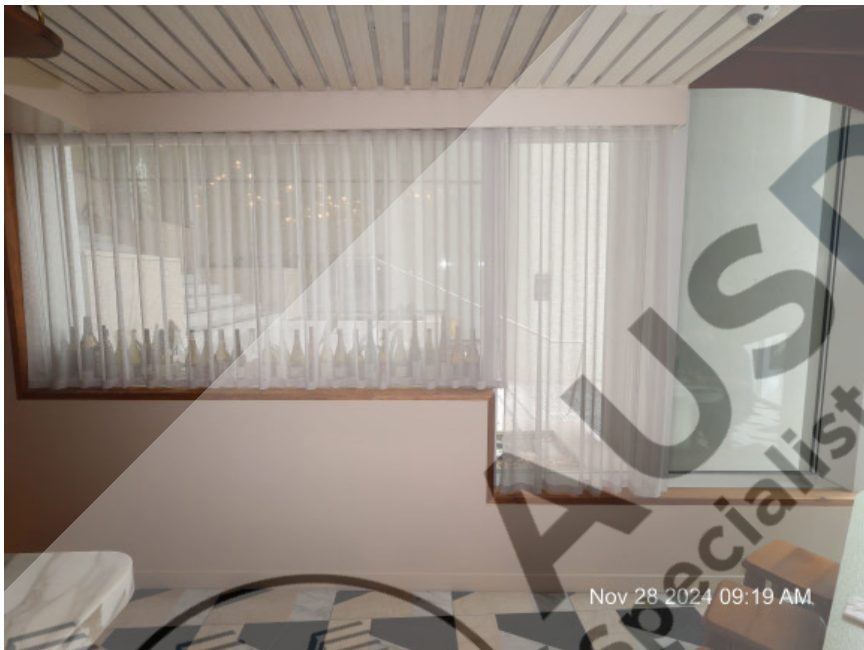
Figure: 0052

East wall in the shop dining area,
south side.

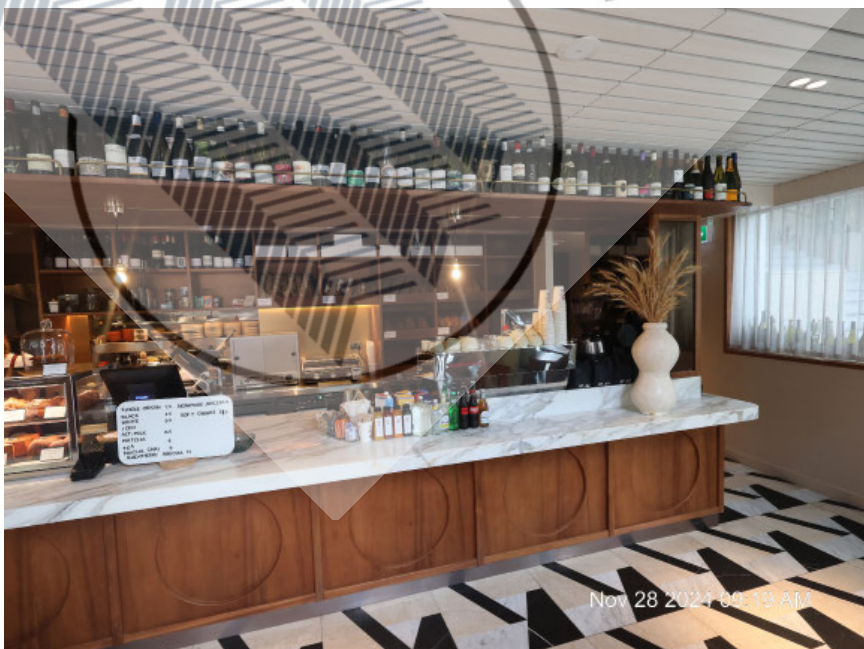
Figure: 0053

East wall in the shop dining area.

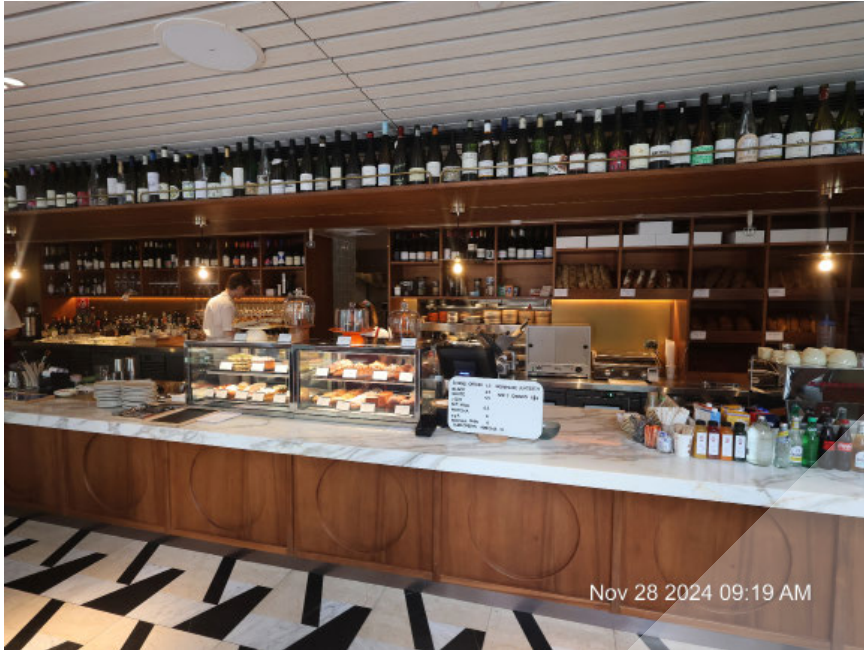
Figure: 0054

Stationary area in the shop,
looking north.

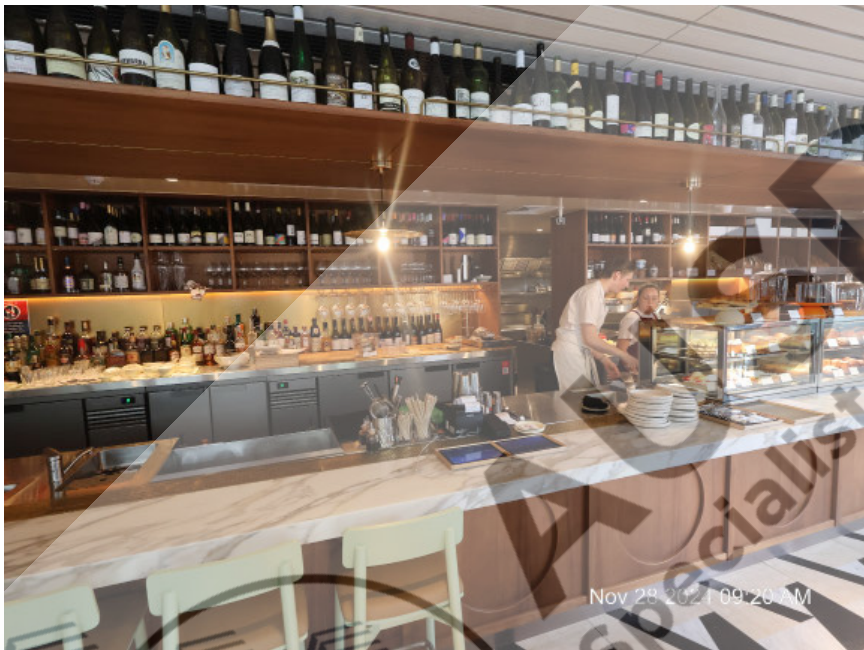
Figure: 0055

Stationary area in the shop,
looking north.

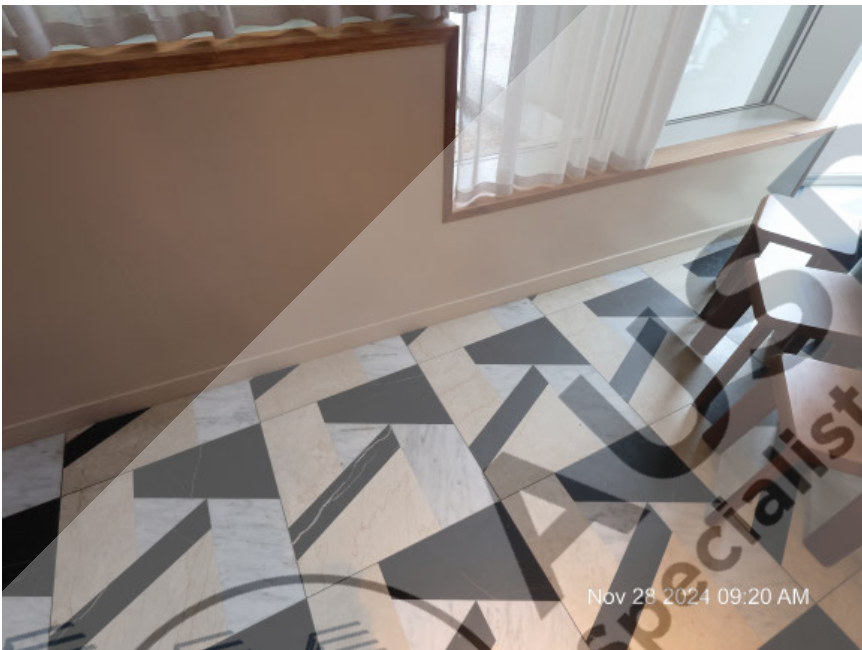
Figure: 0058

General view of the flooring in the shop dining area, looking east.

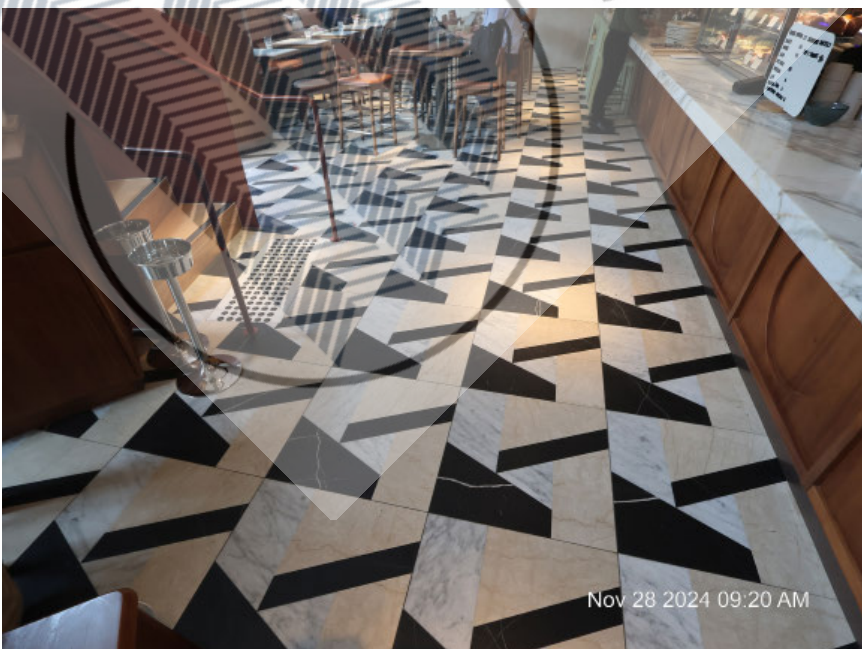
Figure: 0059

Flooring in the shop dining area, east side.

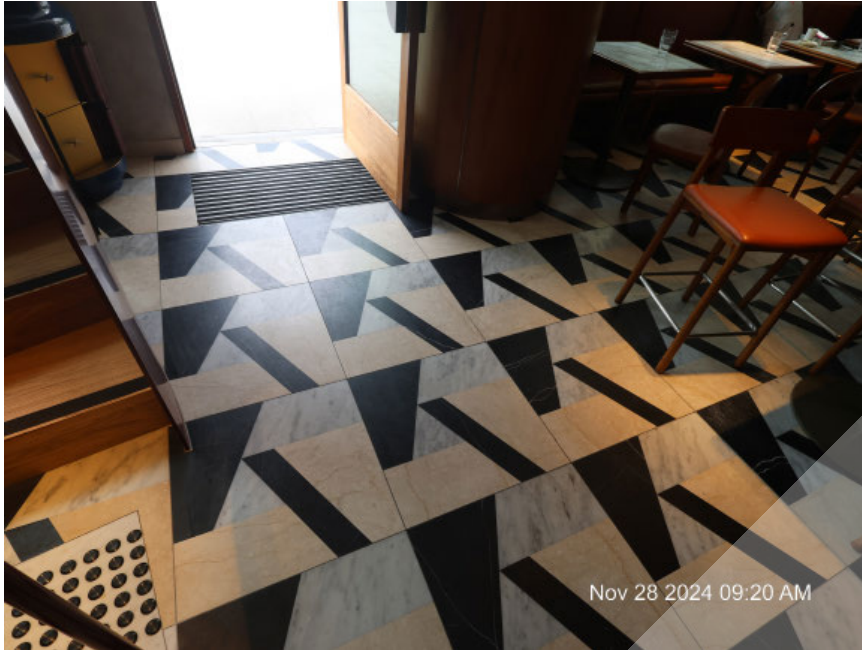
Figure: 0060

General view of the flooring in the shop, looking west.

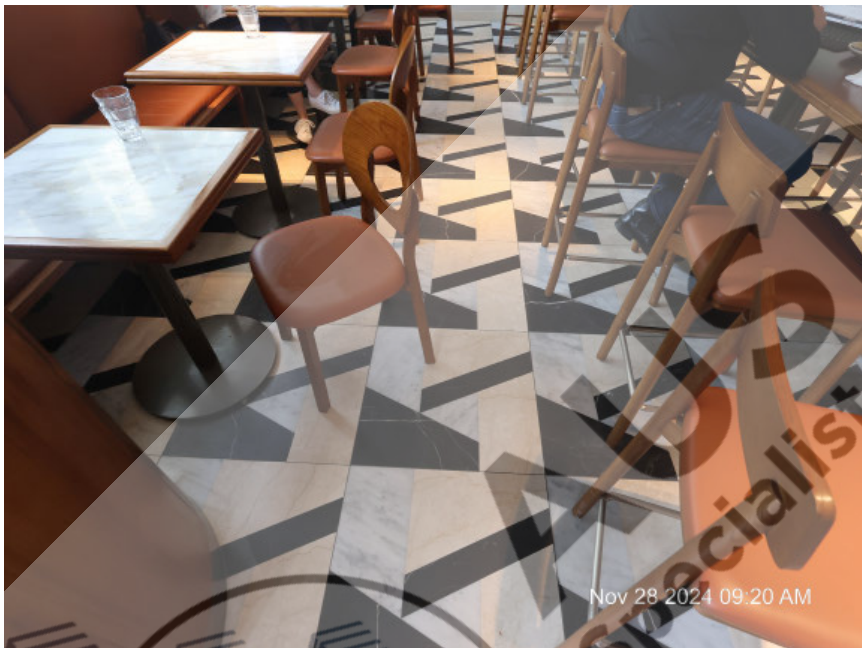
Figure: 0061

General view of the flooring in the shop entryway, looking south.

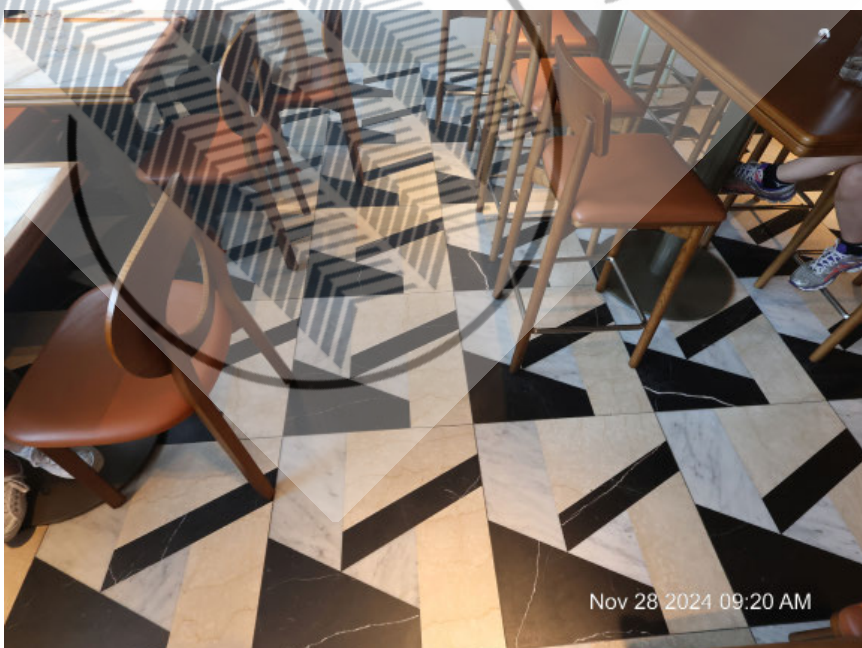
Figure: 0062

General view of the flooring in the shop dining area, looking west.

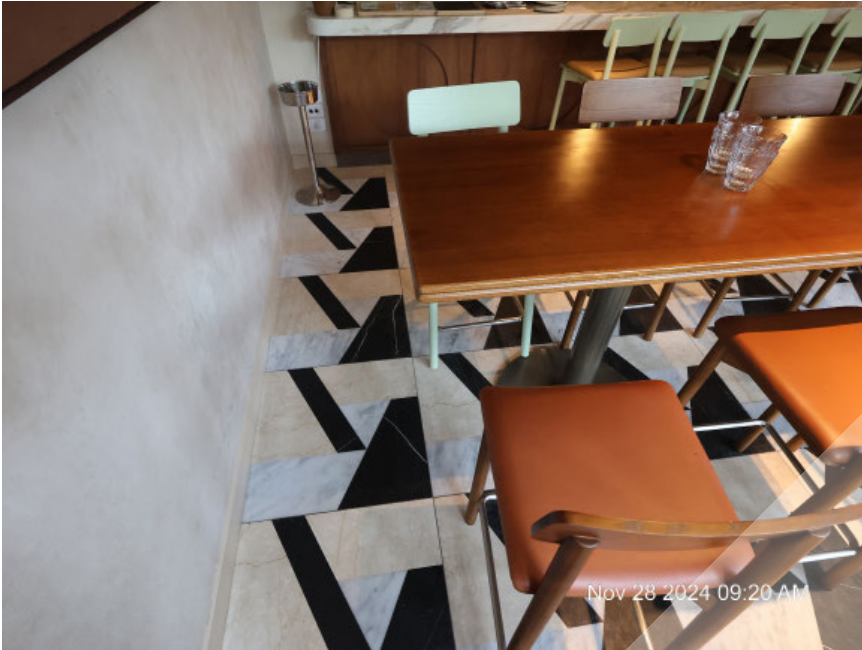
Figure: 0063

General view of the flooring in the shop dining area, looking west.

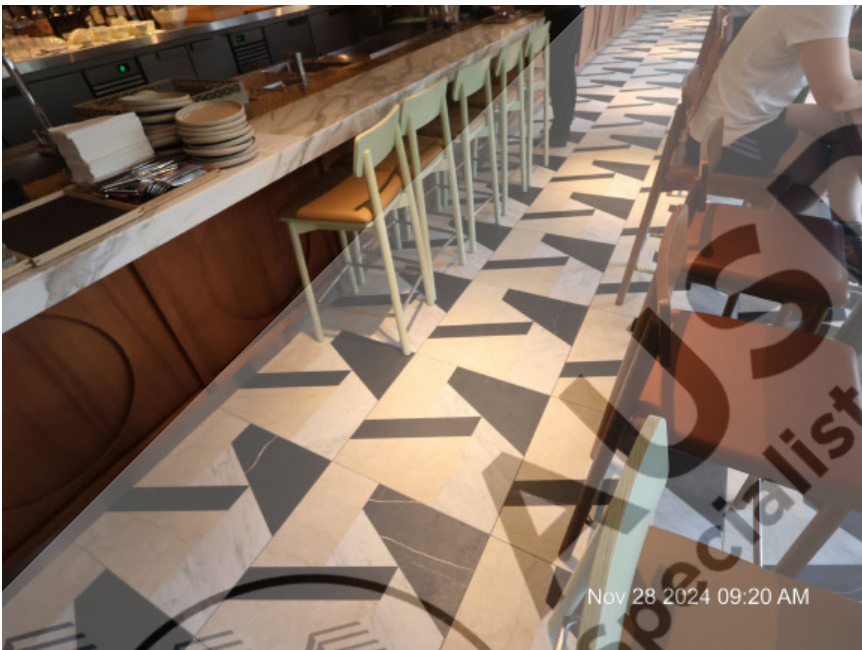
Figure: 0064

Flooring in the shop dining area,
west side.

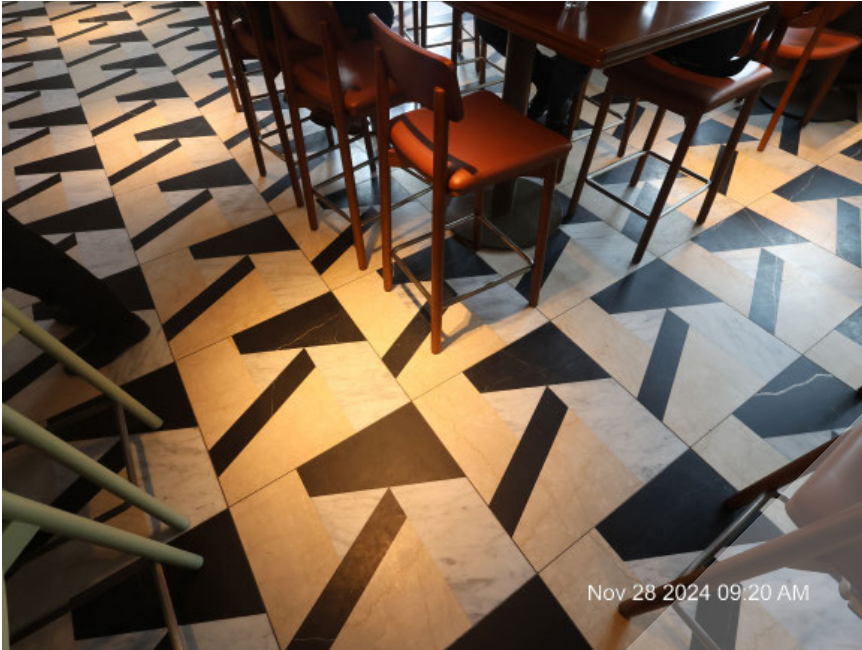
Figure: 0066

Flooring in the shop dining area,
west side.

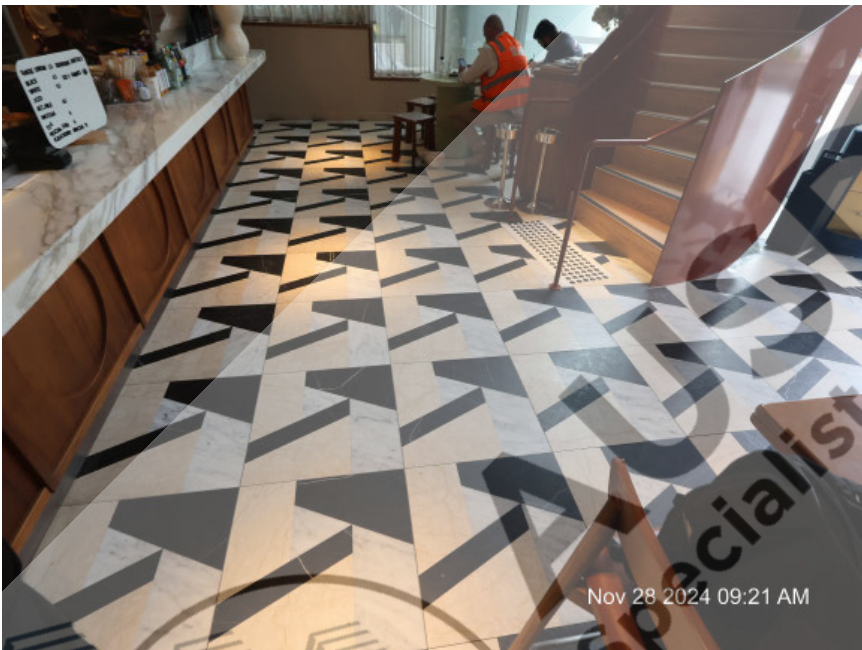
Figure: 0067

Flooring in the shop dining area, looking east.

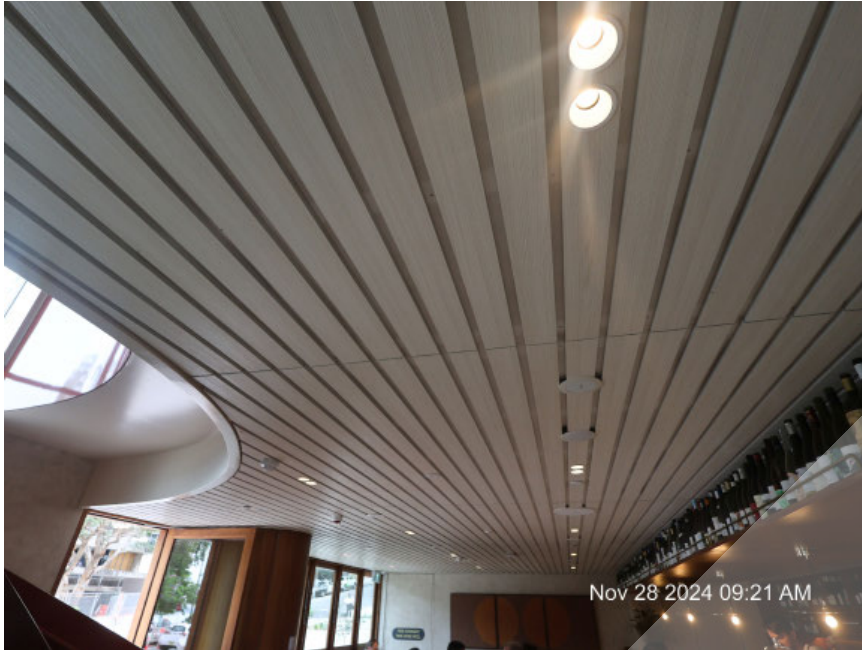
Figure: 0069

Ceiling in the shop dining area, looking east.

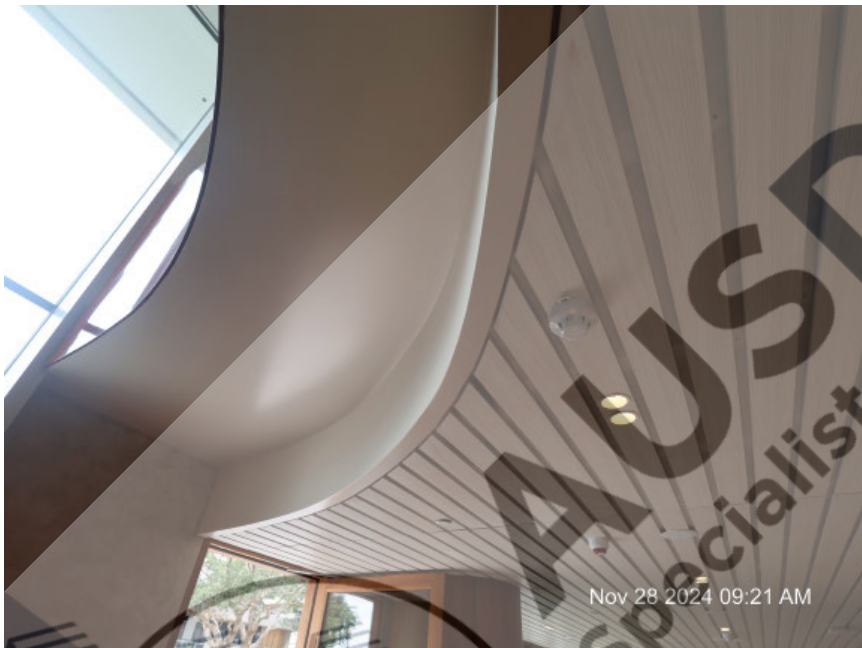
Figure: 0070

Ceiling in the shop dining area,
looking west.

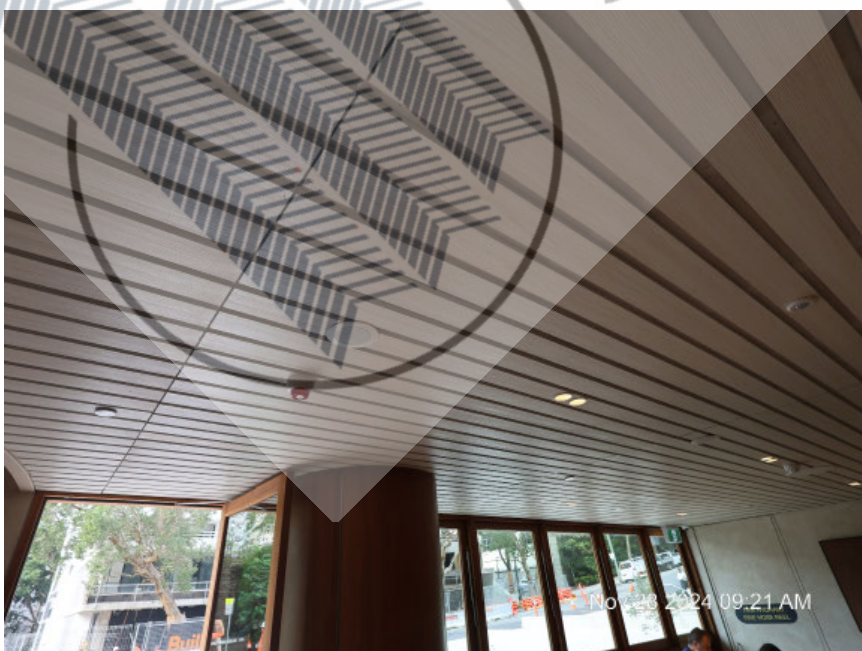
Figure: 0071

Ceiling in the shop entryway,
looking east.

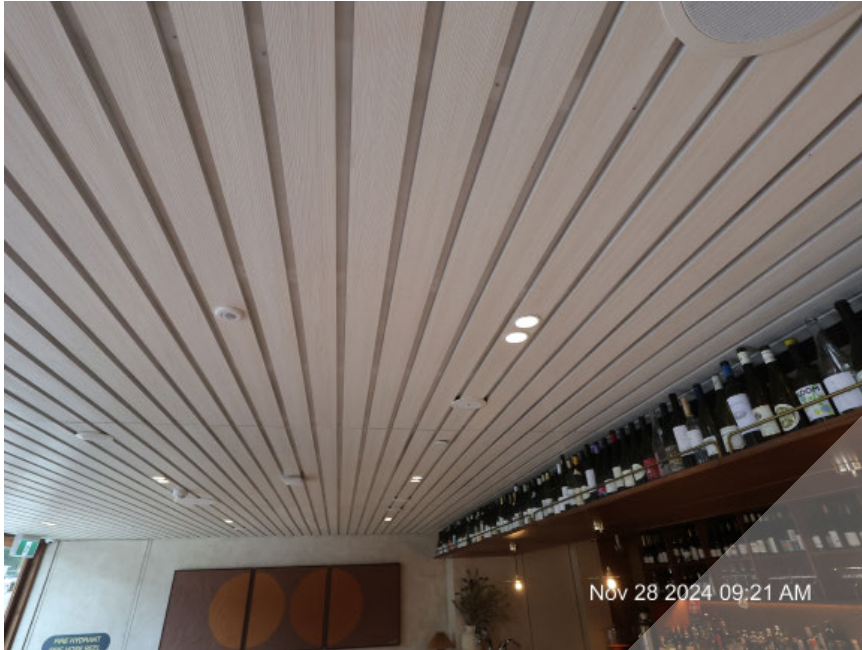
Figure: 0072

Ceiling in the shop dining area,
looking southwest.

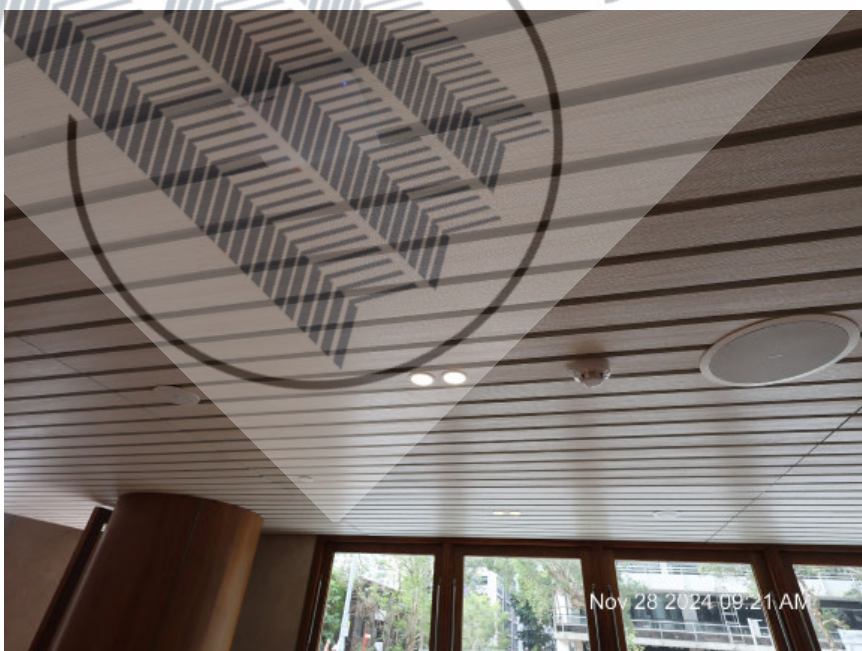
Figure: 0074

Ceiling in the shop dining area,
looking west.

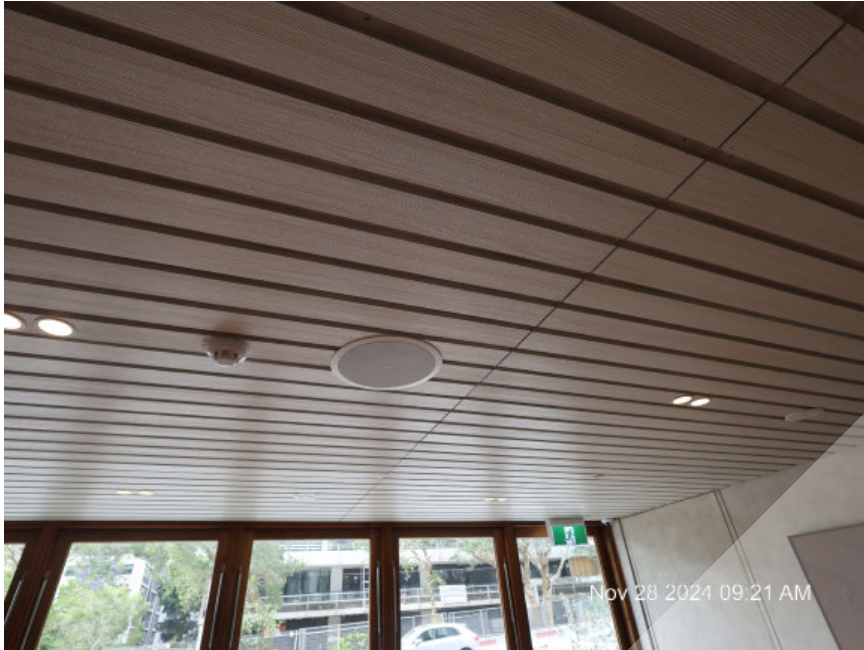
Figure: 0075

Ceiling in the shop dining area,
looking south.

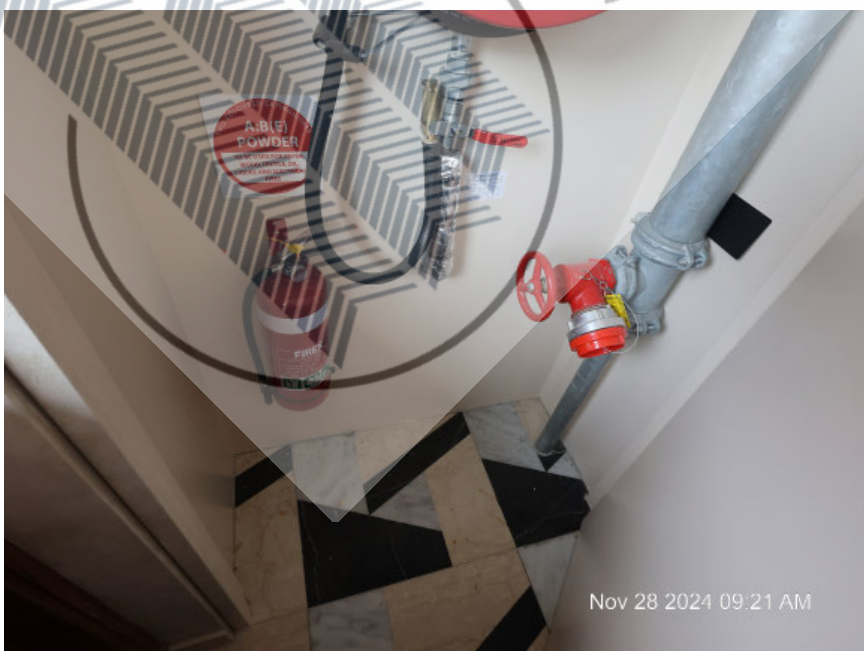
Figure: 0077

Fire hose reel cabinet in the shop, west side.

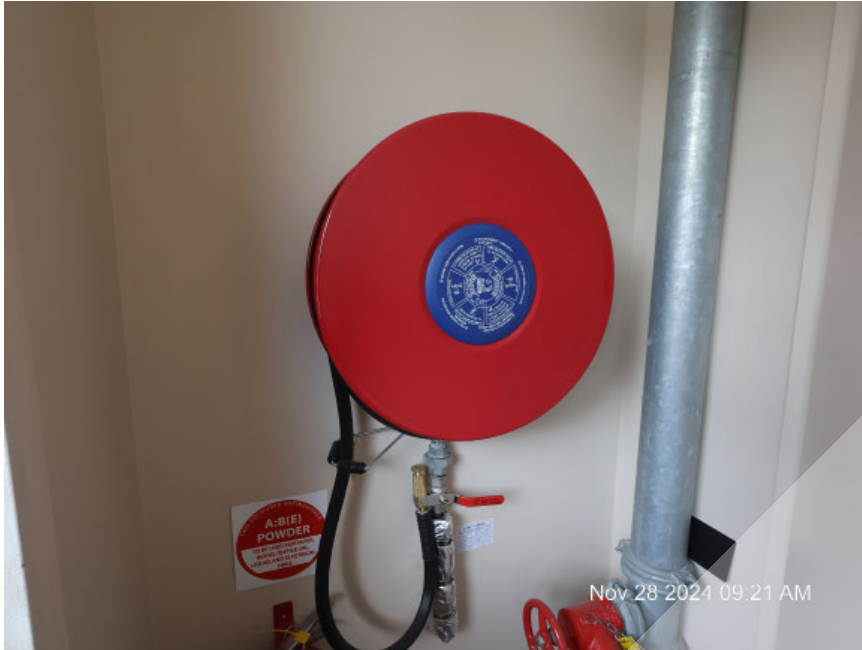
Figure: 0078

Fire hose reel cabinet in the shop, west side.

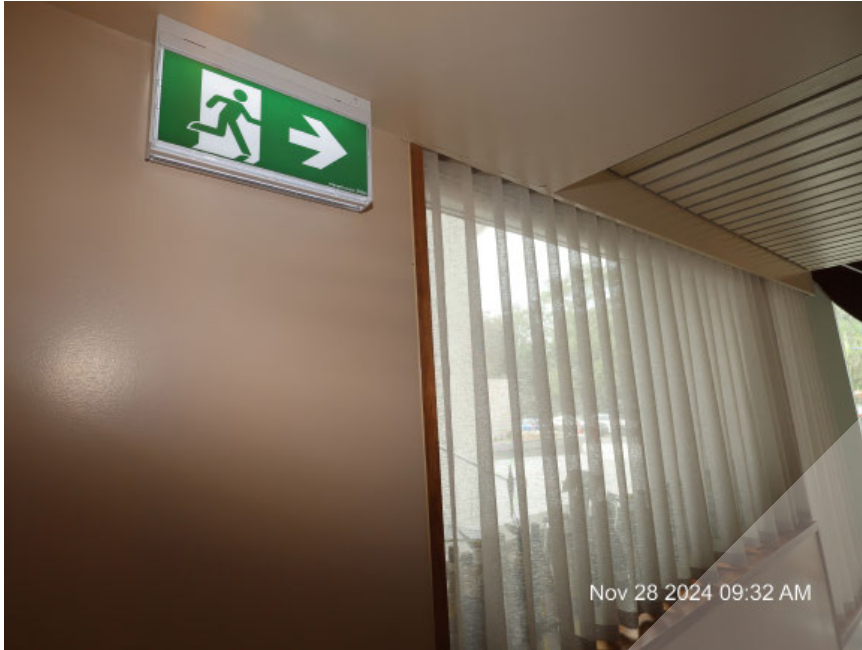
Figure: 0084

East wall in the shop hallway.

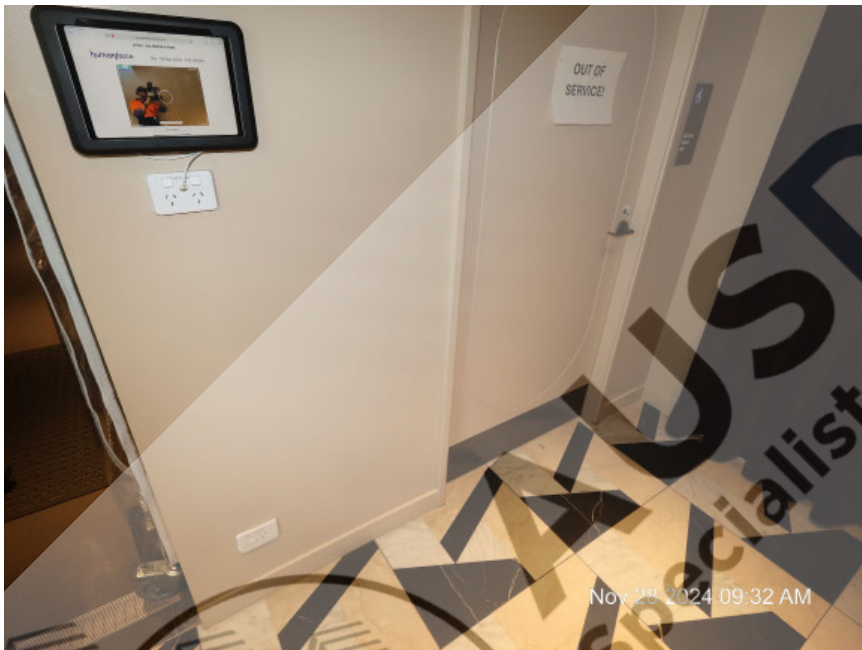
Figure: 0088

West wall in the shop hallway.
