PRE-CONSTRUCTION CONDITION SURVEY

INSPECTION DATE: February 13, 2025

INSPECTOR: Linda Win
ME (Civil), MEM
Civil Engineer

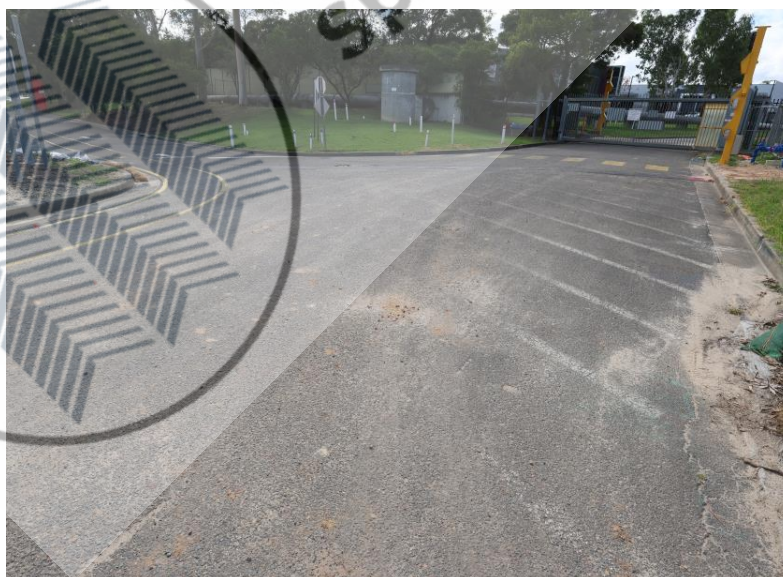
Figure 0003

General view of the roadway on Main Road.

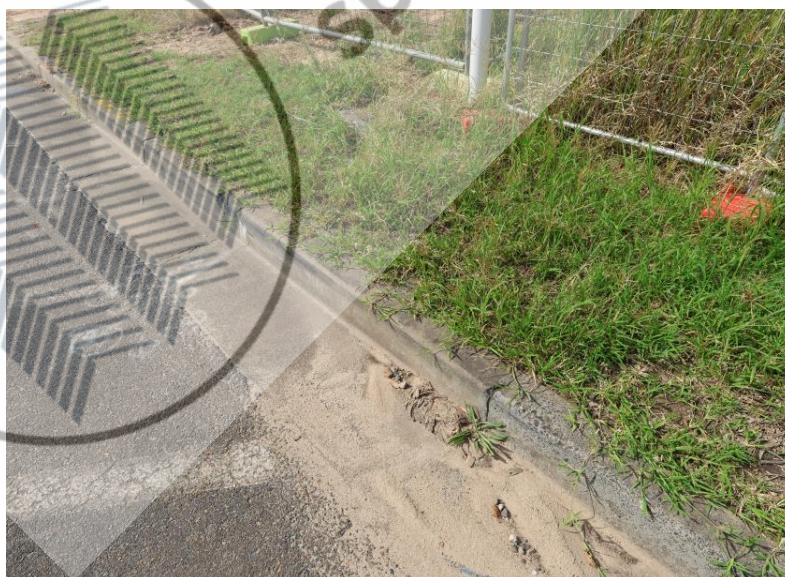
Figure 0006

General view of the kerb and gutter on Main Road.

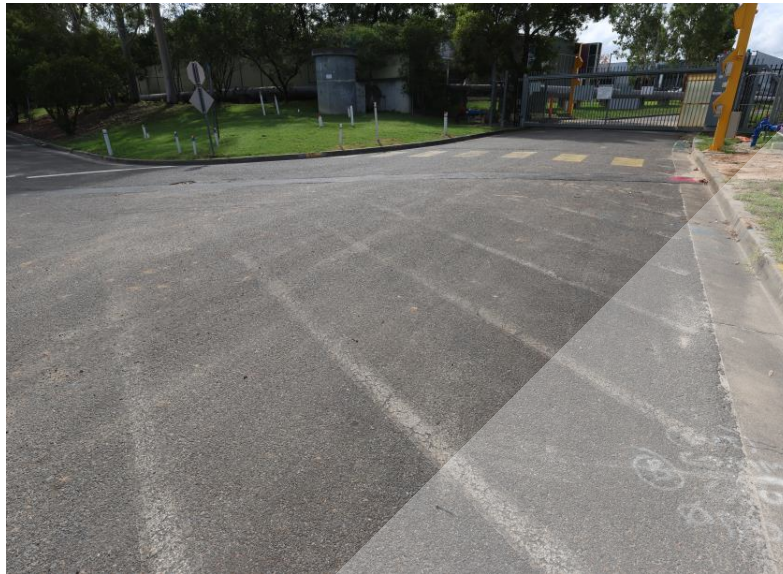
Figure 0007

General view of the roadway on Main Road.

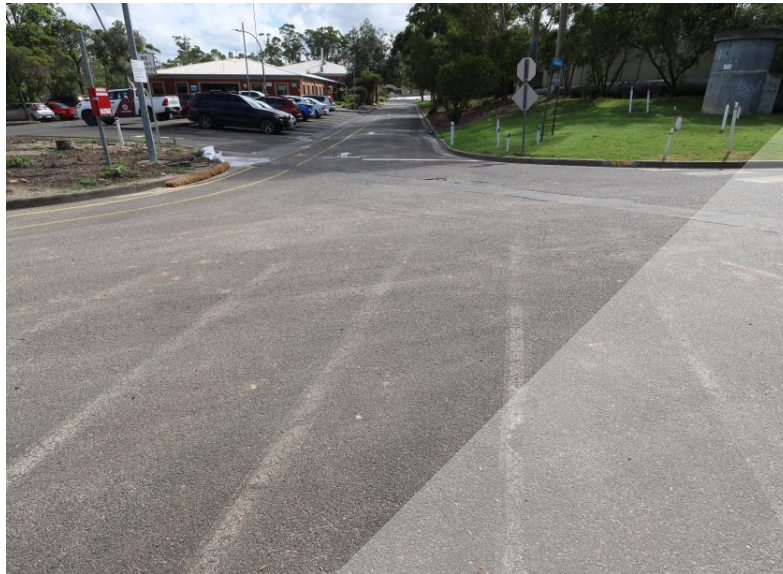
Figure 0010

General view of the roadway on Main Road.

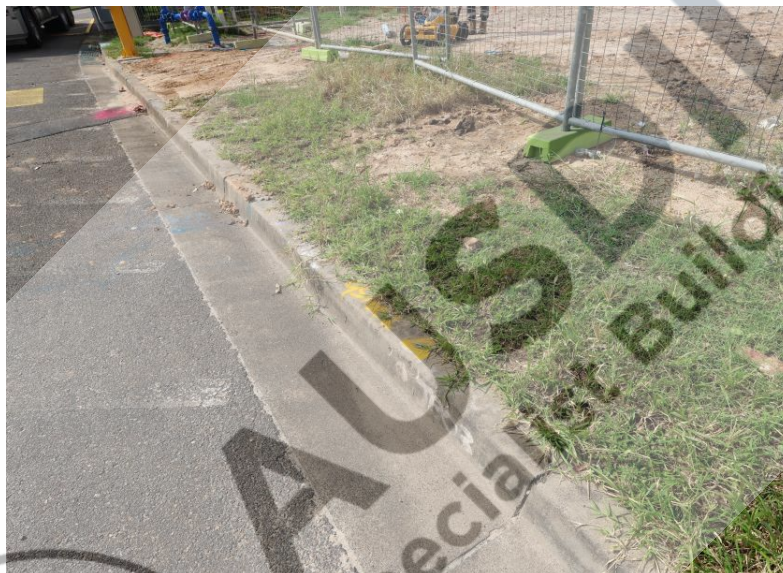
Figure 0011

General view of the kerb and gutter on Main Road.

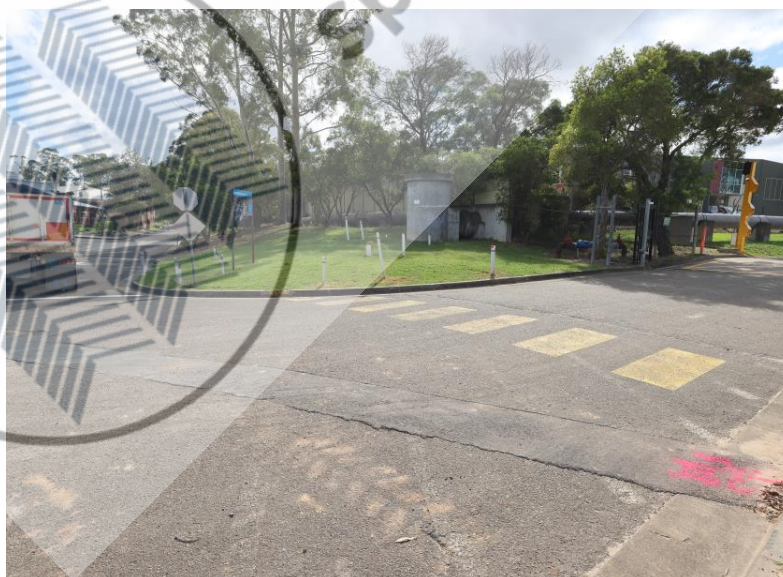
Figure 0012

General view of the roadway on Main Road.

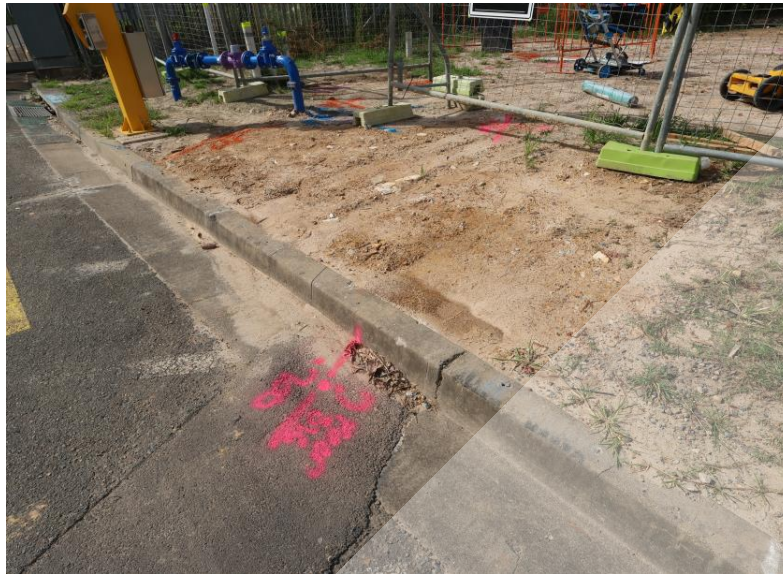
Figure 0013

General view of the curb and gutter on Main Road.

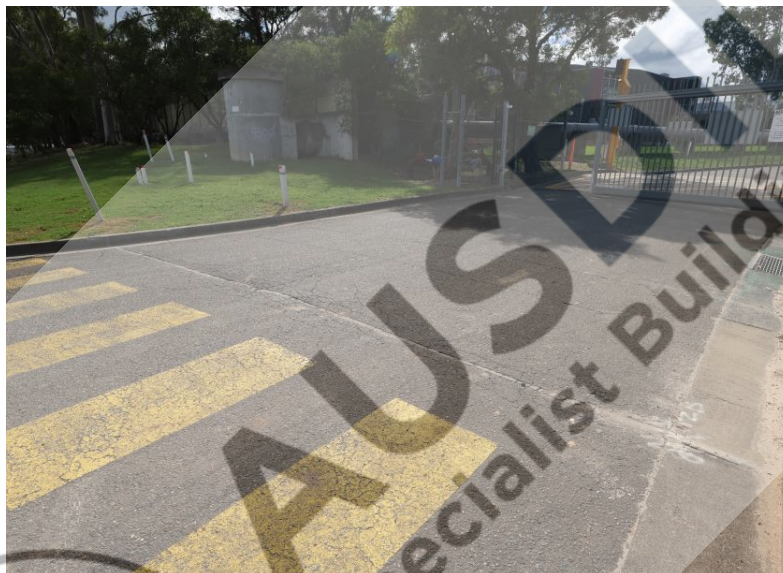
Figure 0014

General view of the roadway on Main Road.

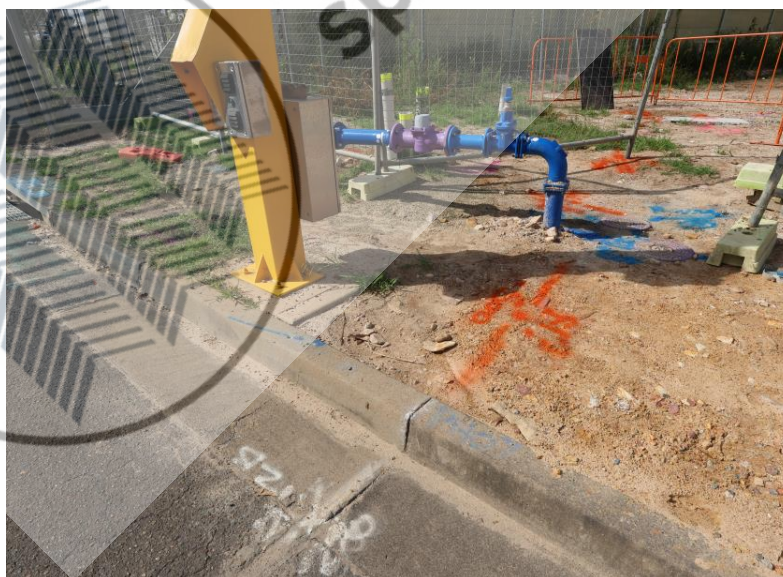
Figure 0015

General view of the curb and gutter on Main Road.

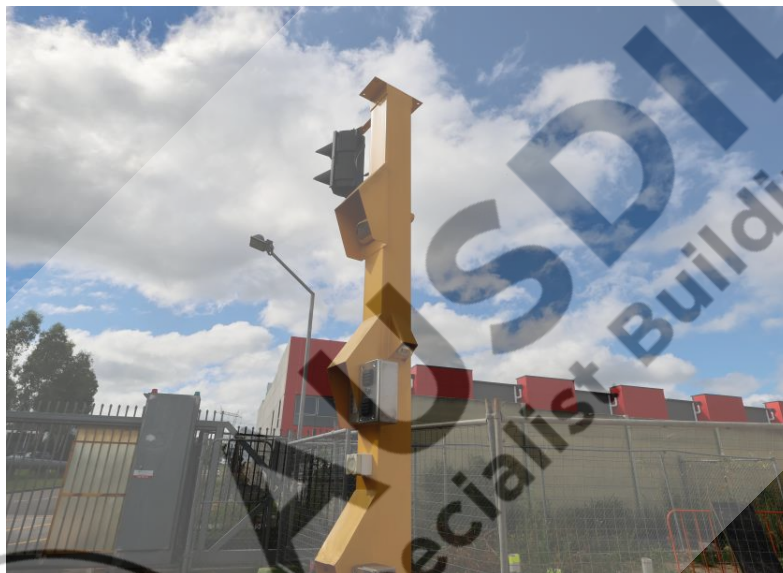
Figure 0017

General view of the signal control on Main Road.

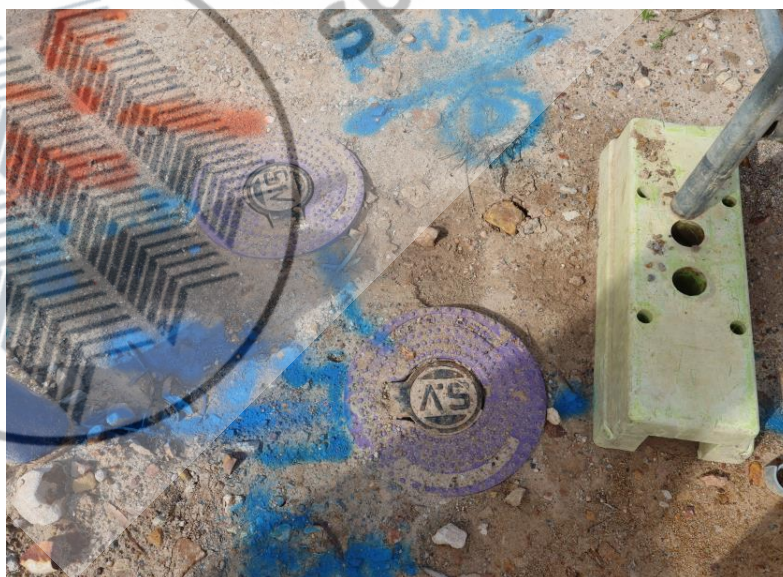
Figure 0018

General view of the pit lid in the grass area on Main Road.

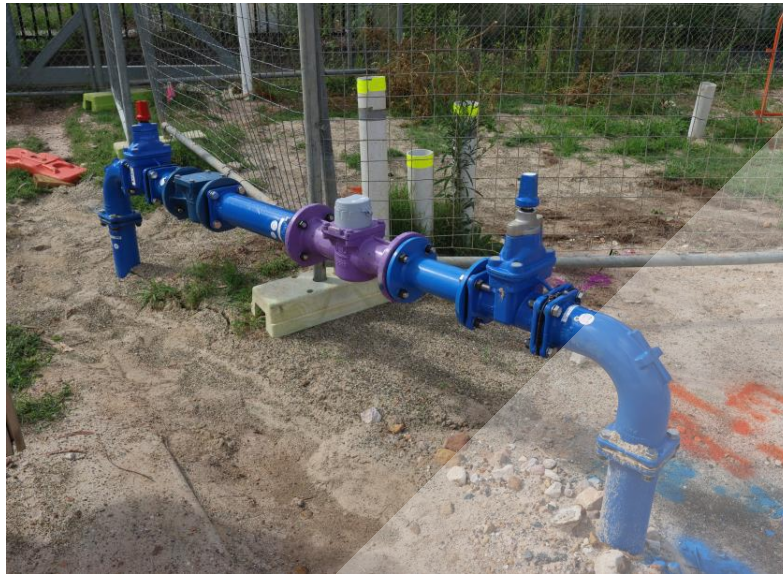
Figure 0019

General view of the fire hydrant on Main Road.

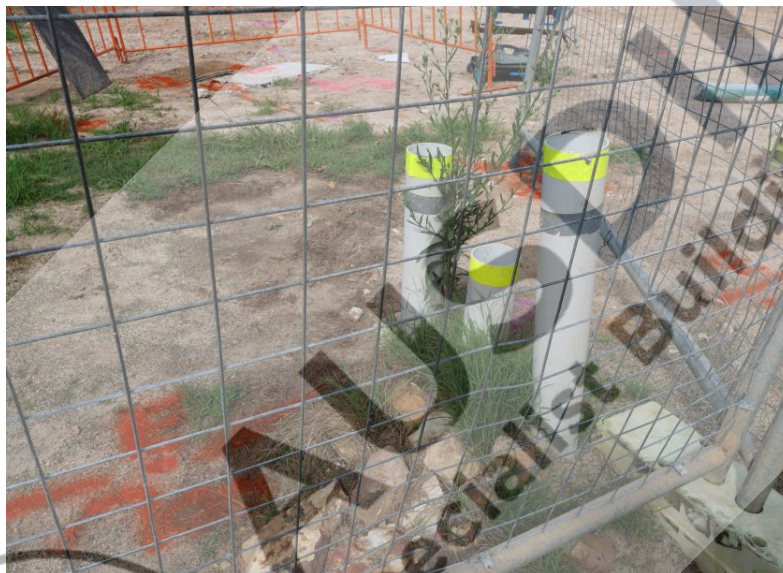
Figure 0020

General view of the pipe in the grass area on Main Road.

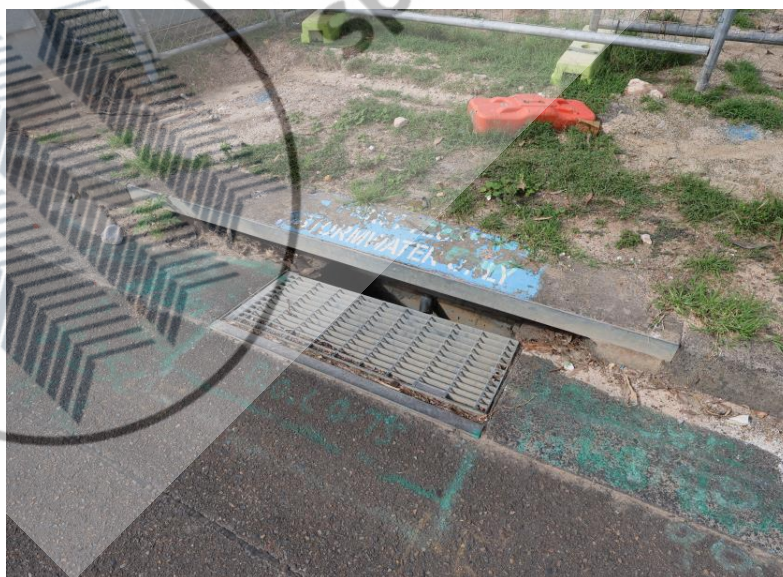
Figure 0021

General view of the storm drain on Main Road.

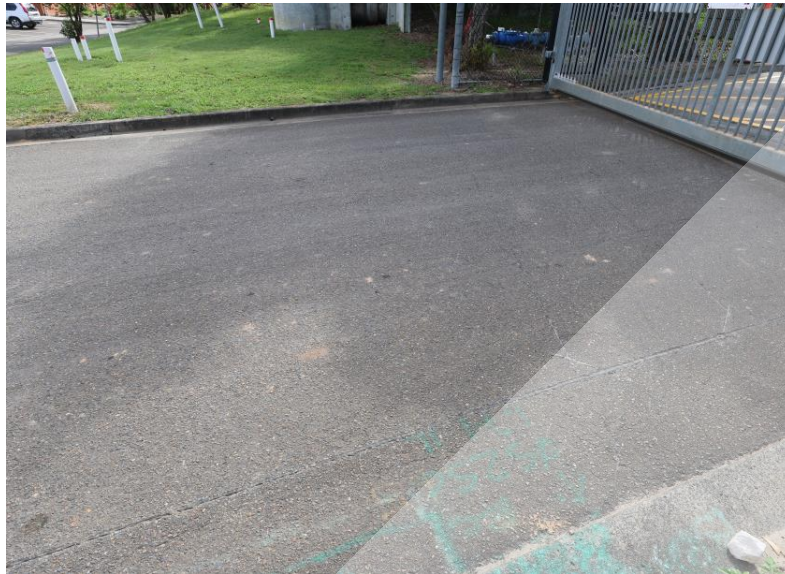
Figure 0022

General view of the roadway on Main Road.

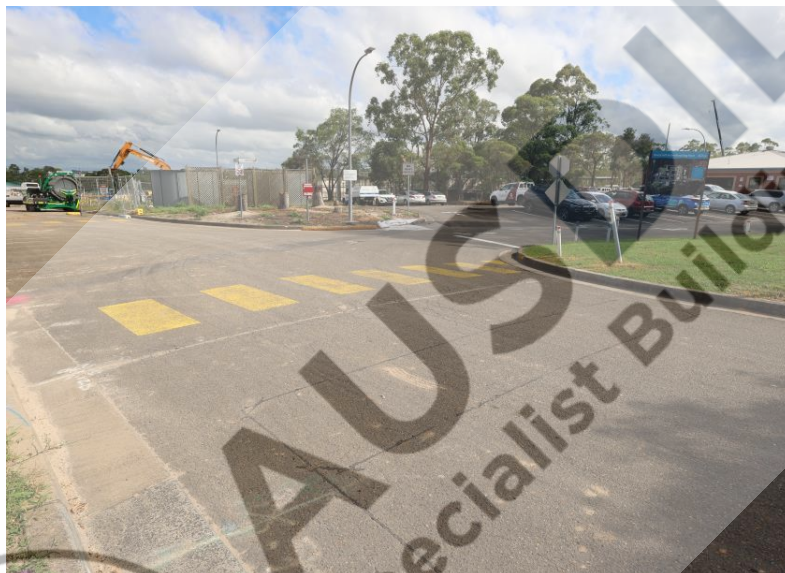
Figure 0023

General view of the roadway on Main Road.

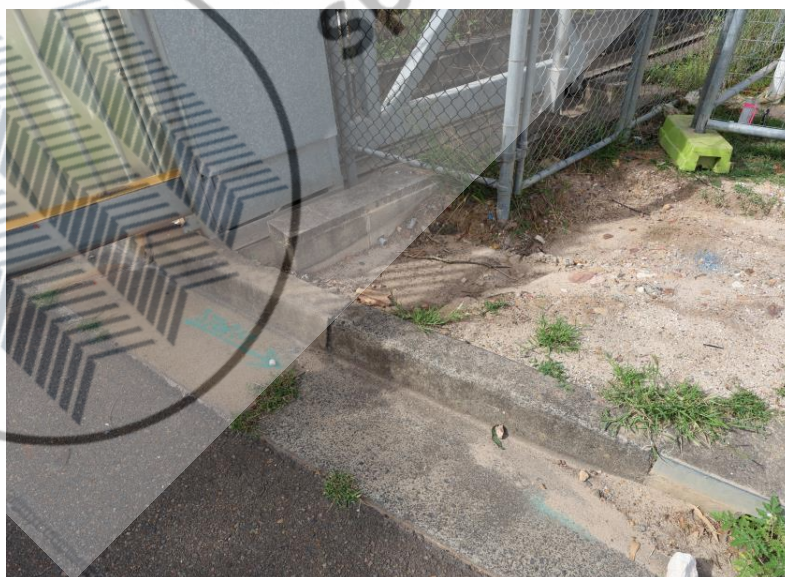
Figure 0024

General view of the kerb and gutter on Main Road.

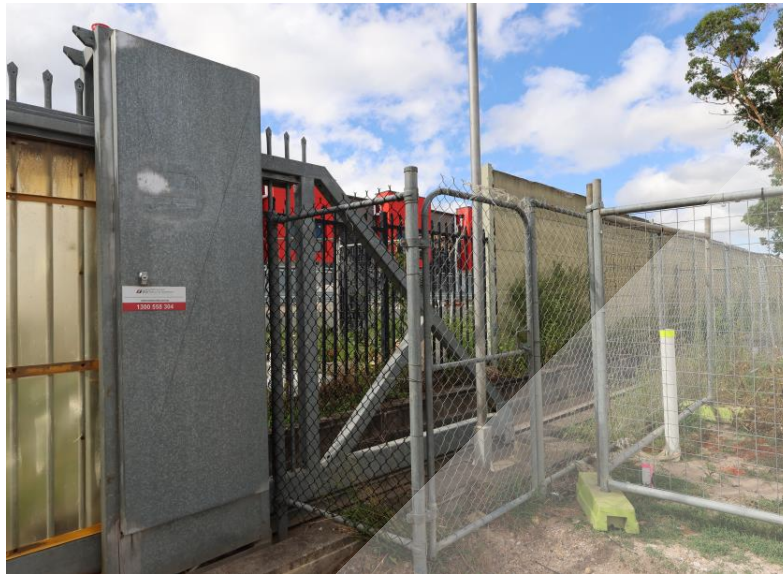
Figure 0025

General view of the gate and fence on Main Road.

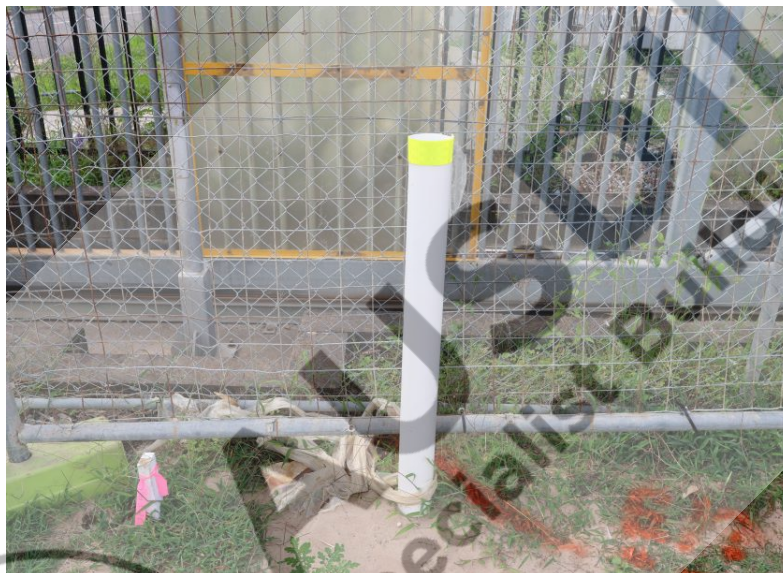
Figure 0026

General view of the pipe in the grass area on Main Road.

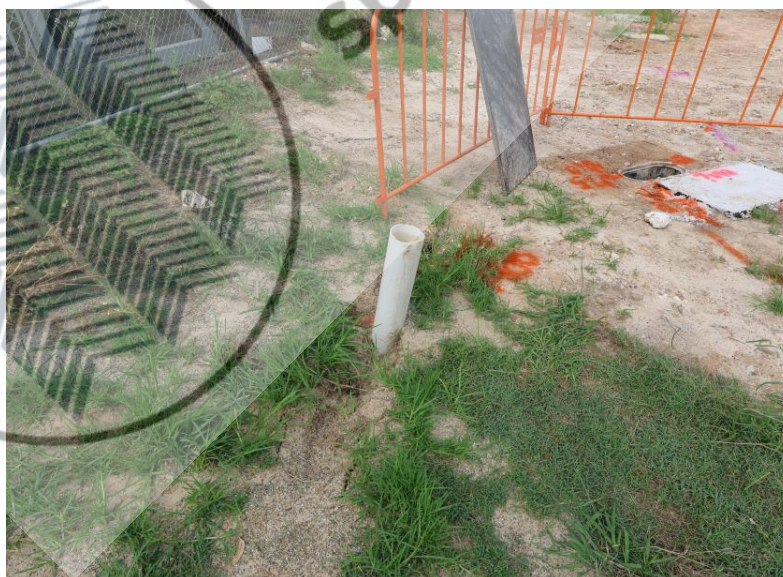
Figure 0027

General view of the pipe in the grass area on Main Road.

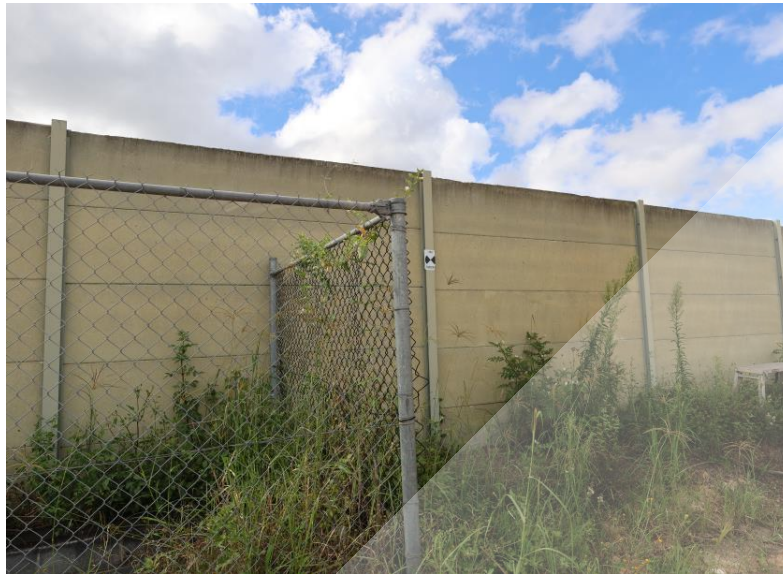
Figure 0031

General view of the fence on Main Road.

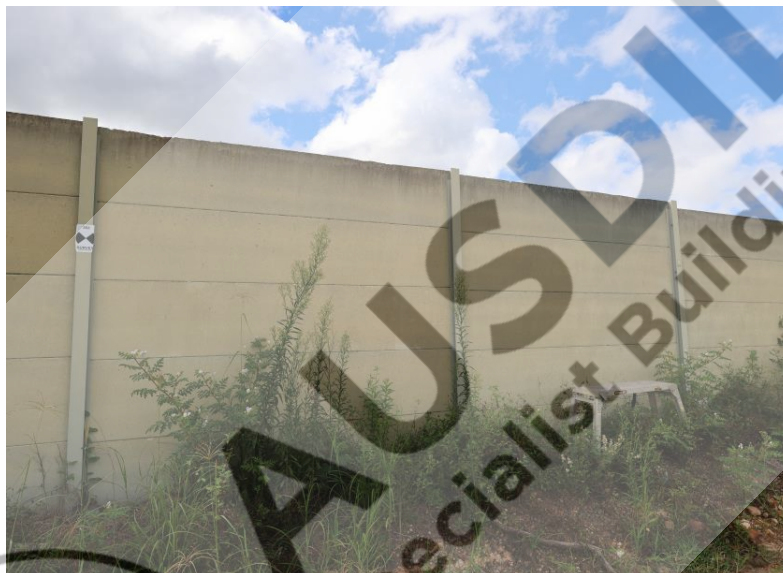
Figure 0032

General view of the fence on Main Road.

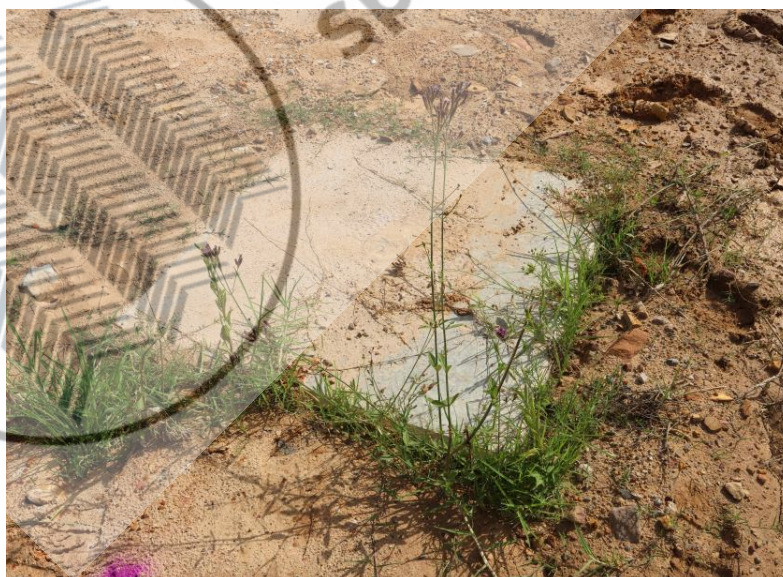
Figure 0033

General view of the pit lid in the grass area on Main Road.

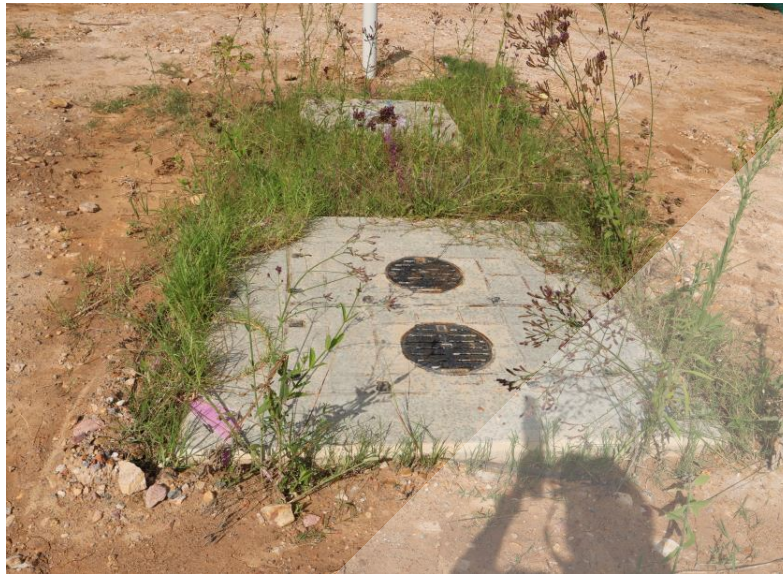
Figure 0034

General view of the pit lids in the grass area on Main Road.

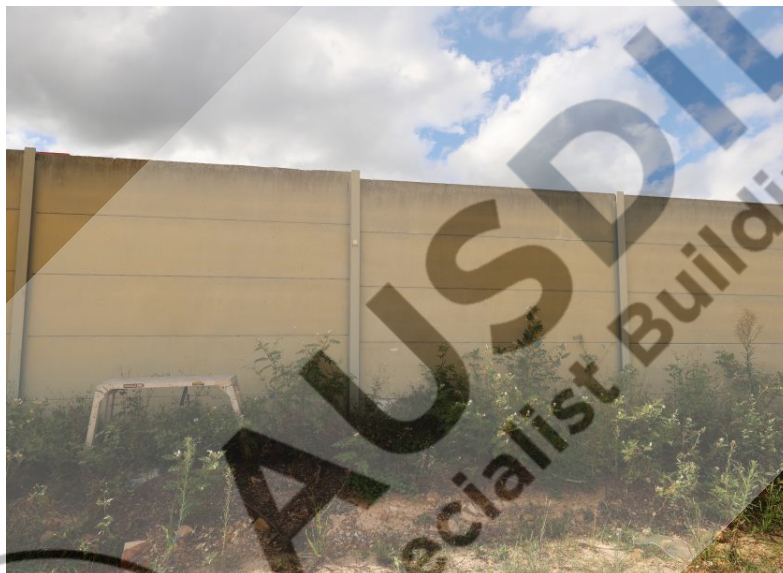
Figure 0035

General view of the boundary wall on Main Road.

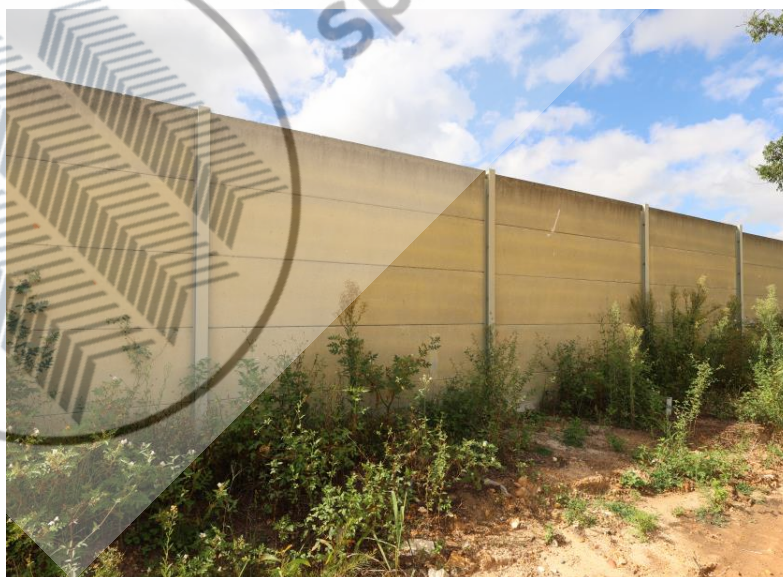
Figure 0036

General view of the boundary wall on Main Road.

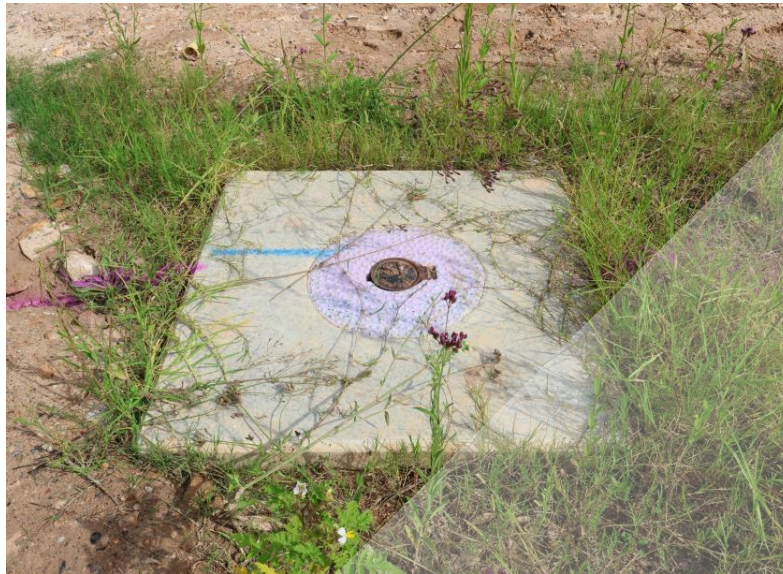
Figure 0037

General view of the pit lid in the grass area on Main Road.

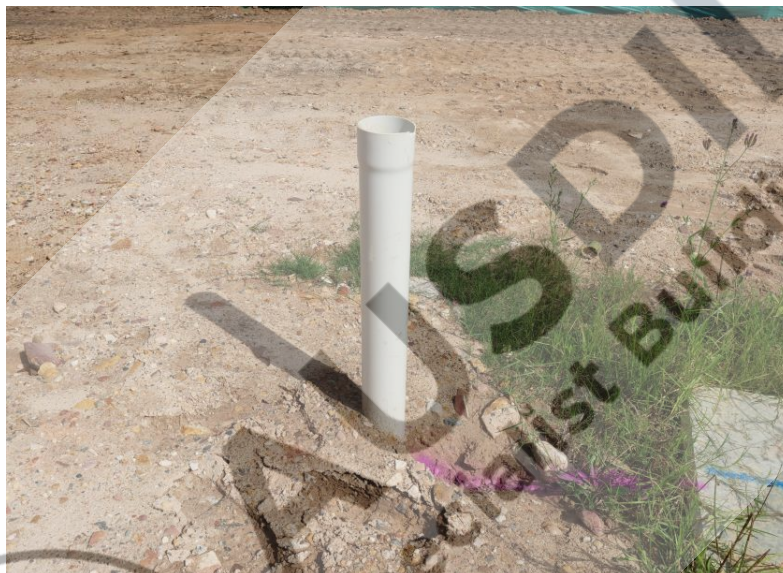
Figure 0038

General view of the pipe in the grass area on Main Road.

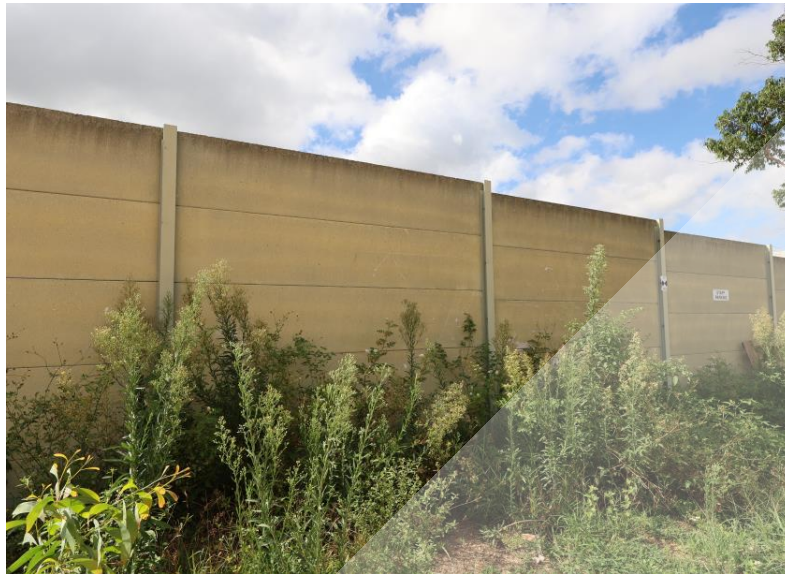
Figure 0040

General view of the boundary wall on Main Road.

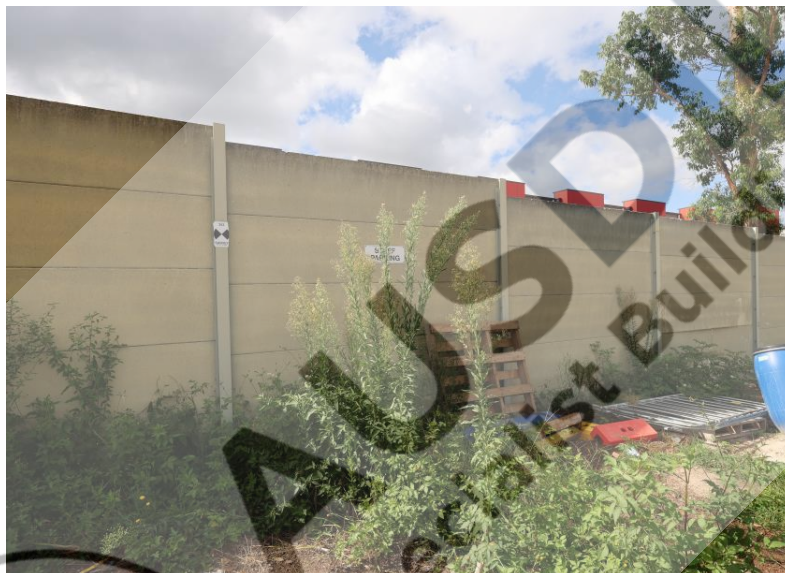
Figure 0041

General view of the boundary wall on Main Road.

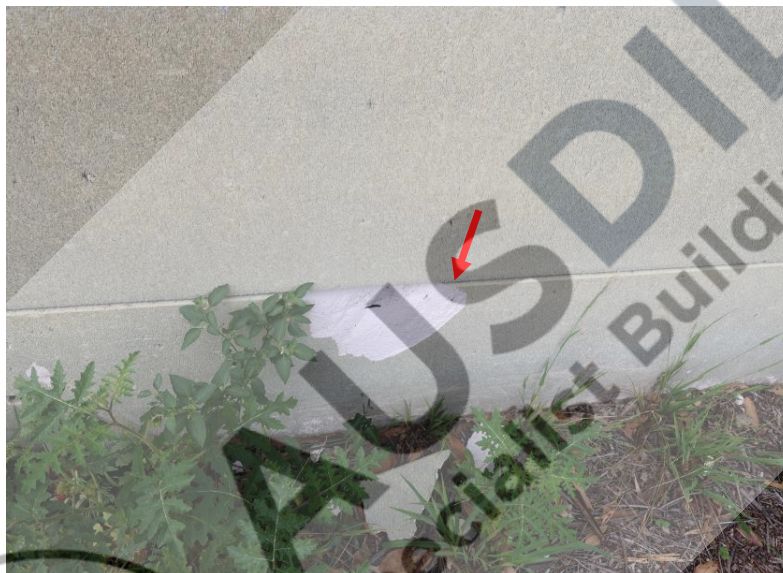
Figure 0050

Chipping in the boundary wall on Main Road.

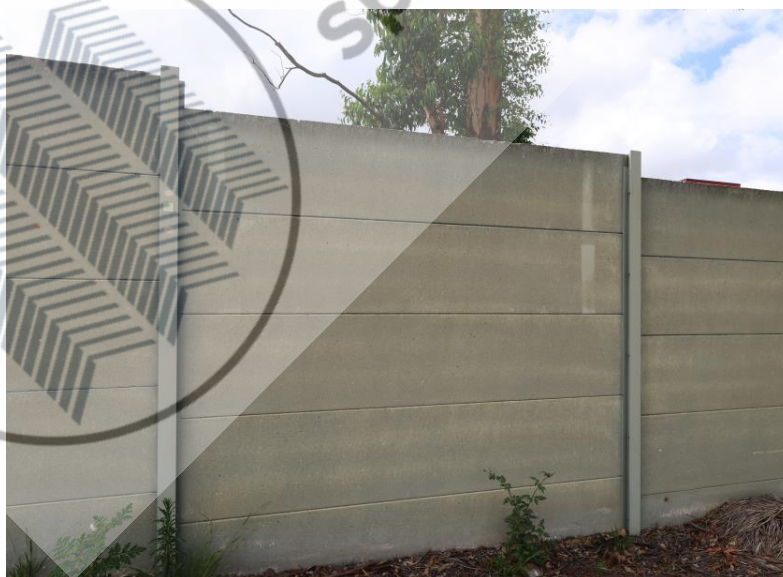
Figure 0051

Chipping in the boundary wall on Main Road.

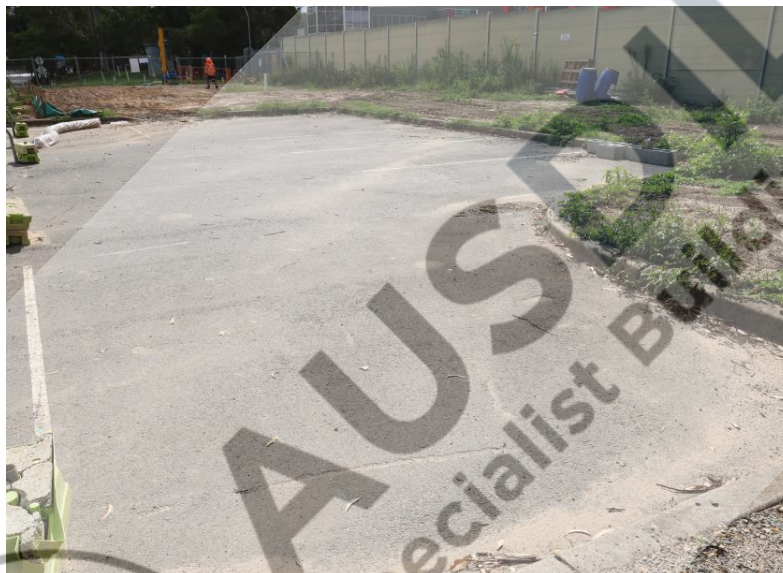
Figure 0071

Moderate cracking in the paving in the site area.
